NATIONAL REGISTER OF HISTORIC PLACES **INVENTORY -- NOMINATION FORM**

TONTEDENTETROTENTED		1 111	14 t T 18/10
SEE INSTRUCTIONS IN HOW T TYPE ALL ENTRIES (O COMPLETE NATIONA COMPLETE APPLICABL		
1 NAME			
HISTORIC			
Fort Davis, Texas			
AND/OR COMMON			
2 LOCATION			
STREET & NUMBER			
Fort Davis, National Historic	Sito	NOT FOR PUBLICATION	
CITY, TOWN	DILE	CONGRESSIONAL DISTR	ІСТ
Fort Davis, Texas	VICINITY OF	21st	
STATE Texas 4	CODE 8	Jeff Davis	243
3 CLASSIFICATION			
CATEGORY OWNERSHIP	STATUS	PRES	ENT USE
_DISTRICT X_PUBLIC	_OCCUPIED	AGRICULTURE	MUSEUM
BUILDING(S)PRIVATE	_UNOCCUPIED	COMMERCIAL	XPARK
_STRUCTURE _BOTH	_WORK IN PROGRESS	_EDUCATIONAL	PRIVATE RESIDEN
X_SITE PUBLIC ACQUISITION	ACCESSIBLE	ENTERTAINMENT	RELIGIOUS
_OBJECTIN PROCESS	AYES: RESTRICTED	A GOVERNMENT	_SCIENTIFIC
BEING CONSIDERED	YES: UNRESTRICTED	_INDUSTRIAL	_TRANSPORTATION
	_NO	MILITARY	_OTHER:
4 AGENCY			
REGIONAL HEADQUARTERS: (If applicable)			
U.S. Government, Department of	f the Interior Nat	ional Park Servi	ce

Fort Davis

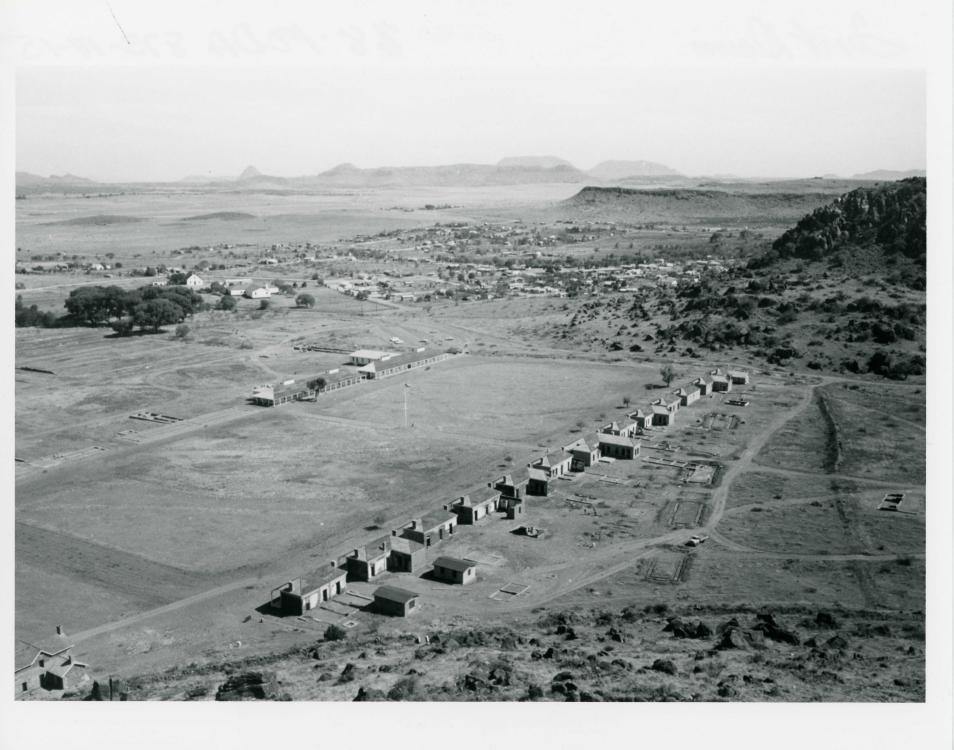
WASO 68-FODA 873-M-15

- 1. Fort Davis, Texas
- 2. Fort Davis, Jeff Davis County, Texas
- 3. Photo by Fred Mang, Jr., 1968 Loc of Neg.: NPS Washington, D.C.
- 4. Restored Officers' Row: south elevation Photo No. WASO 68-FODA-7M NOV 2 1 1978 2063
