United States Department of the Interior
National Park Service
National Register of Historic Places Registration Form

Historic Name: Heermann Store
Other name/site number: Valmont Post Office
Name of related multiple property listing: Historic Farms and Ranches of Bexar County, Texas

Street & number: 4738 W. Loop 1604
City or town: Von Ormy State: Texas County: Bexar
Not for publication: [] Vicinity: [x]

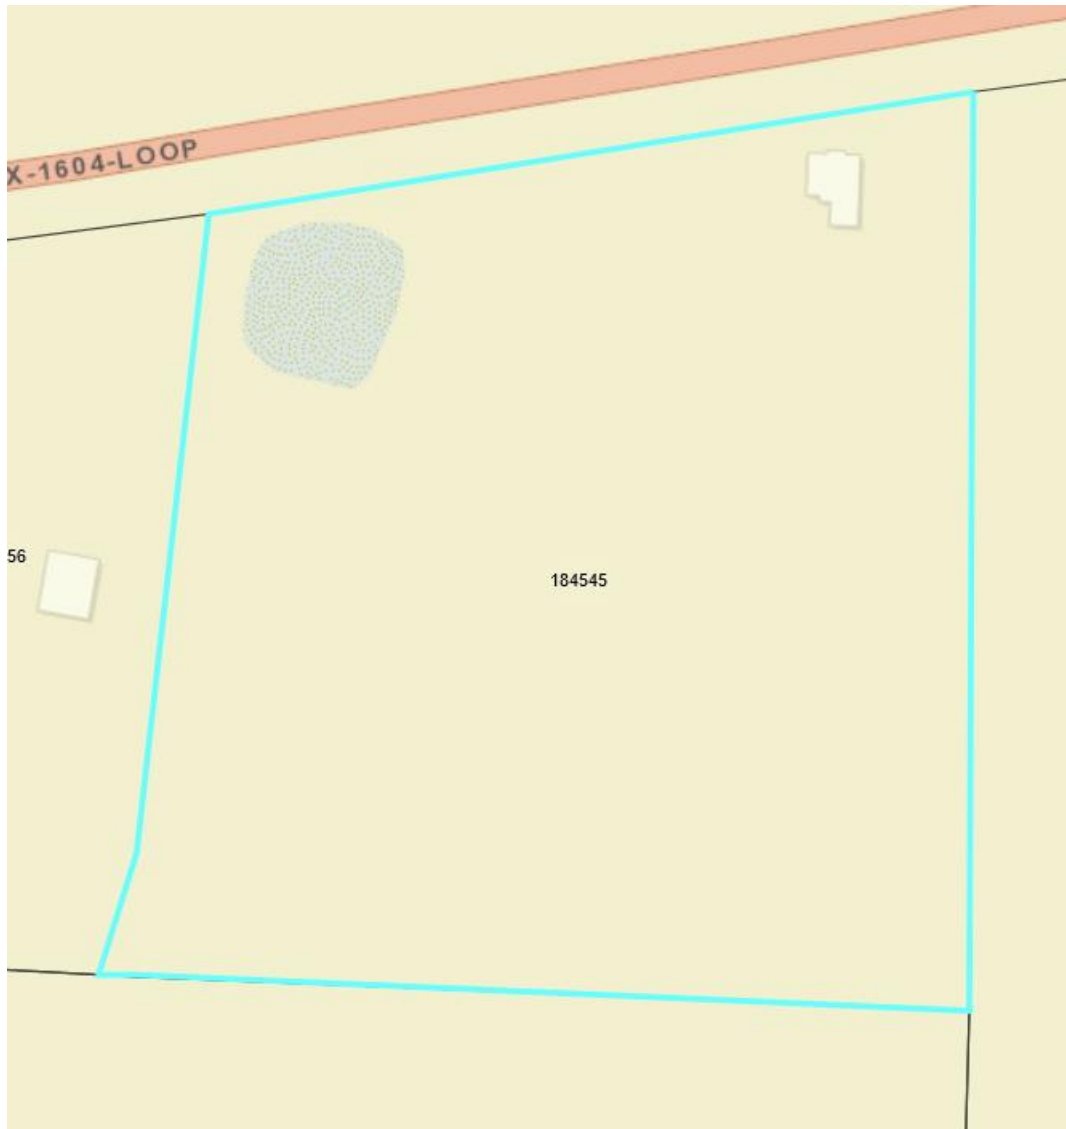
Map 4: Bexar County Appraisal District map showing boundary, accessed July 29th, 2022. The historic district includes approximately 11.28 acres and follows the current legal parcel. The legal parcel is identified by the Bexar Appraisal District as CB 4203 P-9 ABS 188 (Property ID: 184545) in the vicinity of Von Ormy, Bexar County, Texas.

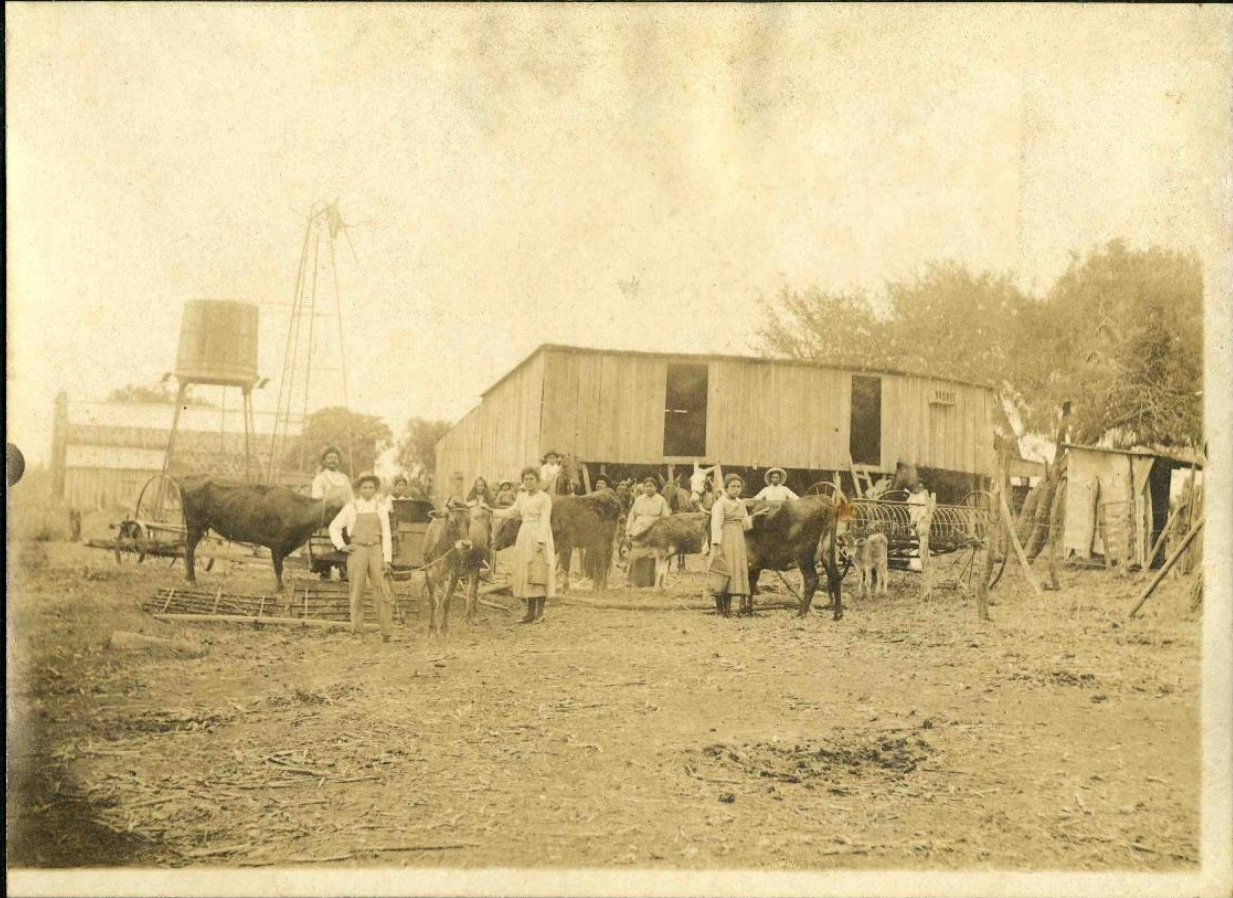
Figure 11: C. 1910 photo of what may be Hernandez family in front of barn (demolished) on Heermann Store property, courtesy San Antonio Conservation Society.

The biggest changes to the property overall were the removal what appears to have been a barn, sheds, water tower, and windmill at an unknown date (Figure 11), as well as the historic addition of Sheds A and B around 1900. A non-historic flag pole was positioned in front of the store, and has since been removed. The house and garage were added in the 1950s and Shed C was added in 2022 outside the period of significance. The pond appears to have been filled in between 2004 and 2008.¹²

During the late 19th century cotton production rose in Bexar County. While the county produced less cotton than other Texas counties, cotton served as an important part of the local agricultural economy.⁴⁰ Since Heermann's Frost Bank stub showed he purchased seed cotton, it can be assumed he was growing and ginning it while running the store. It's important to note that the design of the stone cotton gin differed from the many other contemporaneous wood frame and corrugated metal examples found in Central Texas.⁴¹ It's likely that under the Heermann ownership the barn, sheds, water tower, and windmill were also added near the store and cotton gin (Figure 11).

When John Easterly (1861-1939) and his wife Johanna Lohrberg Colmes Easterly (1861-1912) acquired the Heermann Store property it was largely used for agricultural and commercial purposes.⁴⁷ The store was used as residence for sharecroppers, likely as a saloon, and for produce storage, while the cotton gin remained in use. According to a historic photograph, the barn, sheds, water tower, and windmill were extant during the Easterly ownership (Figure 11). It's also likely that during this period, both Sheds A and B were added to the property.

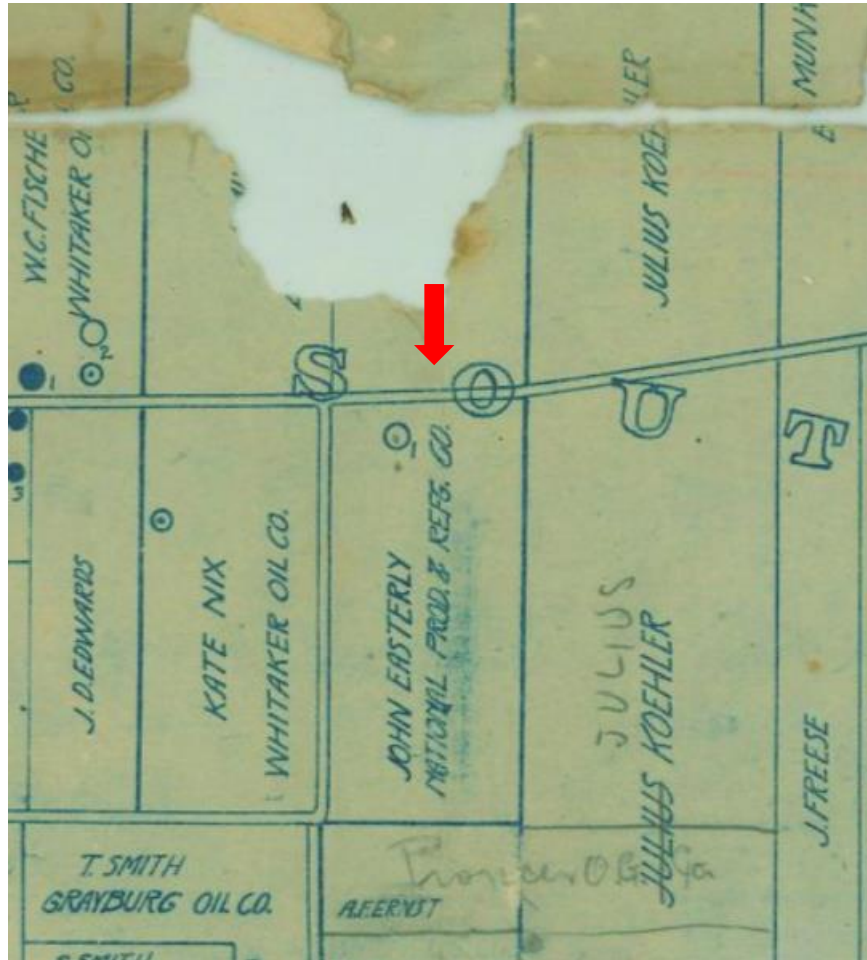
Figure 13: Map of Bexar County Oil Fields, 1919, showing Heermann Store property listed as John Easterly National Produce & Refrigeration Company. *Texas General Land Office*, accessed August 3, 2022, <https://s3.glo.texas.gov/glo/history/archives/map-store/index.cfm#item/79307>.

A 1919 Map of Bexar County Oil Fields lists the property with John Easterly as owner of the National Produce and Refrigeration Company, indicating the store was likely used for storage and sale of produce during the 1910s.⁴⁸ The large storage basement may have accommodated that kind of enterprise (Figure 13).

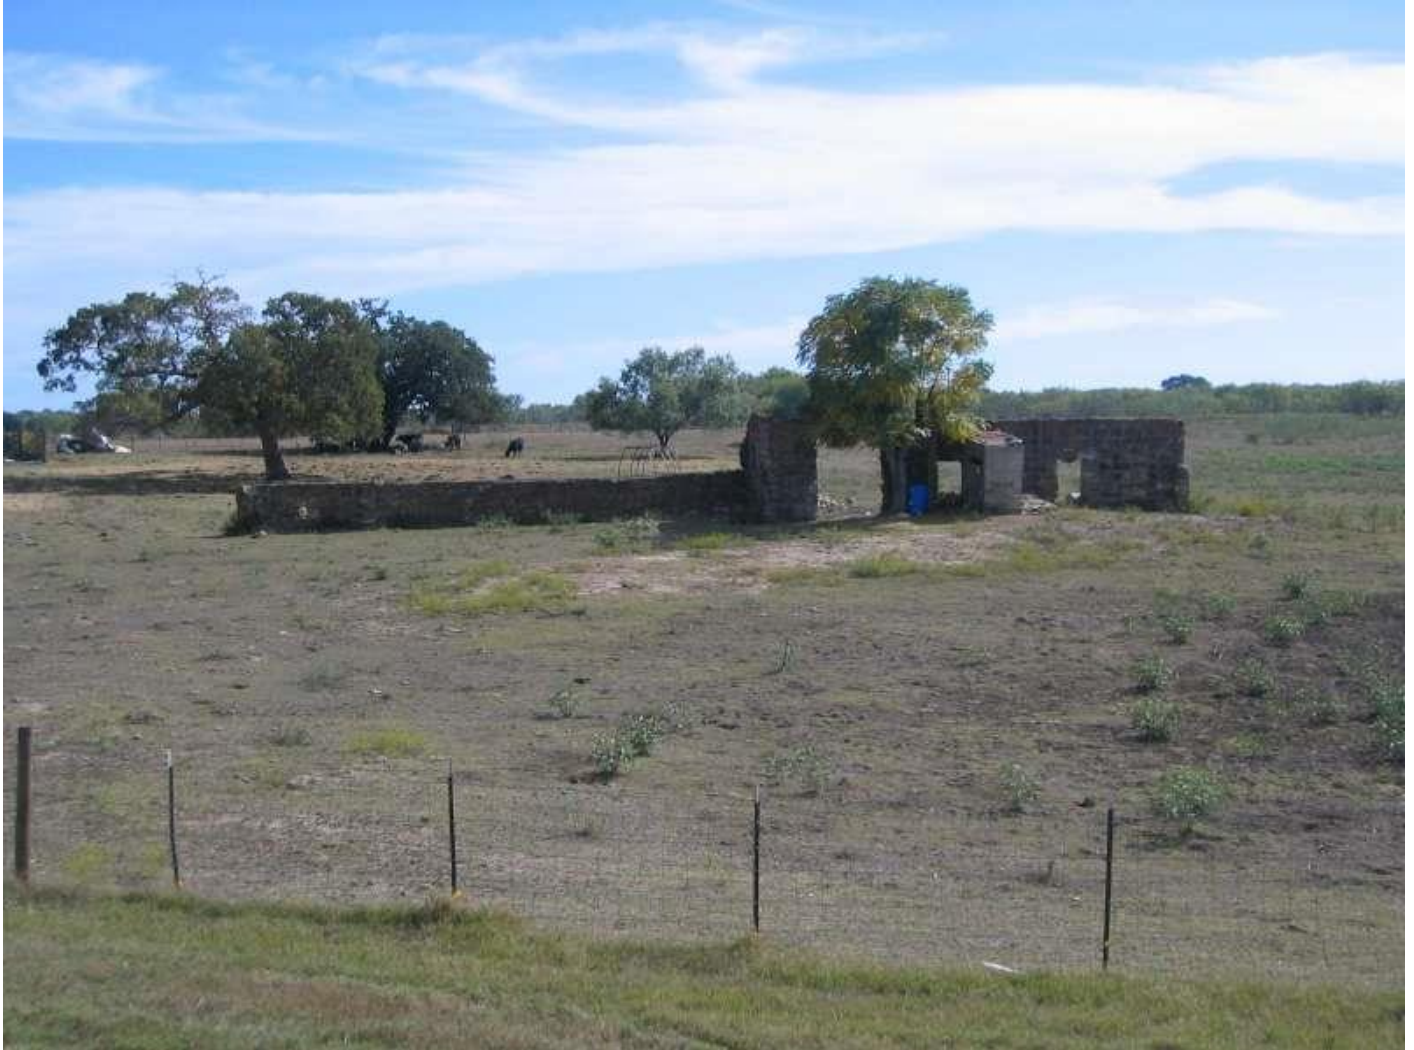
Figure 16: C. 2007 photo of ruins on Heermann Store property with vegetation removed, courtesy San Antonio Conservation Society.

Resource 8: Ruins of Cotton Gin (Contributing Site) (Figure 16, Photos 17-20)

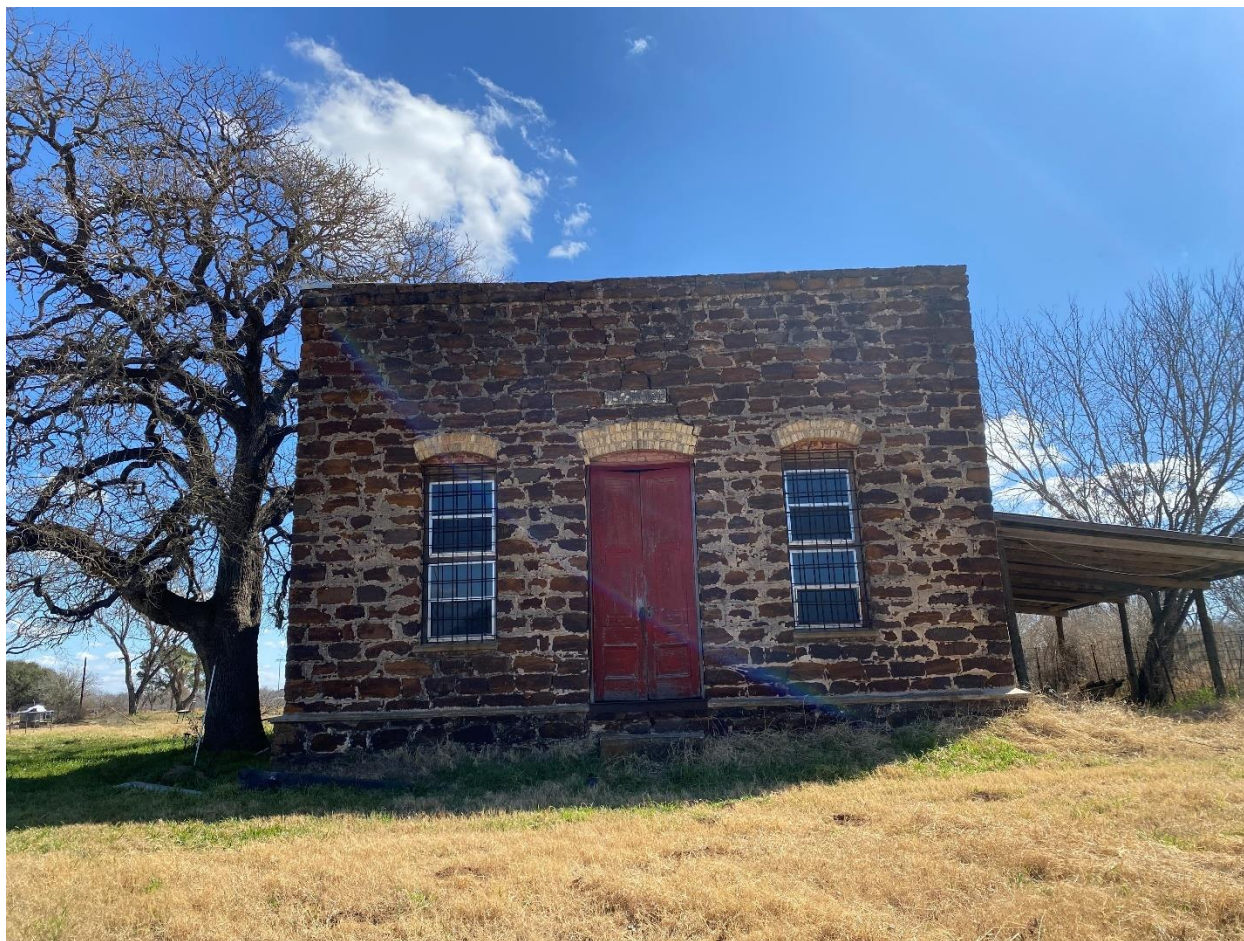
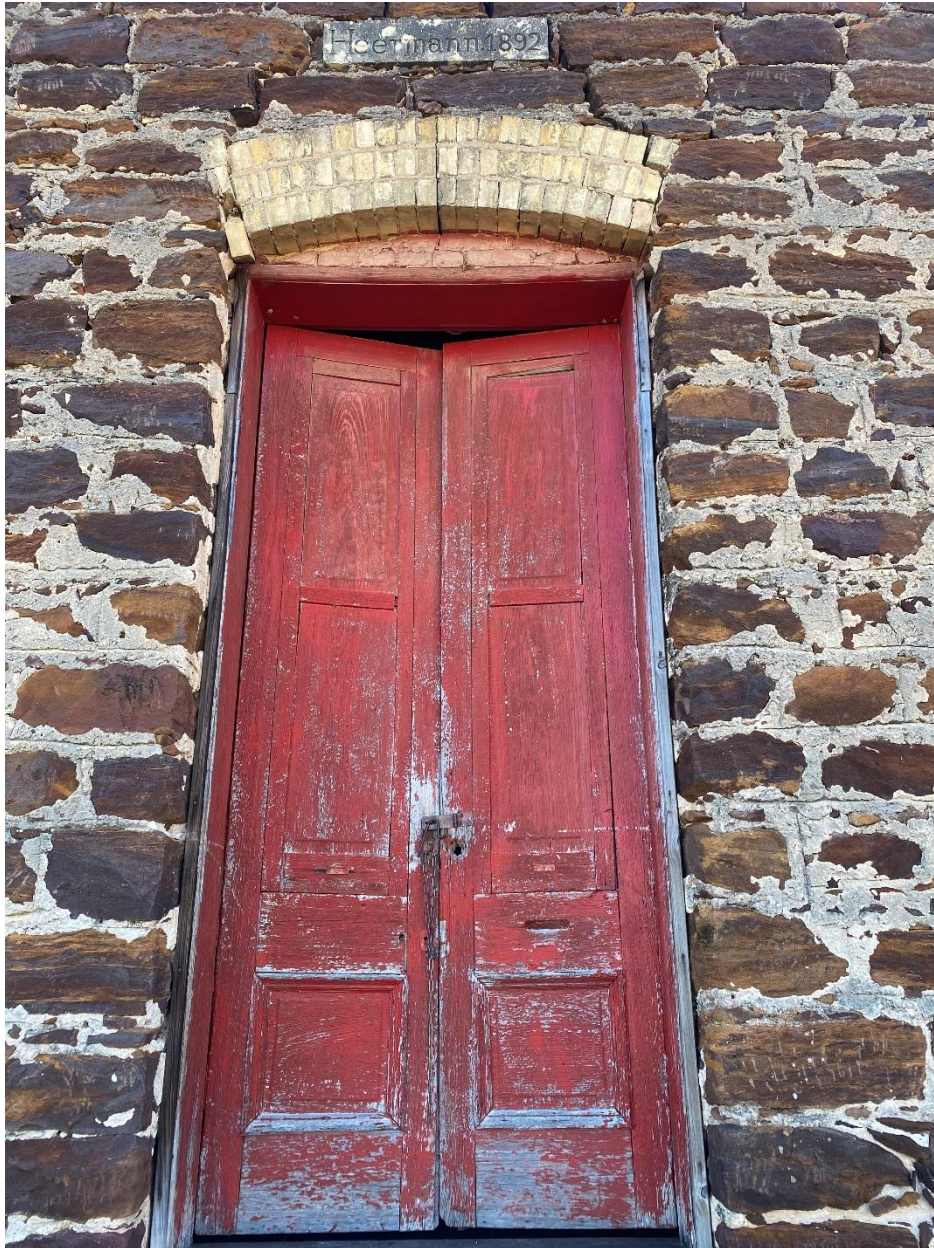
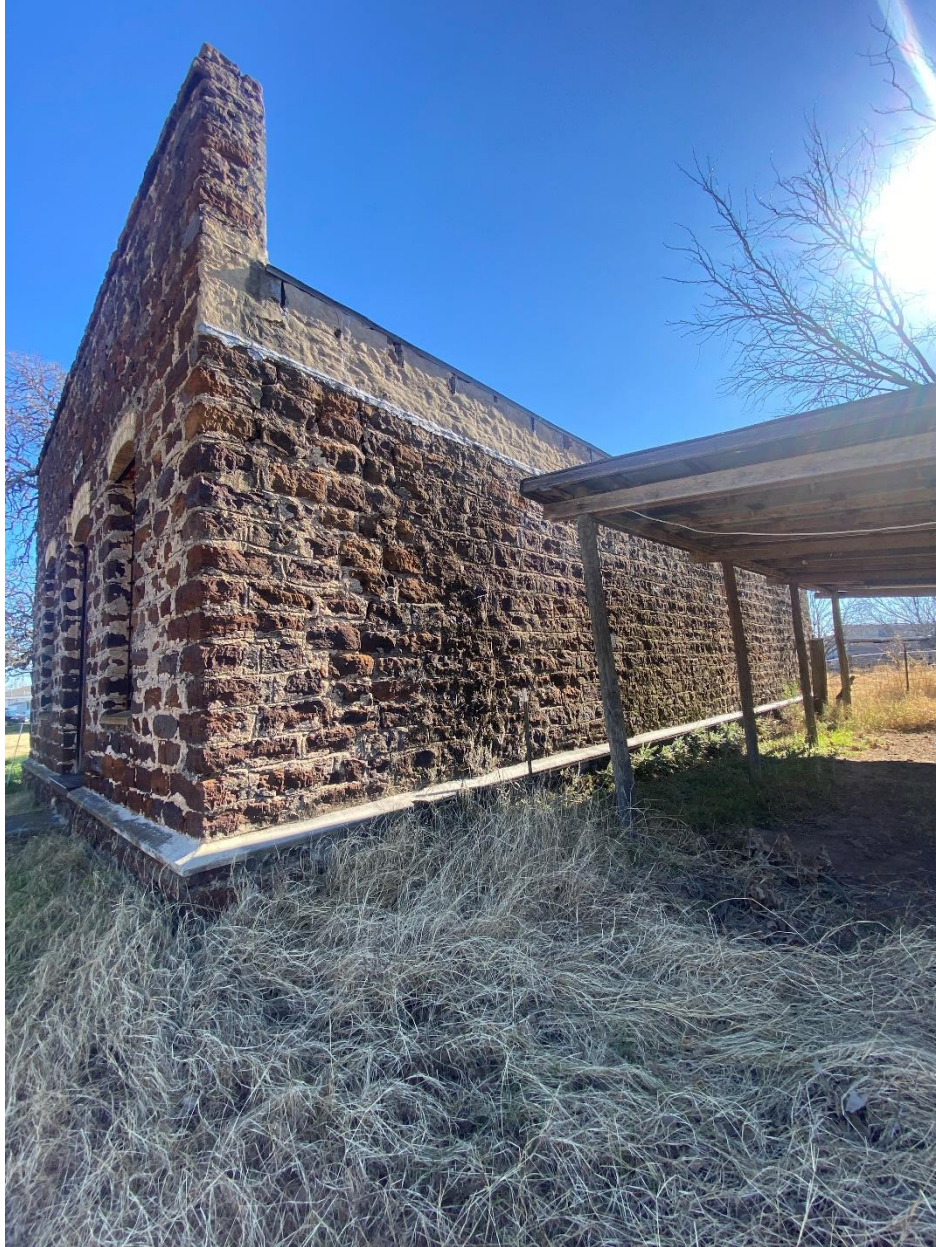
Photo 1: Primary (west) elevation of Heermann Store, camera facing southeast.

Photo 2: Primary (west) elevation of Heermann Store showing main entrance, camera facing southeast.

Photo 3: Primary (west) and south elevations of Heermann Store, camera facing east.

Both the foundation and exterior walls are constructed of dark reddish brown semi-dressed sandstone block in a coursed to semi-coursed pattern and lime-based mortar. The stone basement walls are 24' thick from the basement floor to the water table. Foundation walls appear to be in good condition with only minor areas of eroded mortar, primarily near the ground surface. The water table is a Portland-cement-based concrete poured into a form and sloped on top to shed water. Vents between the ground surface and the water table are braced with vertical iron rounds and horizontal iron plates. The exterior stone walls above the water table are constructed of the same materials but only measure 18 inches thick. Walls are mortared with lime-based, coarse-sand-tempered mortar that extrudes out onto the stone surface. Lines indicating the centers of mortar joints were decoratively scored into the mortar with a trowel when wet.

The primary (west) and rear (east) elevations each have two sets of double hung replacement windows positioned at either side of the double wood doors. Brick arches are located above all windows and doors. The brick arches on the primary elevation are likely red brick painted with a buff color, while rear elevation arches appear to be red brick. A cut limestone block is centered above the main entrance on the primary façade engraved with "Heermann 1892." The primary elevation also features a single course of stone providing modest detail for the parapet. On this elevation, a vertical crack runs from the raised parapet down to the brick arch. There is evidence of a roof leak (now repaired) in the area of the crack. On the rear elevation, much of the mortar has eroded over the southeast window.

The primary and rear elevations have two original fenestrations framing each of the doorways. The windows have sloped sills of Portland-cement-based poured concrete. Original vertical and horizontal iron bars cover each window. Window jambs and interior trim are likely original, and grooves in the side jambs for sash cords can still be seen. All original window sashes are missing. A historic photograph shows that the original windows were double hung, four-over-four light (Figure 10). Each of the sets of window sashes have been replaced with a pair of one-over-one aluminum windows, one above the other, framed with scrap lumber fastened to the original jambs. Although the sashes are missing, the remaining window elements are in good condition.

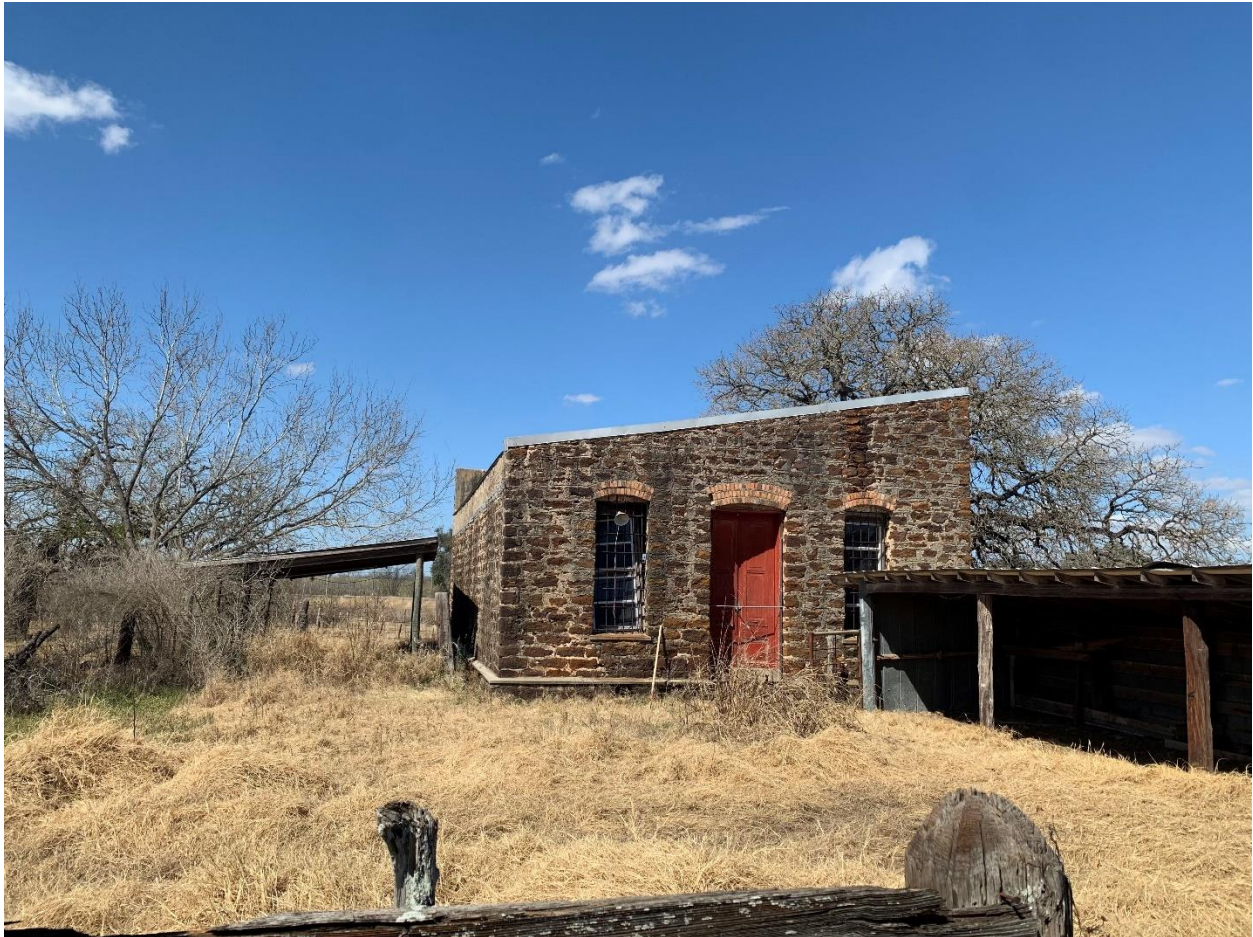
Photo 4: Rear (east) elevation of Heermann Store showing Sheds A and B, camera facing northwest.

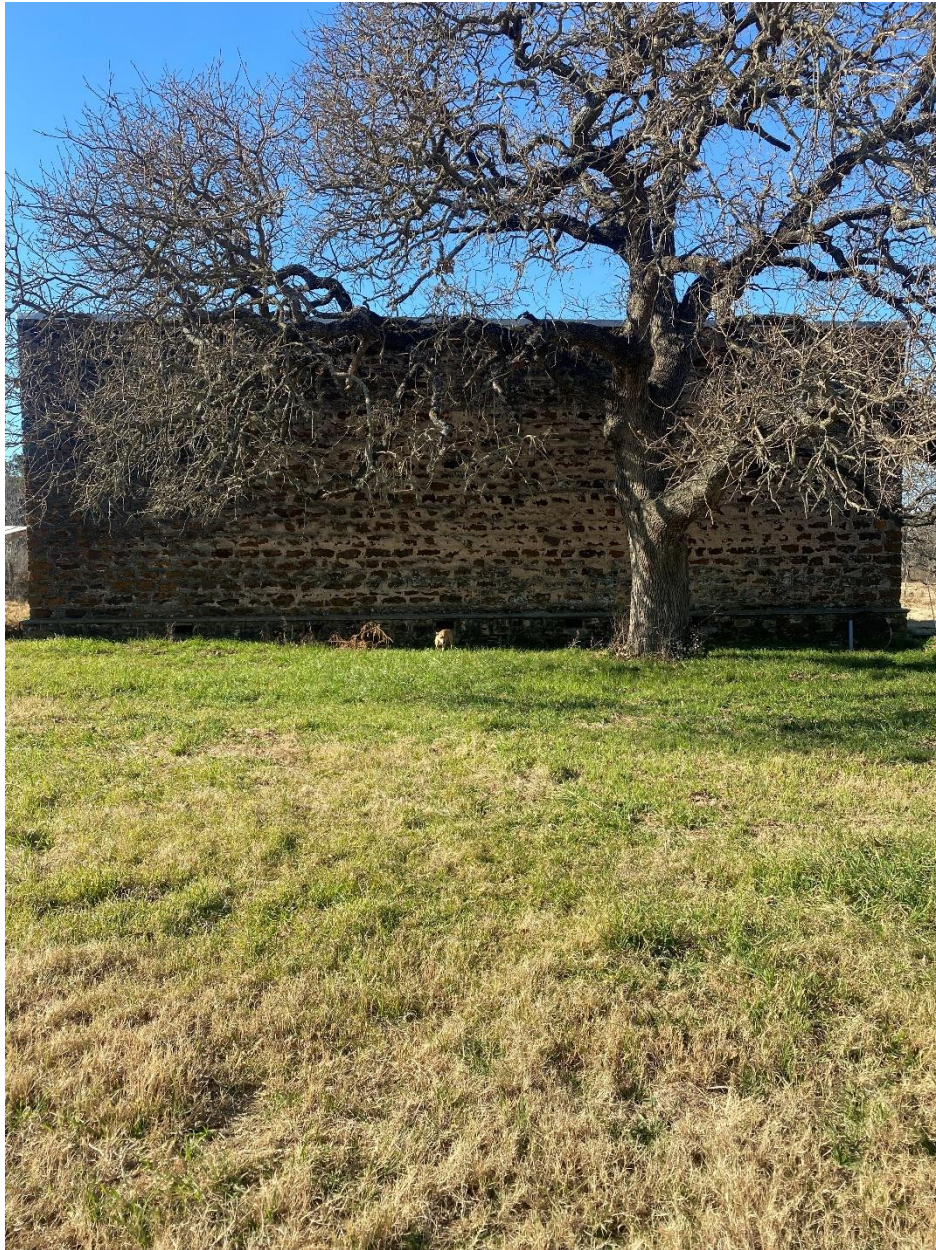
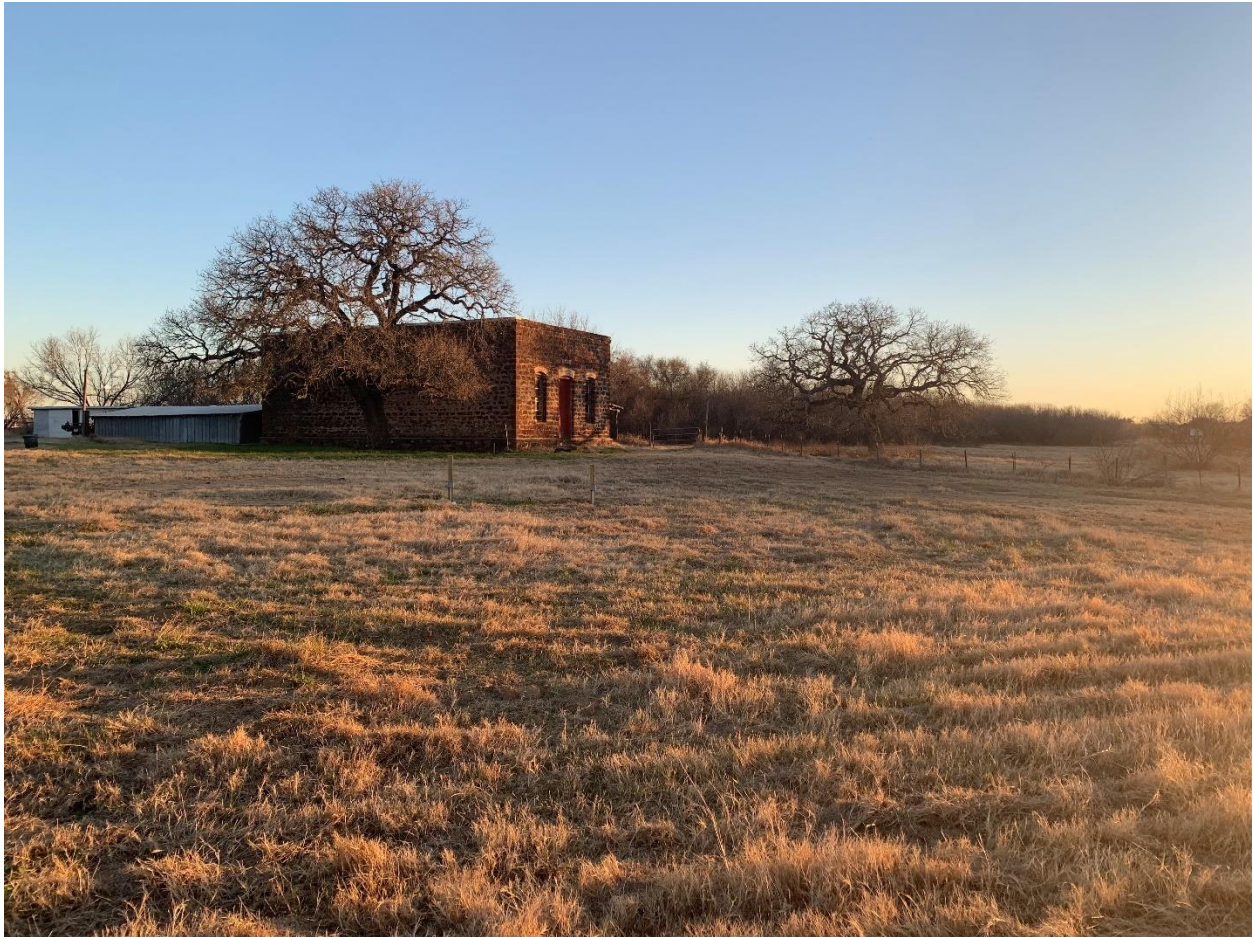
Photo 5: North elevation of Heermann Store, camera facing southwest.

Photo 6: Primary (west) and north elevations of Heermann Store, camera facing south.

The north elevation is partially obscured by a Post Oak tree and does not appear to have any cracking. The five vents below the water table are somewhat evenly spaced along this elevation. The south elevation has four vents below the water table. Like the primary and rear elevations, conditions of the walls are good, and the majority of the mortar joints are intact.

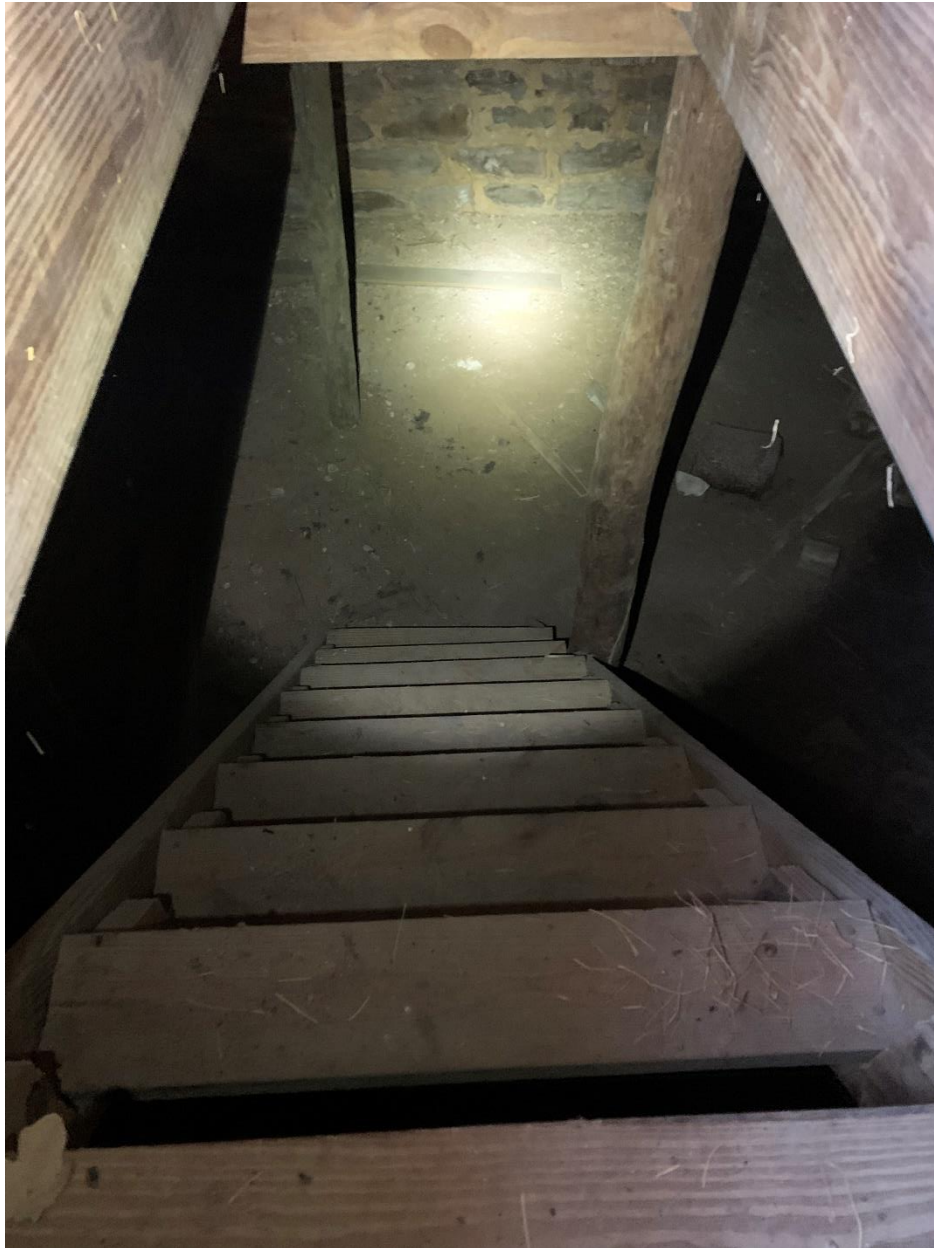
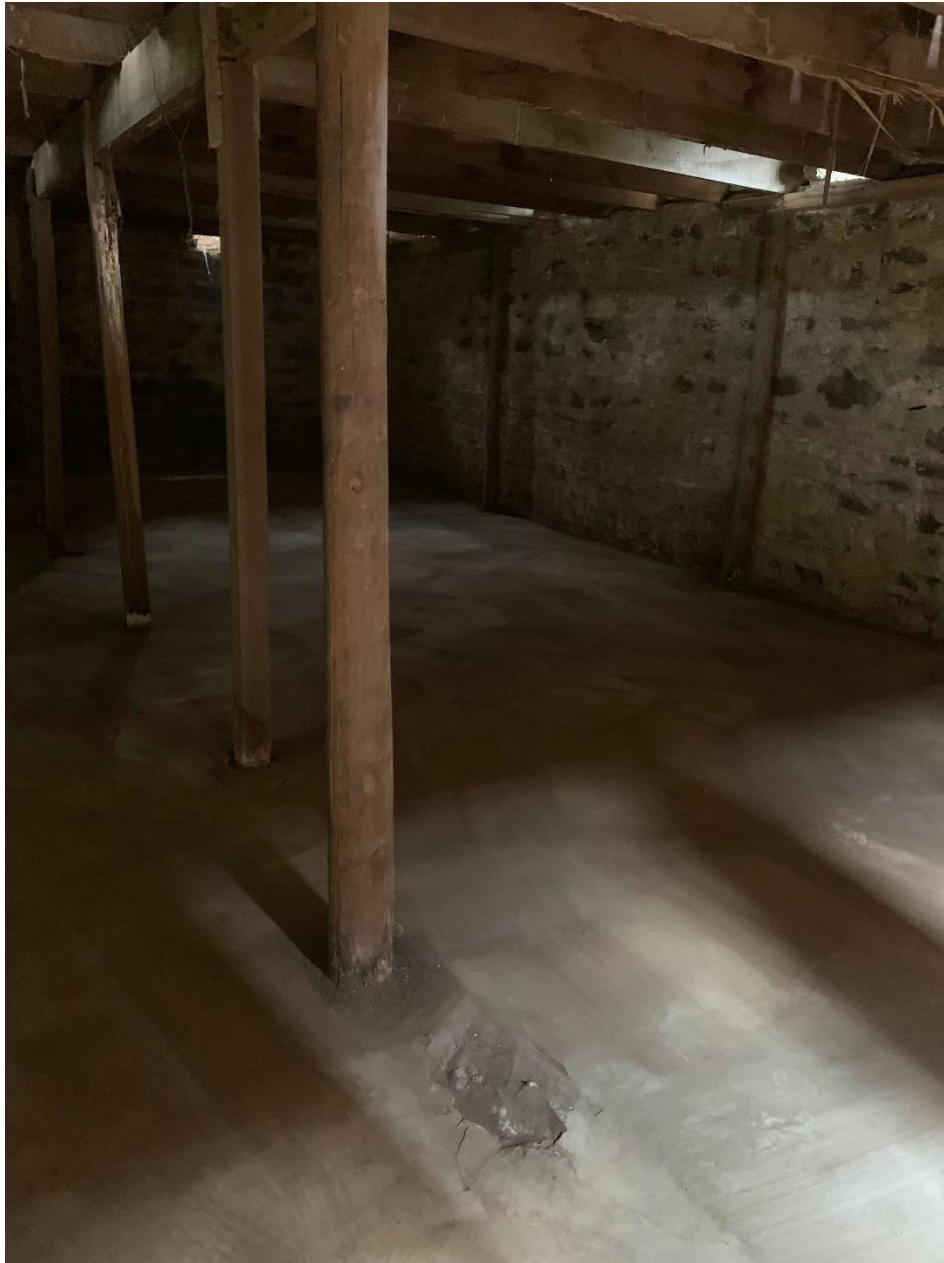
Photo 7: Heermann Store cellar.

Photo 8: Heermann Store cellar.

The floor system is supported by posts and beams (Photos 7-8). Posts, beams, and joists are a mixture of rough-sawn and plane-sawn lumber, and much of the members of the structural system have been replaced. The basement floor is a hardened surface covered with dirt. The ceiling is roughly 10 feet high.

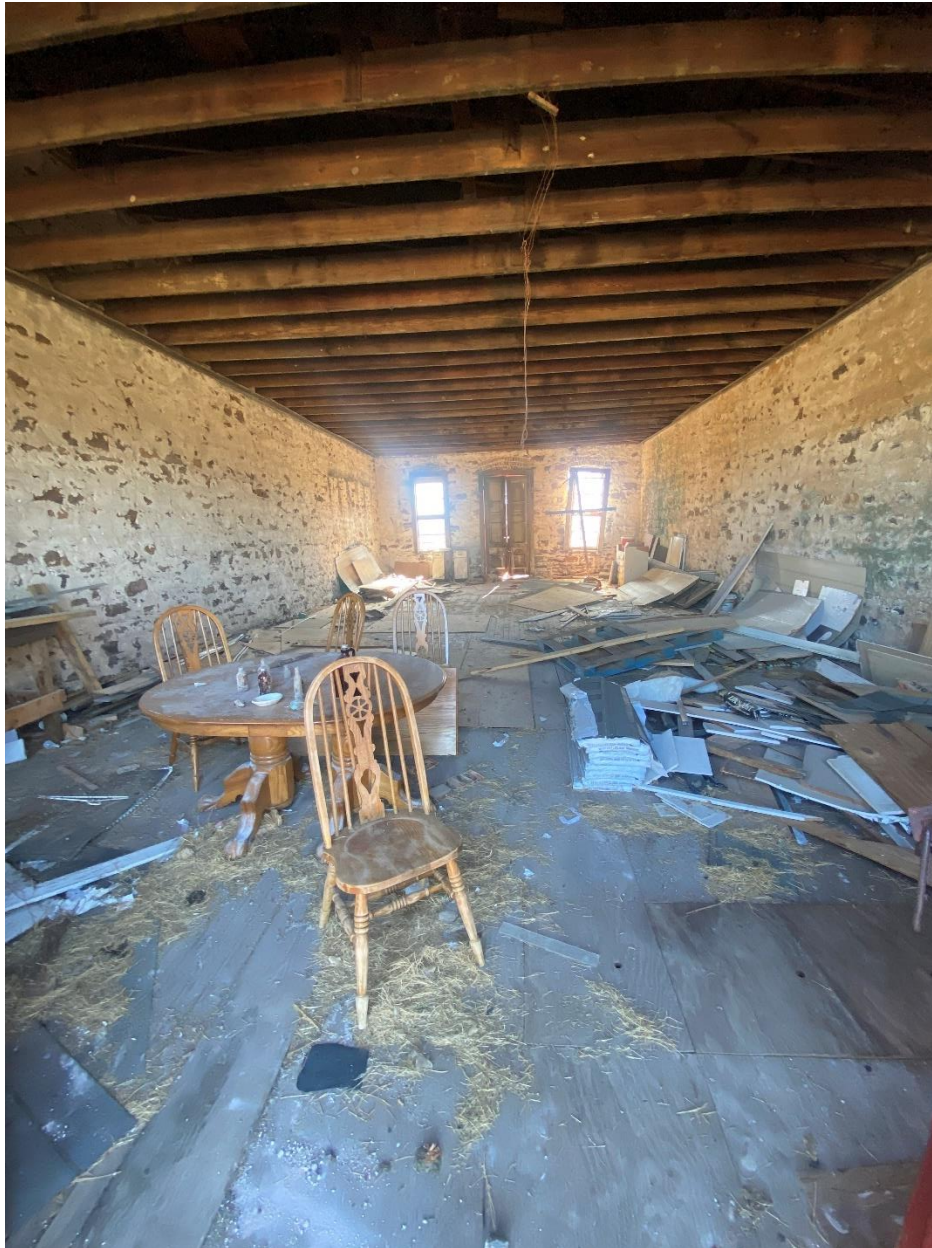
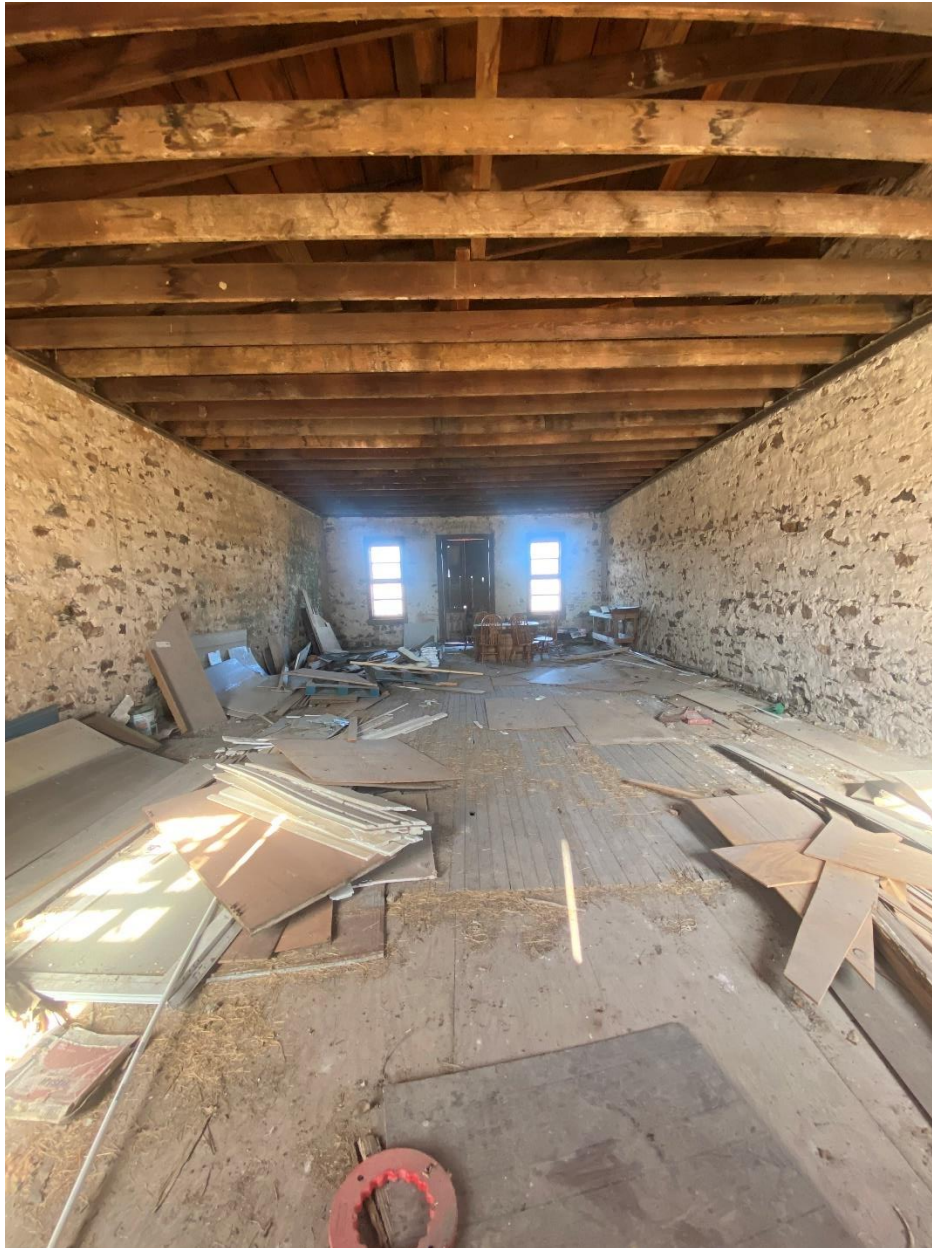
Photo 9: Heermann Store ground floor, camera facing southeast.

Photo 11: Heermann Store ground floor, camera facing northwest.

The main floor has a large open floor plan (Photos 9, 11). The wood floor planks vary in width. Most of the historic flooring is 3' wide, with other planks that are 6' and 12' wide. The flooring is nailed directly to the floor joists. Some of the flooring has been replaced with plywood. The stairway is a replacement and may not be in its original location.

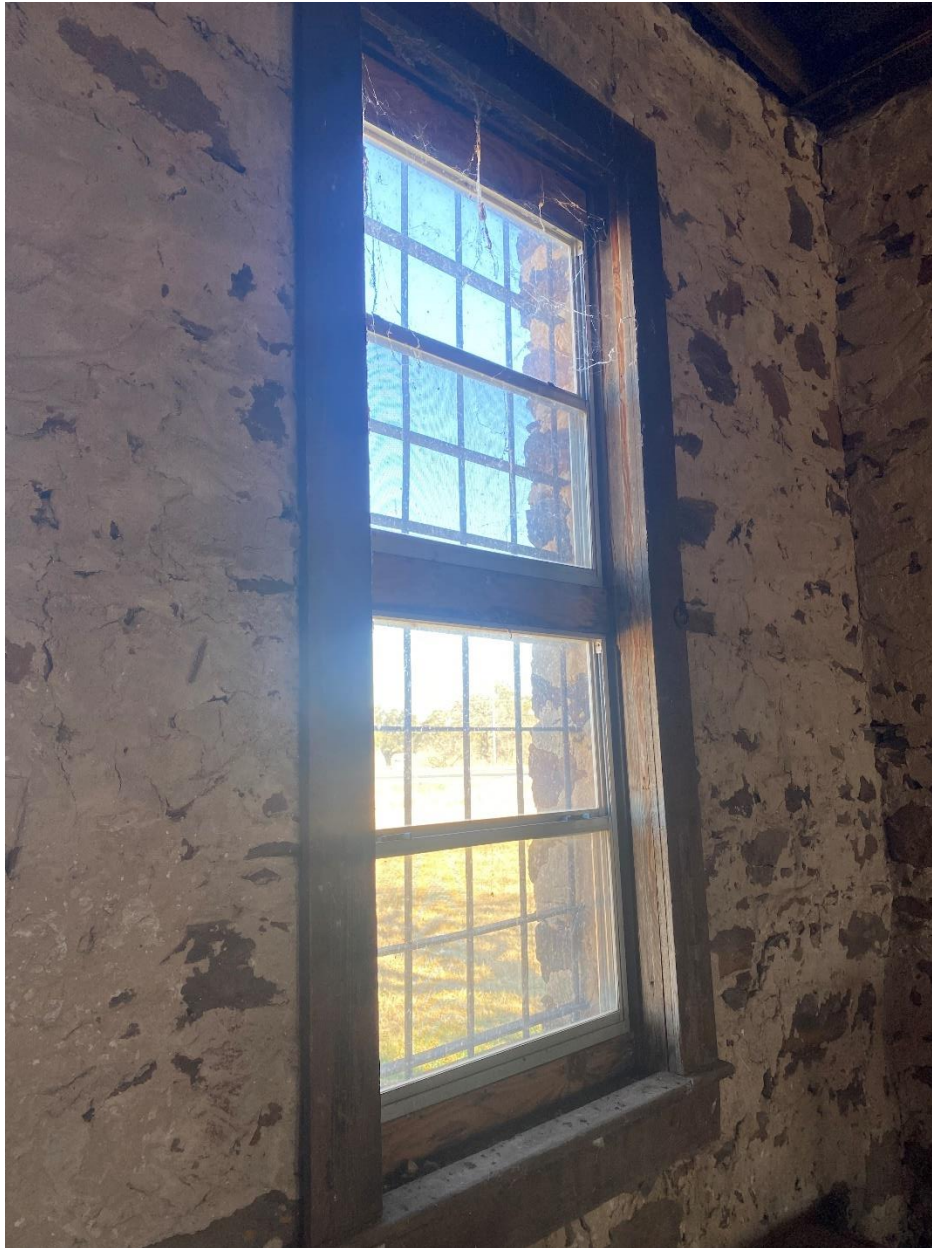
Photo 10: Replacement window in original openings, Heermann Store.

The Heermann Store is remarkably intact and changes are minor. While parts of the original historic windows remain, each of the sets of window sashes have been replaced with a pair of one-over-one aluminum windows, one above the other, framed with scrap lumber fastened to the original jambs. The structural system in the basement has replacement wood, the basement stairs were replaced, and some of the main flooring was replaced. Some cracking from erosion on the exterior appears to have been repaired on the interior. The flashing on the parapet and roof appears to be replacement. These changes likely occurred in the mid-late 20th century. An electrical panel was added in 2022.

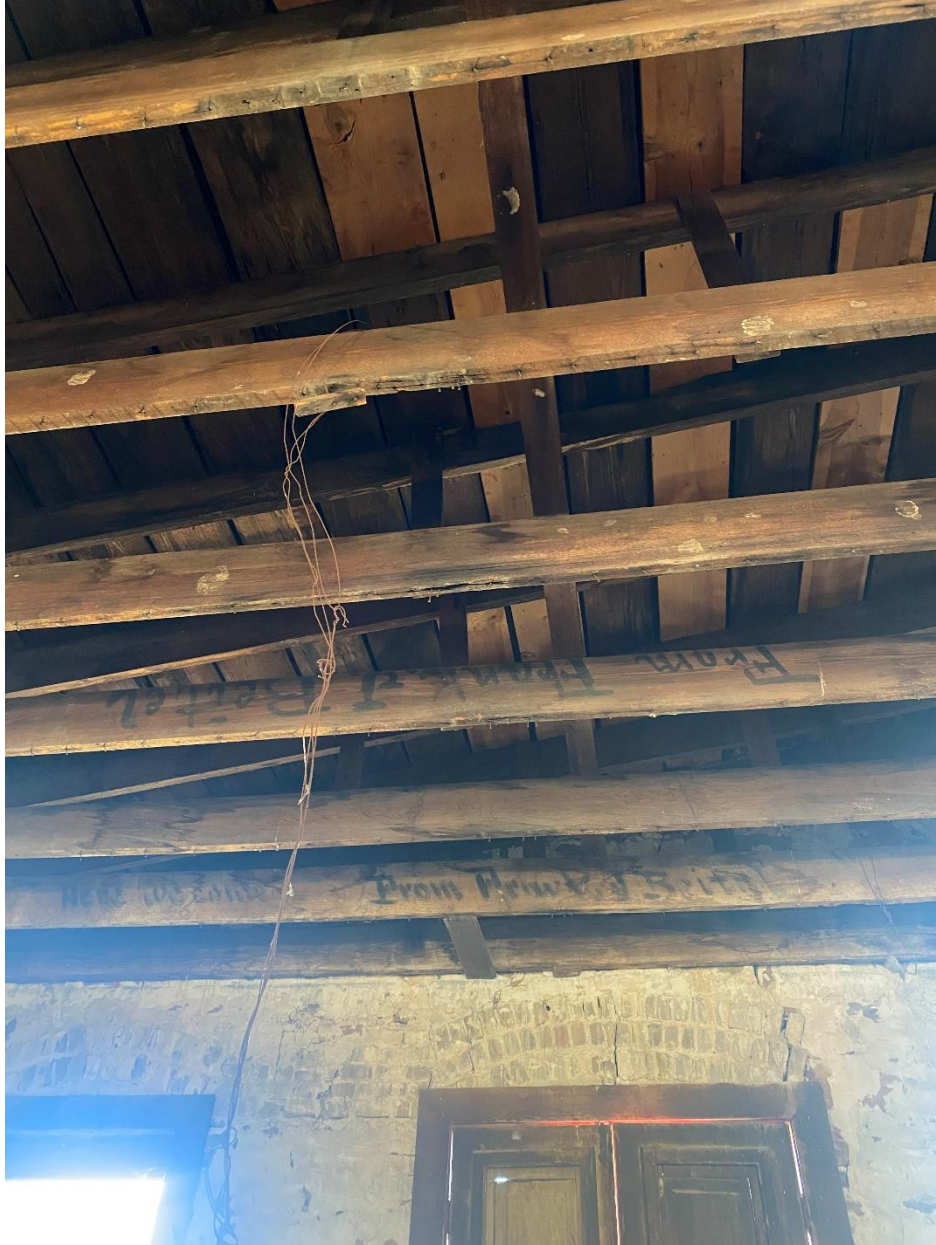
Photo 12: Heermann Store original rafters from Beitel Lumber Company of San Antonio. Rafters read “From Frank J. Beitel.”

The shed roof system is constructed of plane-sawn rafters built into the stonemasonry walls and fastened to ceiling joists on the west wall (low end). The ends of the rafters sit on ledges on top the walls as well as being built into the masonry. Ceiling joists are also plane sawn, and they are braced to rafters with vertical members in addition to being fastened to the rafters at their ends at the west wall. The roof deck is constructed of shiplap plane-sawn boards of varying sizes. Most of the boards appear to be original with some replacements. The roof exterior is covered in replacement composite shingles. The top of the east (rear) elevation wall is slanted for the shed roof and has a strip of aluminum or galvanized steel flashing. Metal flashing is also visible along the north and south elevations.

Interiors walls are covered primarily with a lime-based, fine-sand-tempered plaster, with a few minor areas of repair plaster. Most of the interior plaster remains intact. When facing the primary entrance, the door on the left has a lockset, which is likely original. The lockset is opened with a skeleton key. The words "From Frank J. Bietel" are shown on the rafters, indicating the original wood was purchased Bietel Lumber Company in either San Antonio or Kerrville (Photo 12).⁵

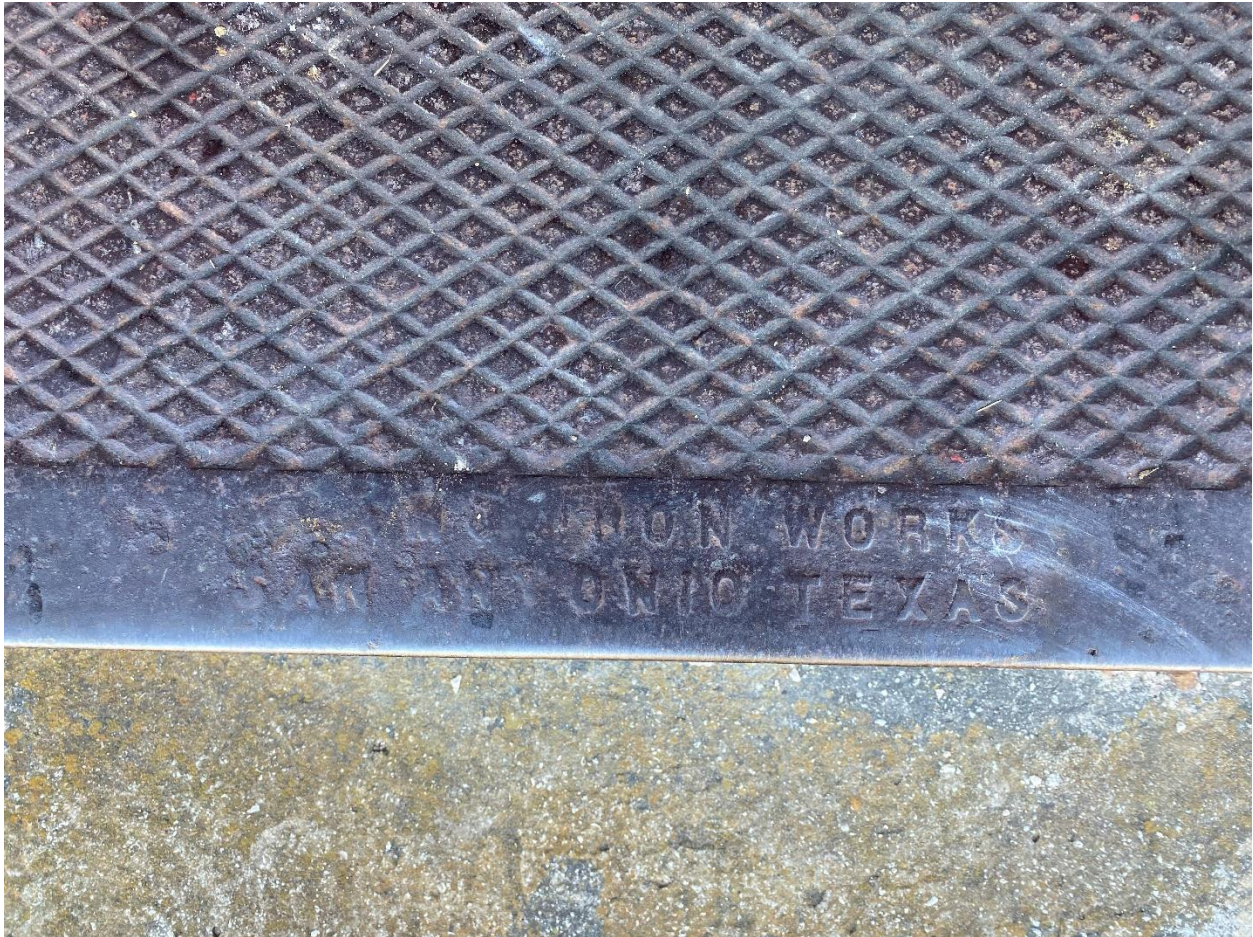
Photo 13: Original floor plate at main entrance of Heermann Store. Reads “Alamo Iron Works San Antonio Texas.”

Each of the four original doors in the building are three-panel style wood doors. The upper two panels form a removable piece above the lock rail. This removable piece fits into the top of the door with a metal pin and has a handle at the bottom of the piece. On the interiors of doors are the remnants of three-light fixed windows with two horizontal muntins, but glass has since been removed. The doors are currently painted red on the exteriors and unpainted on interiors. There are no layers of paint underlying the red paint indicating the doors were likely not painted historically. Thresholds outside both sets of doors are cast iron plates that bear the name "Alamo Iron Works."
