United States Department of the Interior
National Park Service
National Register of Historic Places Registration Form

Historic Name: Heermann Store
Other name/site number: Valmont Post Office
Name of related multiple property listing: Historic Farms and Ranches of Bexar County, Texas

Street & number: 4738 W. Loop 1604
City or town: Von Ormy State: Texas County: Bexar
Not for publication: [] Vicinity: [x]

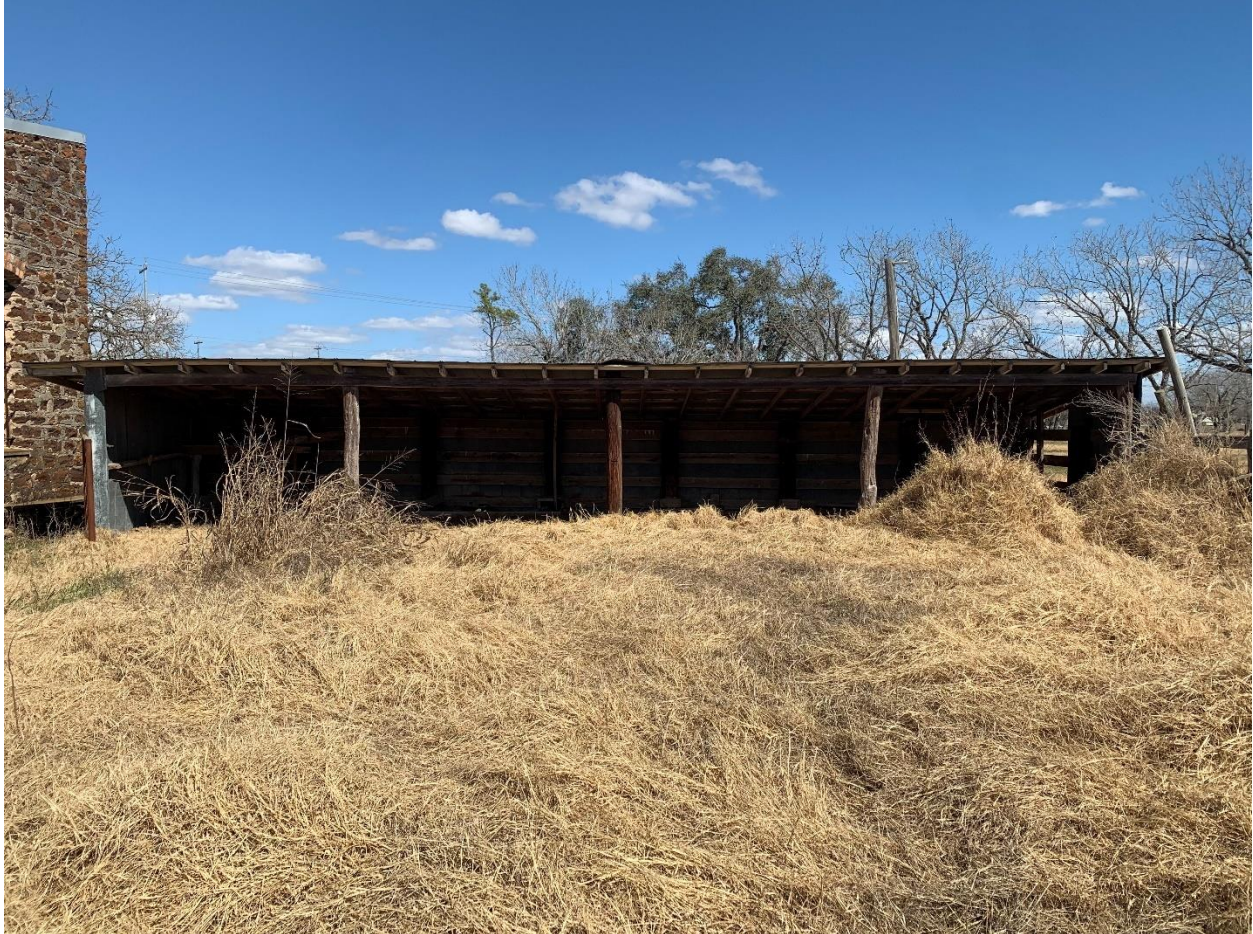
Photo 14: Southwest elevation of Shed A. Camera facing northeast.

Shed A is a rectangular wood framed and corrugated metal structure located directly behind the Heermann Store. Oriented southwest toward Shed B, it was likely built c. 1900. It has a slanted shed roof, a dirt floor, and four open bays in the primary (southwest) elevation. It was likely used as a barn for livestock or for machinery storage.

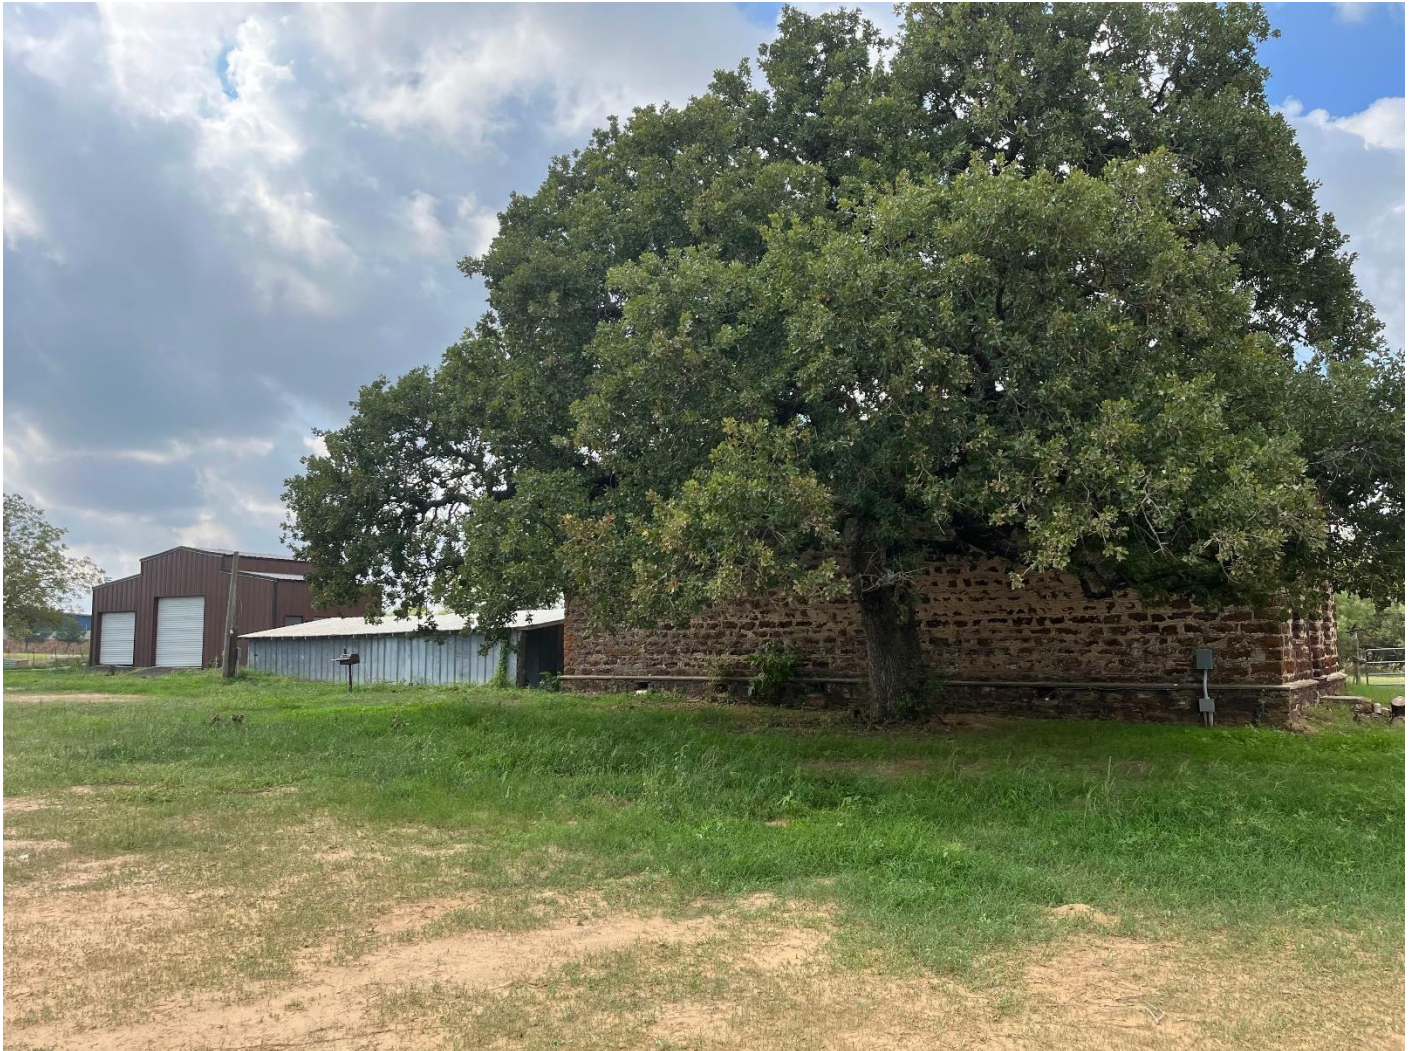
Photo 15: Northeast elevation of Shed C shown at rear of Heermann Store. Camera facing southwest.

Shed C is a rectangular metal building located to the southeast of Shed B. Built in 2022, it replaced an earlier non-contributing 1974 rectangular wood framed structure. It has two large vehicle doors on the northeast elevation and three pedestrian doors on the northwest elevation. The building is non-contributing due to age.

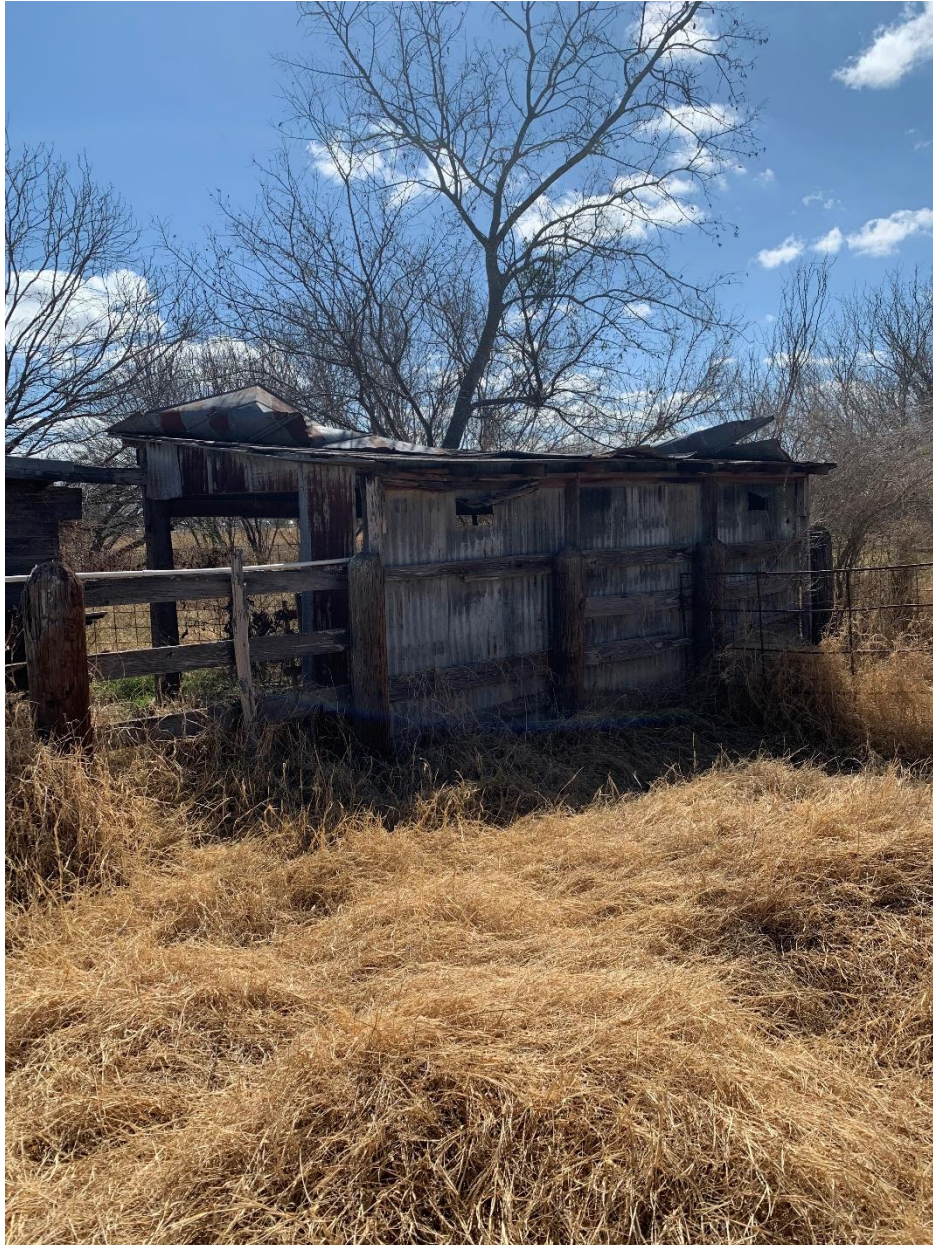
Photo 16: Northwest and northeast elevations of Shed B. Camera facing south.

Resource 4: Shed B (Contributing Structure) (Photo 16)

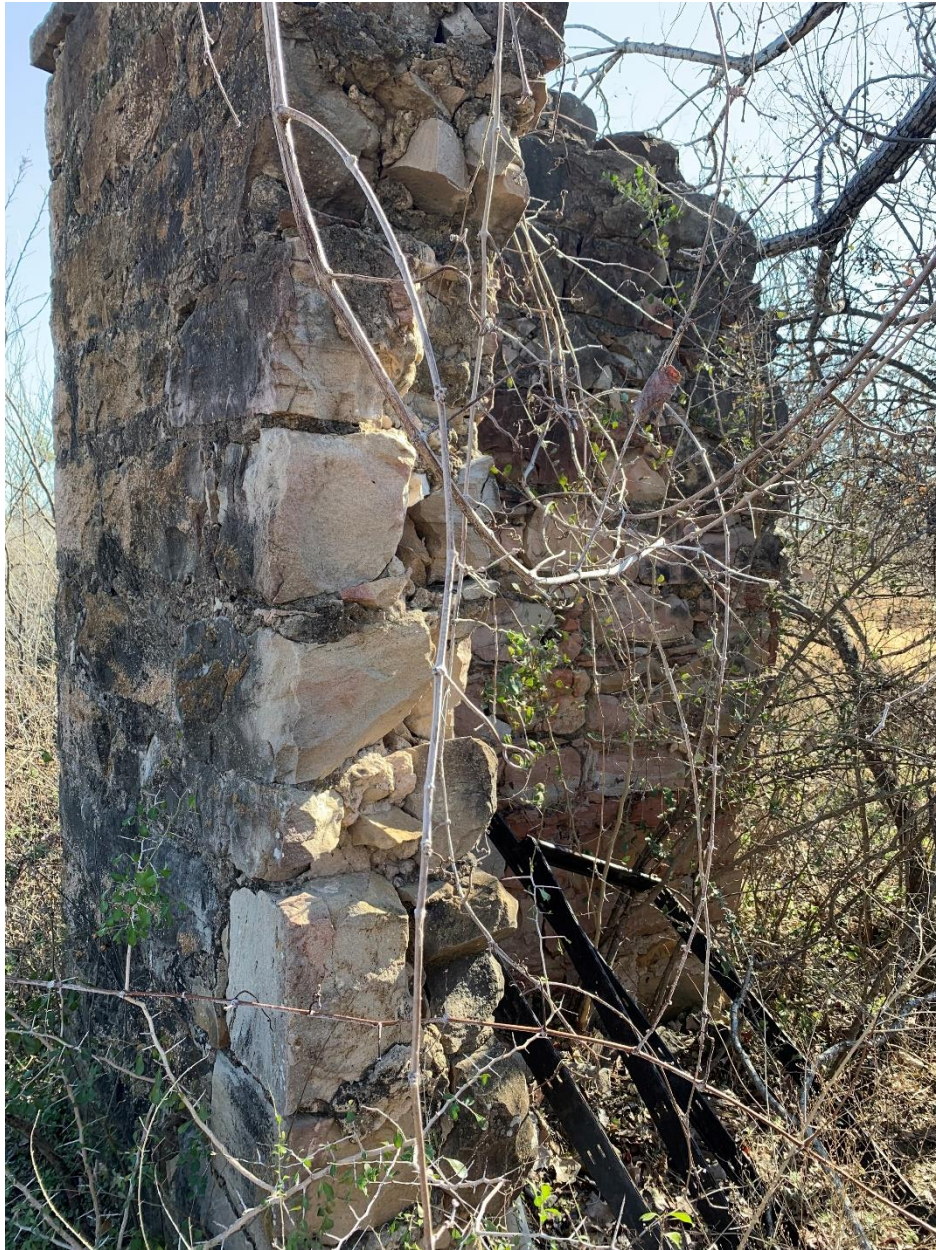
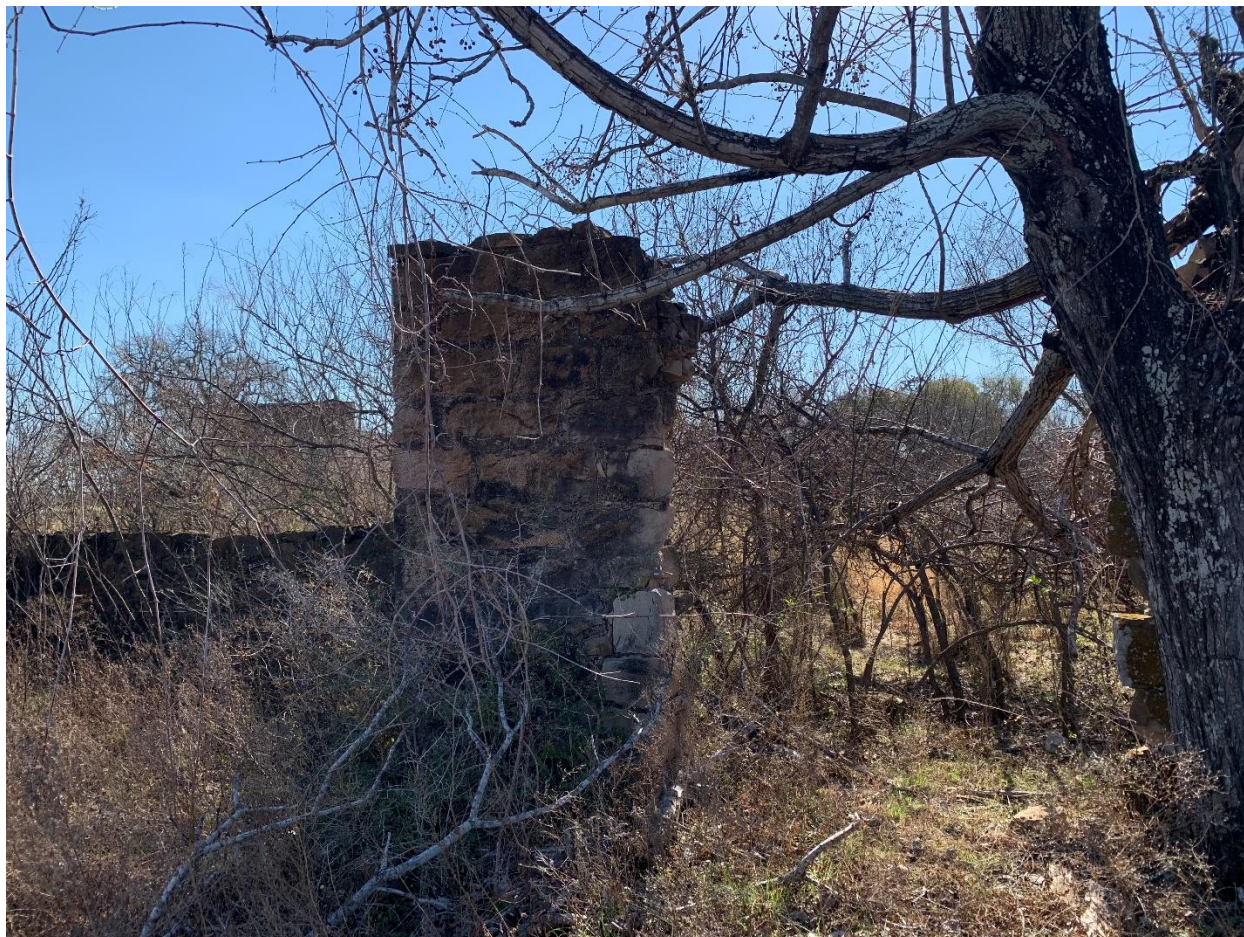
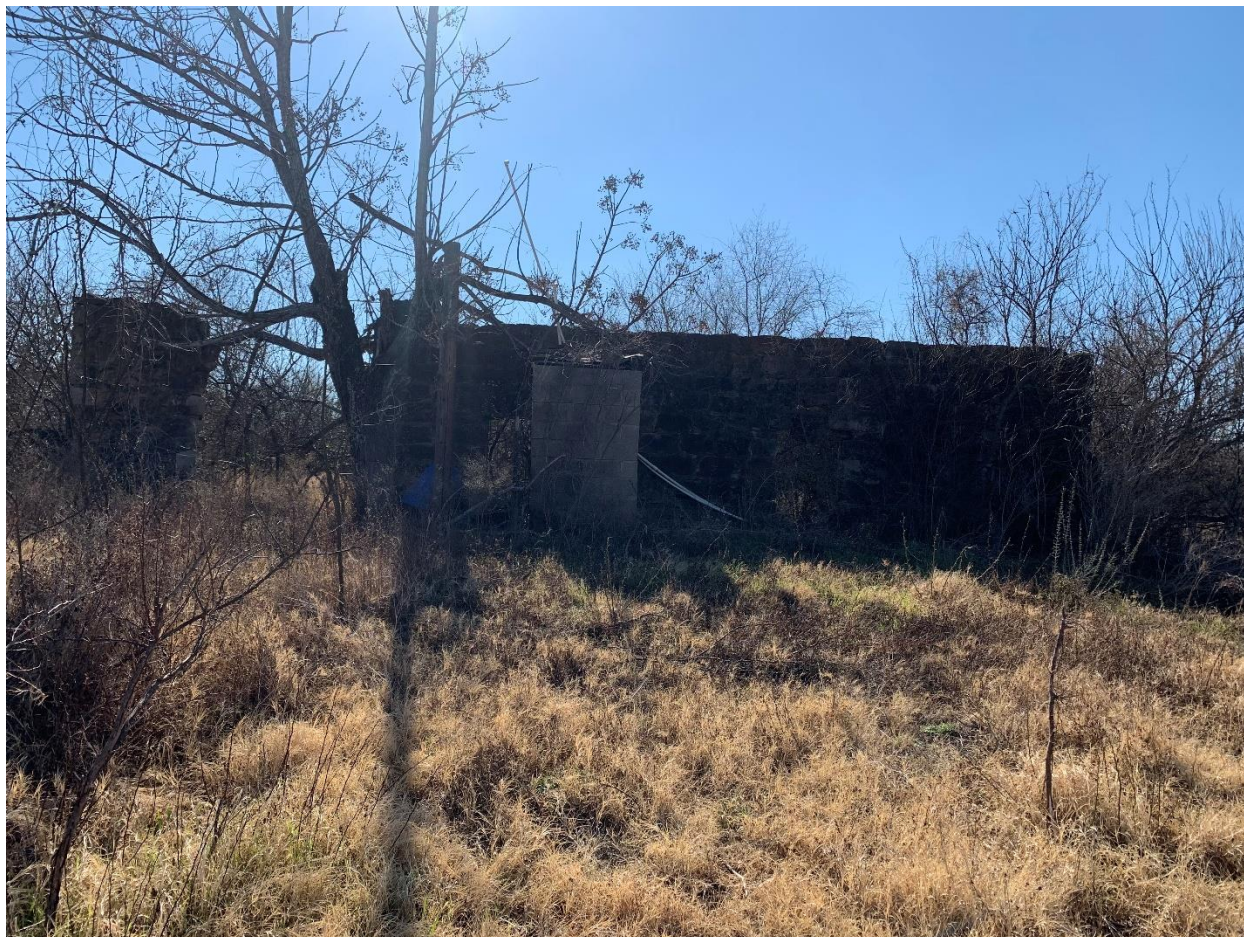
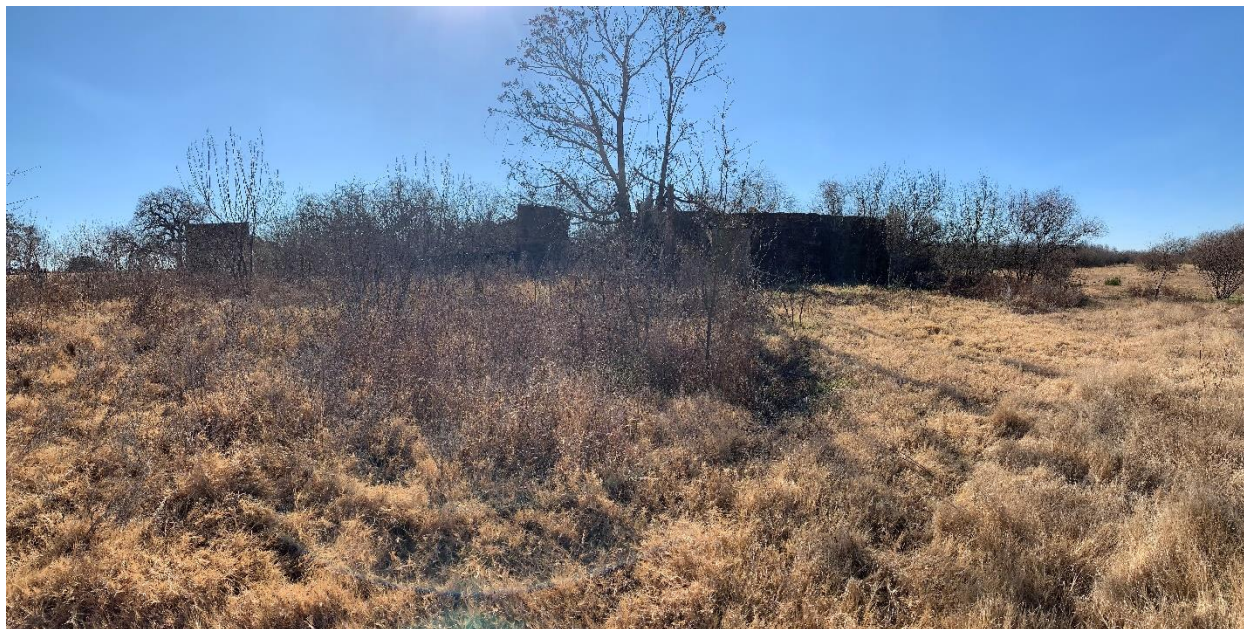
Photo 17: Cotton gin ruins.

Photo 18: Cotton gin ruins.

Photo 19: Cotton gin ruins.

Photo 20: Cotton gin ruins.

The ruins of a cotton gin, stone fence, and well likely constructed c. 1885 are located to the northwest of the Heermann Store, closer to Highway 1604. A historic aerial shows the cotton gin appears to have been a rectangular structure.⁸ Currently overgrown with vegetation, there appears to be one remaining wall which is in roughly the same condition as it was when the HABS documentation was completed for the Heermann Store in 2010. The primary elevation of the ruin is roughly parallel to the front façade of the Heermann Store, and originally faced the Rockport Road to the northwest. The cotton gin was a vernacular stone masonry building constructed of similar sandstone with lime-based mortar that was used for the construction of the Heermann Store. The sandstone is rough cut and not well shaped.

Around 1970, the former owner bulldozed all but the one standing wall, and he left one rock to indicate where there was an opening in the structure. The remaining wall has fire damage providing evidence the building burned at some point. Oral histories support this, though the exact date of the fire is unknown.⁹

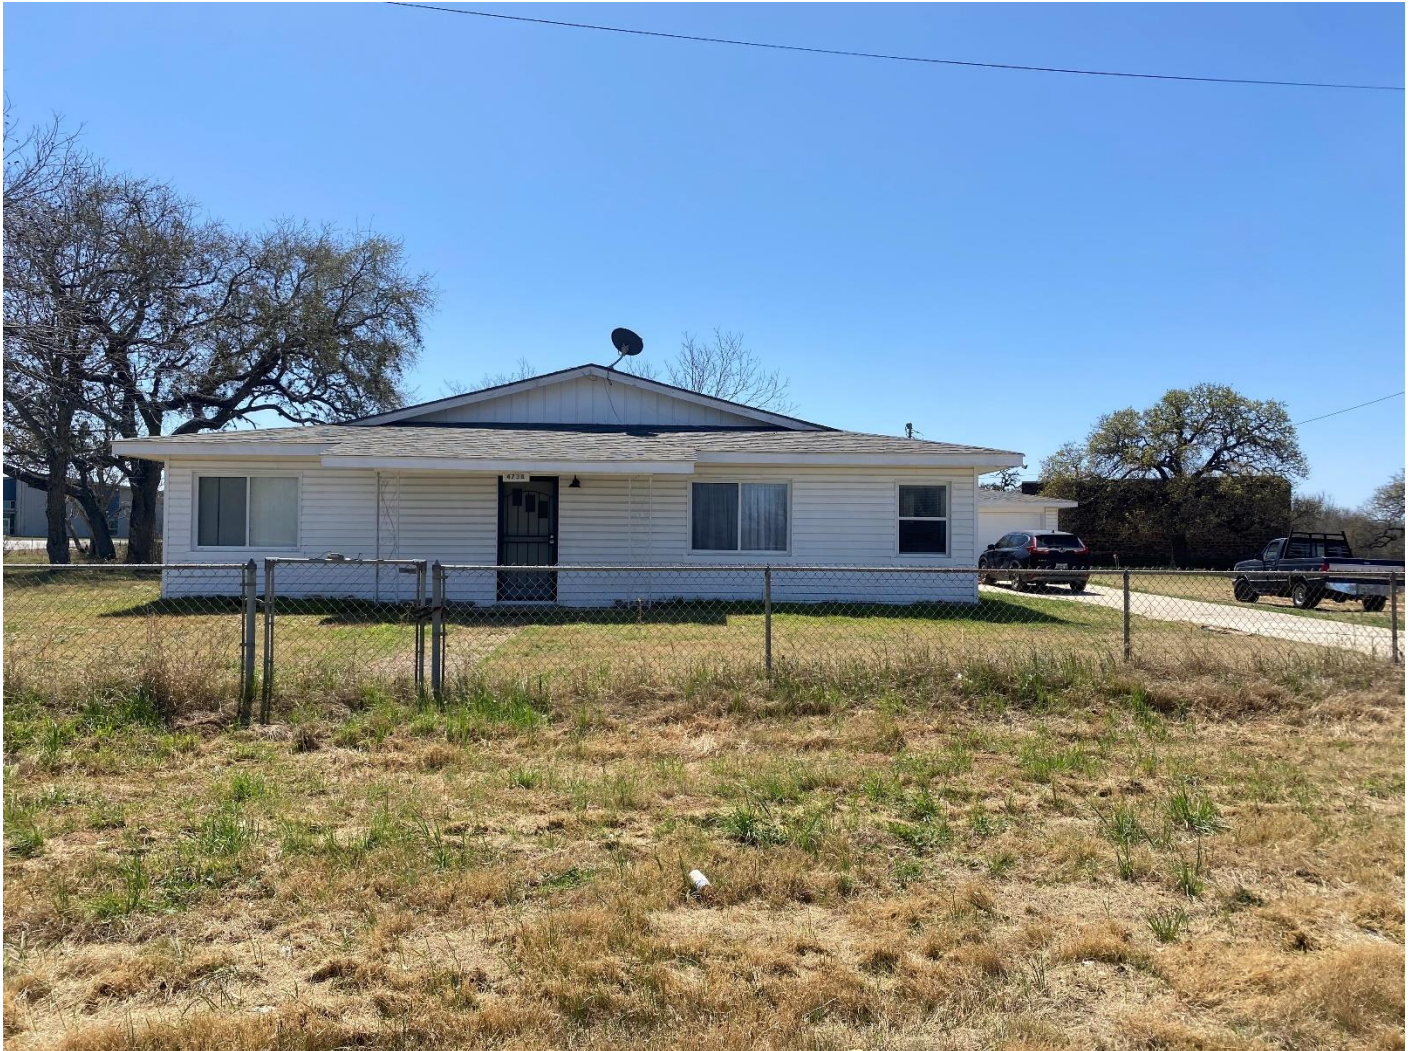
Photo 21: Primary (north) elevation of house. Camera facing south.

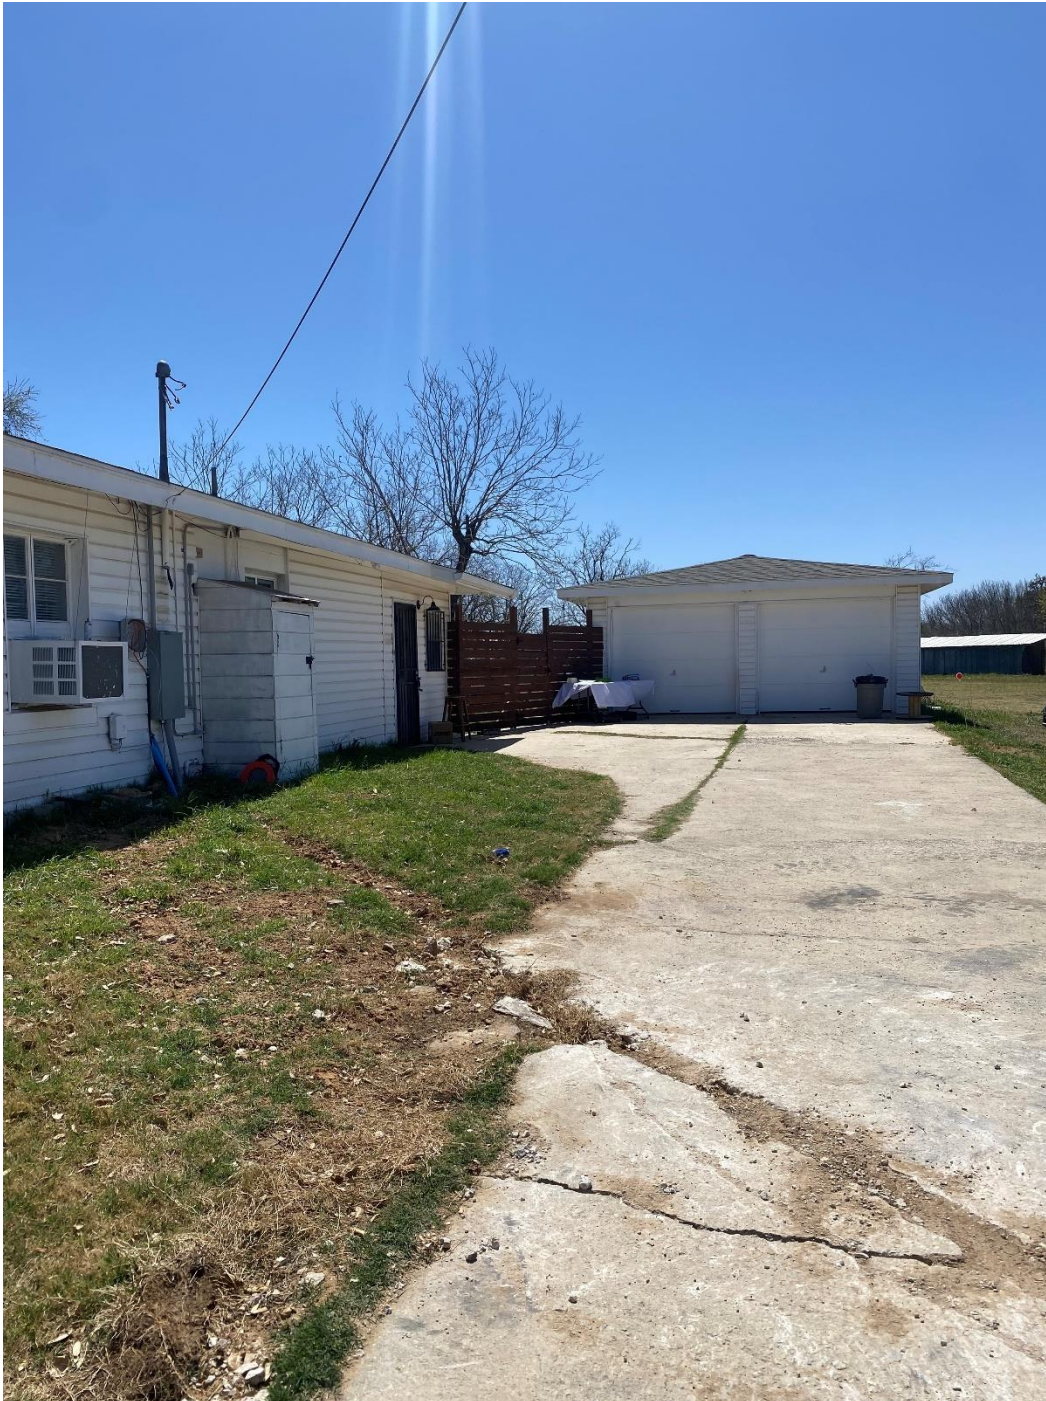
Photo 22: Primary (north) elevation of garage. Camera facing south.

Resource 7: Garage (Non-Contributing Building) (Photo 22)
