National Register of Historic Places Registration Form

1. Name of Property	
Historic Name: Stowers Building Other name/site number: G. A. Stowers Furniture Company Building Name of related multiple property listing: NA

2. Location	
Street & number: 820 Fannin City or town: Houston State: Texas County: Harris Not for publication: □ Vicinity: □	
3. State/Federal Agency Certification	
As the designated authority under the National Historic Preservation Act, as amended, I he Information Information Information of eligibility meets the documentation standards Register of Historic Places and meets the procedural and professional requirements set for property Information Inform	s for registering properties in the National
I recommend that this property be considered significant at the following levels of significan ☐ national ☐ statewide ☑ local	ce:
Applicable National Register Criteria: ☐ A ☐ B ☑ C ☐ D	
State Historic Preservation Officer	B.4
Signature of certifying official / Title	Date
Texas Historical Commission State or Federal agency / bureau or Tribal Government	
In my opinion, the property ☐ meets ☐ does not meet the National Register criteria.

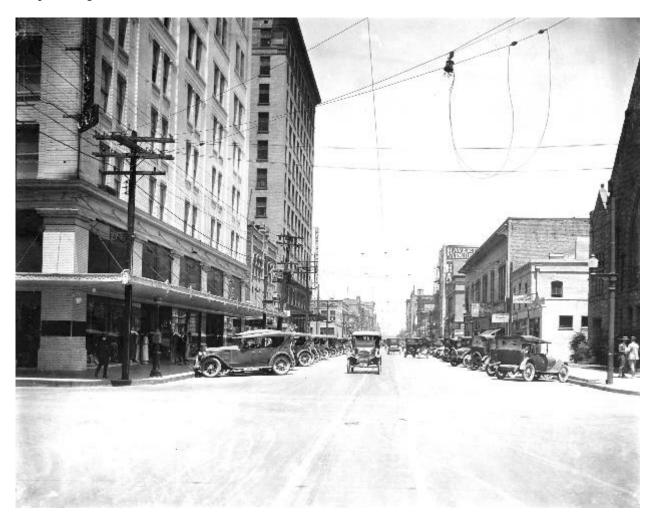
Historic Photo #2

Partial west and south elevations (behind Beatty-West Building), view east down Walker from Main Street camera facing east, 1916. Courtesy HMRC, HPL; see photo log for call number.

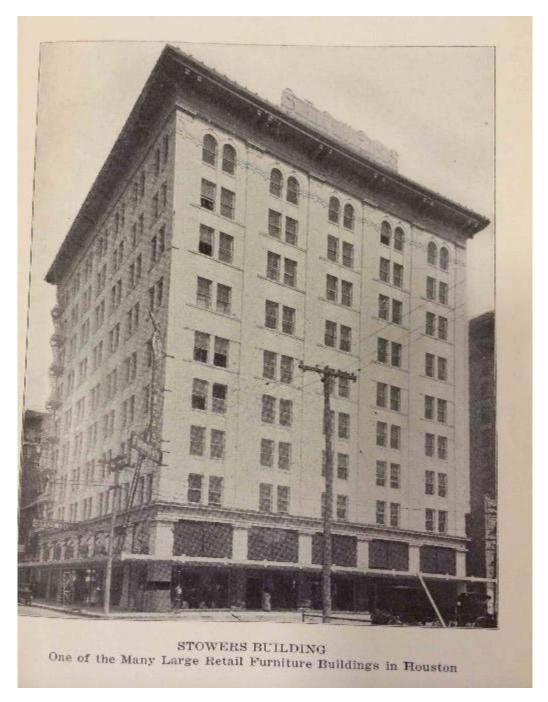
Historic Photo #4 East façade, camera facing west, 1930. Courtesy HMRC, HPL; see photo log for call number.

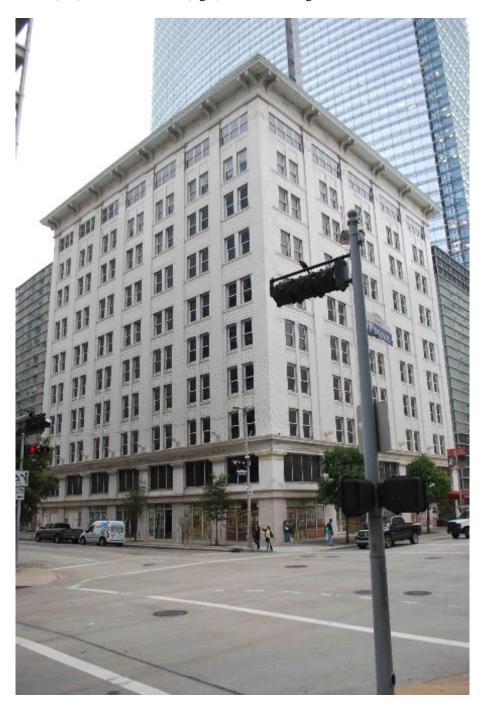
Photo #2 East façade (center) and partial south façade (left), camera facing west, 2014.

Photo #2 (TX_HarrisCounty_StowersBuilding_photo_0002)
East façade (center) and partial south façade (left), camera facing west.

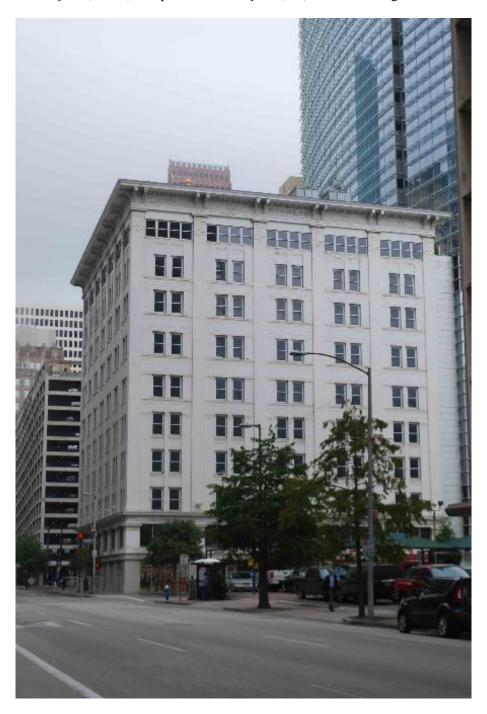
Photo #3
East elevation and roof, camera facing west taken from the roof of the 1121 Walker, 2014.

Photo #3 (TX_HarrisCounty_StowersBuilding_photo_0003)
East elevation and roof, camera facing west taken from the roof of the 1121 Walker

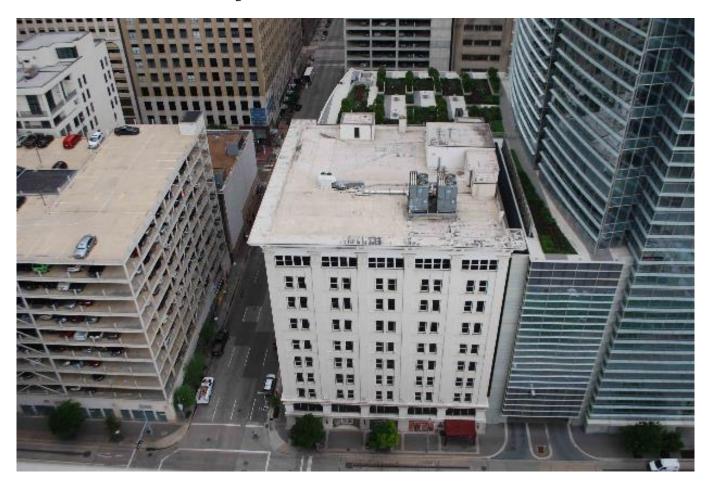
Photo #4 East elevation, cornice detail (BG Place, 811 Main in background), camera facing northwest, 2014.

Photo #4 (TX_HarrisCounty_StowersBuilding_photo_0004)
East elevation, detail of cornice with BG Place (811 Main) in background, camera facing northwest

emphasis to the gradual introduction of the building's terminus. This is accomplished by full width rectangular spandrels that span the entirety of each bay below and above the windows. The tenth floor has groupings of four 1/1 windows set into each bay. A pressed tin cornice tops the building with paired brackets aligning with the pilasters and divisions of the bays. In the center bay of the south and east elevations, the frieze has "STOWERS" embossed on it.

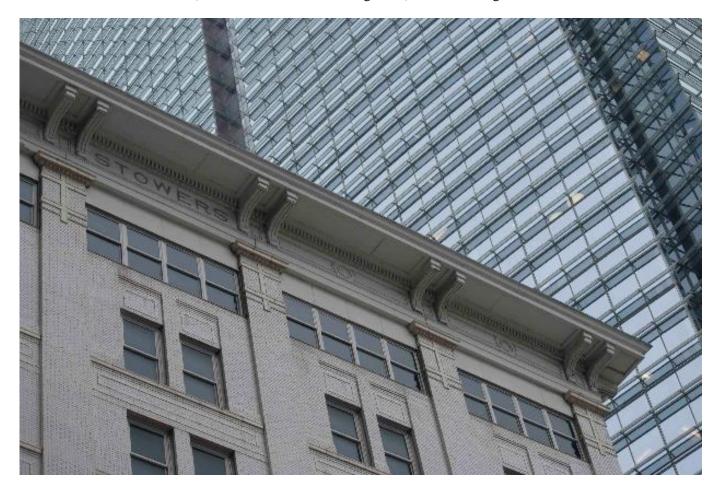
Photo #5 East elevation, detail of cornice and glazed brick, 2014.

Photo #5 (TX_HarrisCounty_StowersBuilding_photo_0005) East elevation, detail of cornice and glazed brick

The Scanlan Building, designed by Daniel Burnham of Chicago in 1909, is the only other skyscraper in downtown Houston to use glazed brick for the exterior veneer. The Scanlan Building's brick is grey in color as compared to the white brick of the Stowers Building. A contemporary and notable building with a glazed brick exterior is the 40-story Equitable Building in New York constructed in 1915.

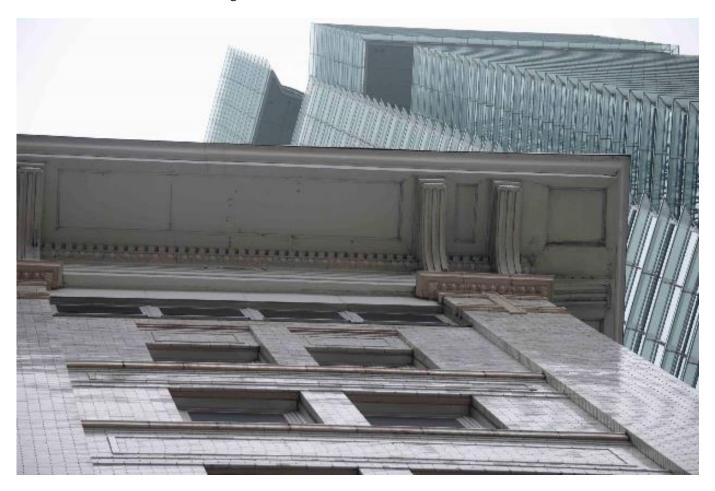
Photo #6 Interior, tenth floor, camera facing south, 2014.

Photo #6 (TX_HarrisCounty_StowersBuilding_photo_0006) Interior, tenth floor, camera facing south

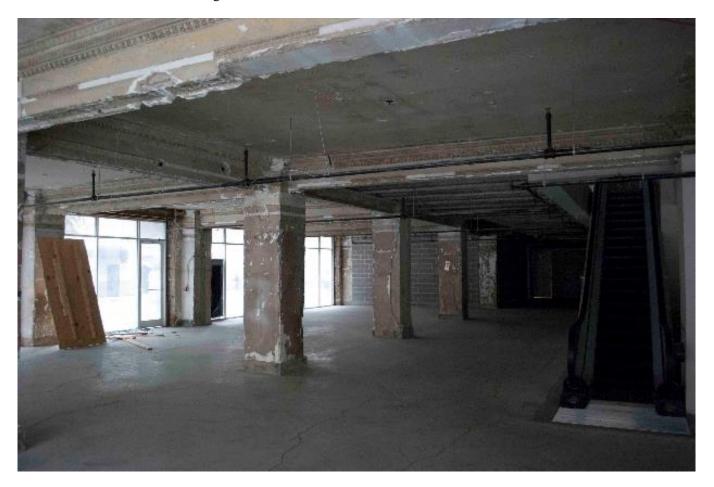
Photo #7 Interior, first floor, camera facing southwest, 2014.

Photo #7 (TX_HarrisCounty_StowersBuilding_photo_0007) Interior, first floor, camera facing southwest

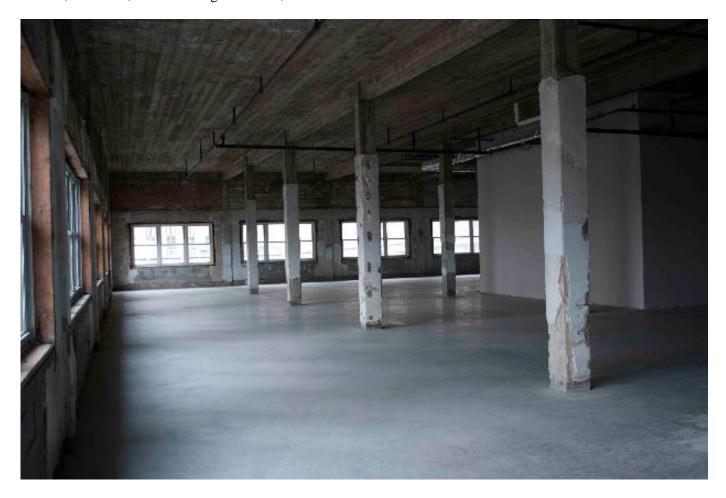
Photo #8 Interior, first floor, detail of column, camera facing northwest, 2014.

Photo #8 (TX_HarrisCounty_StowersBuilding_photo_0008) Interior, first floor, detail of column, camera facing northwest

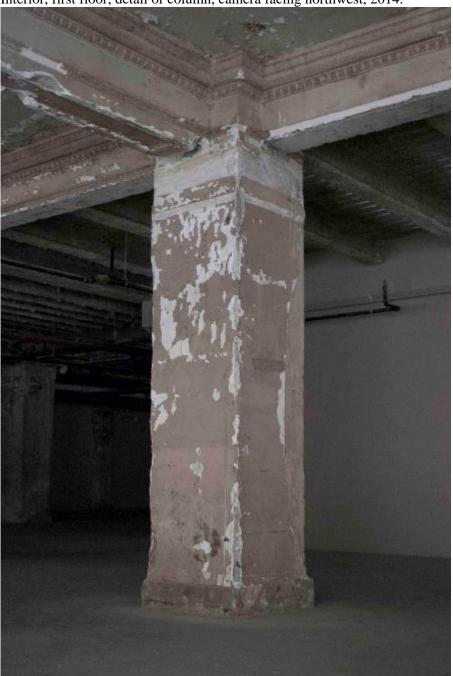
Photo #9 Interior, first floor, detail of decorative plaster, 2014.

Photo #9 (TX_HarrisCounty_StowersBuilding_photo_0009) Interior, first floor, detail of decorative plaster

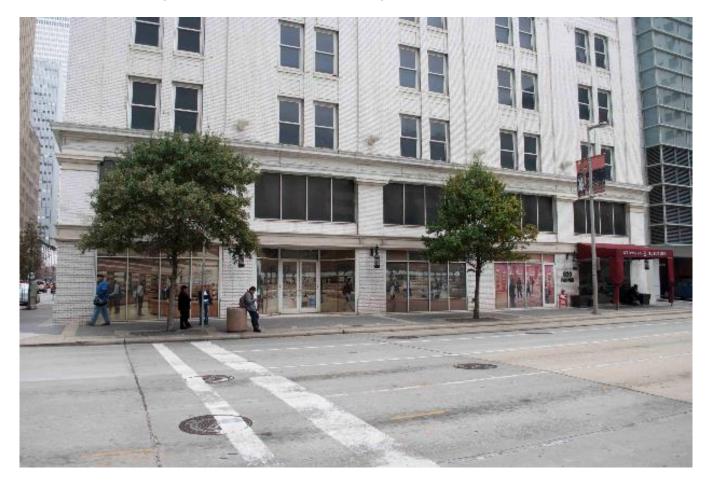
Photo #11 South elevation, detail of ground floor storefront, camera facing northeast, 2014.

Photo #11 (TX_HarrisCounty_StowersBuilding_photo_0011) South elevation, detail of ground floor storefront, camera facing northeast
