National Register of Historic Places
Inventory—Nomination Form

historic Jernigan, A.J., House

street & number 602 Harthan

Jernigan House
602 Harthan, Austin, Travis County, Texas

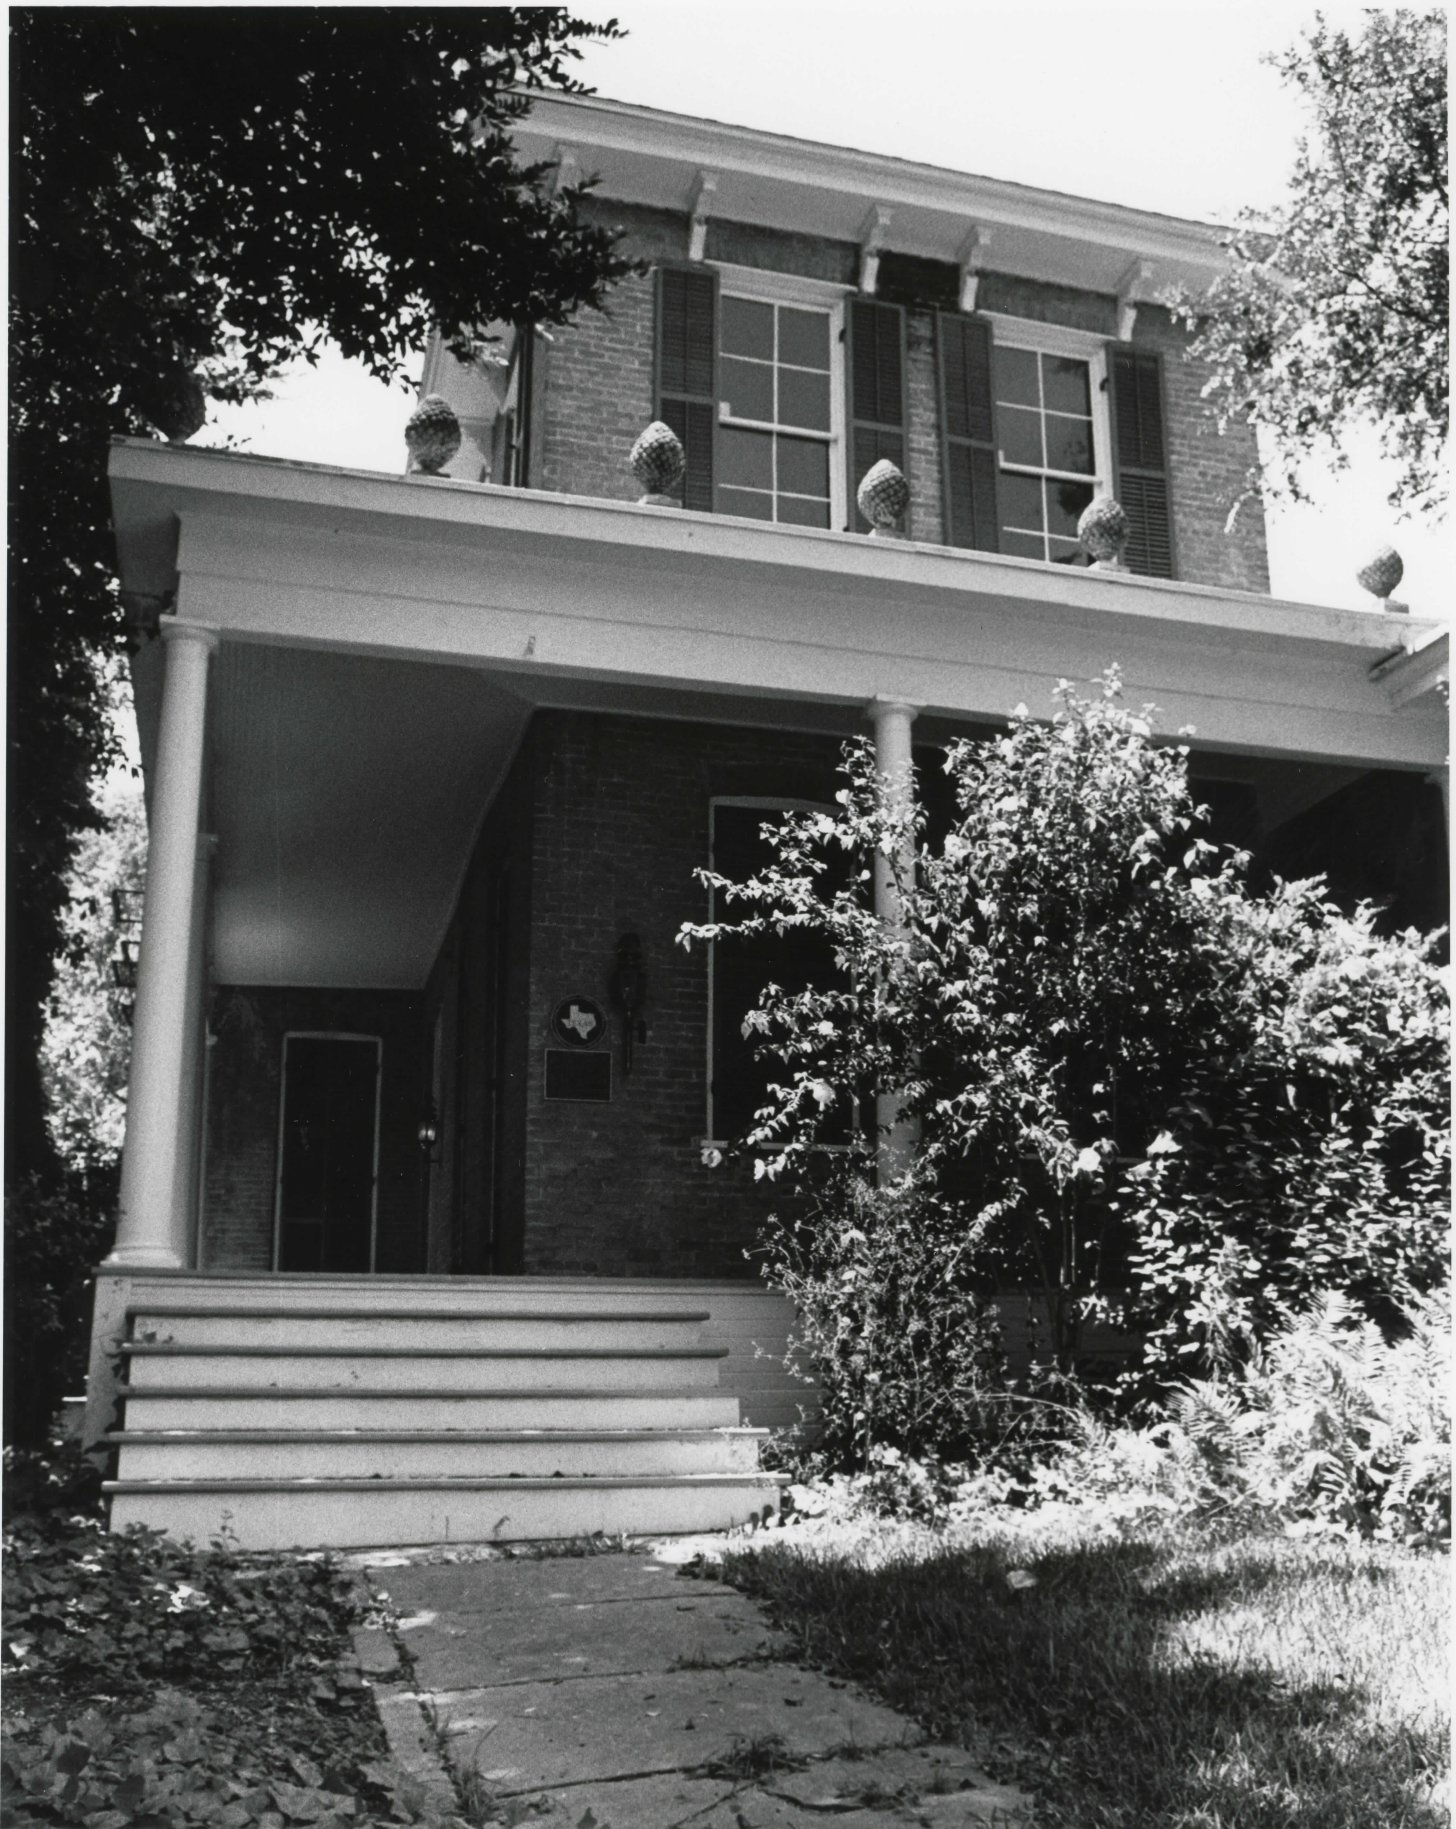
Photo 1 of 5

East facade, looking west

The east facade, which faces the present street entrance, is composed of five bays, three in the two-story portion of the house and two in the projecting, adjacent, one-story wing to the north. Each bay contains a lone window in each story.

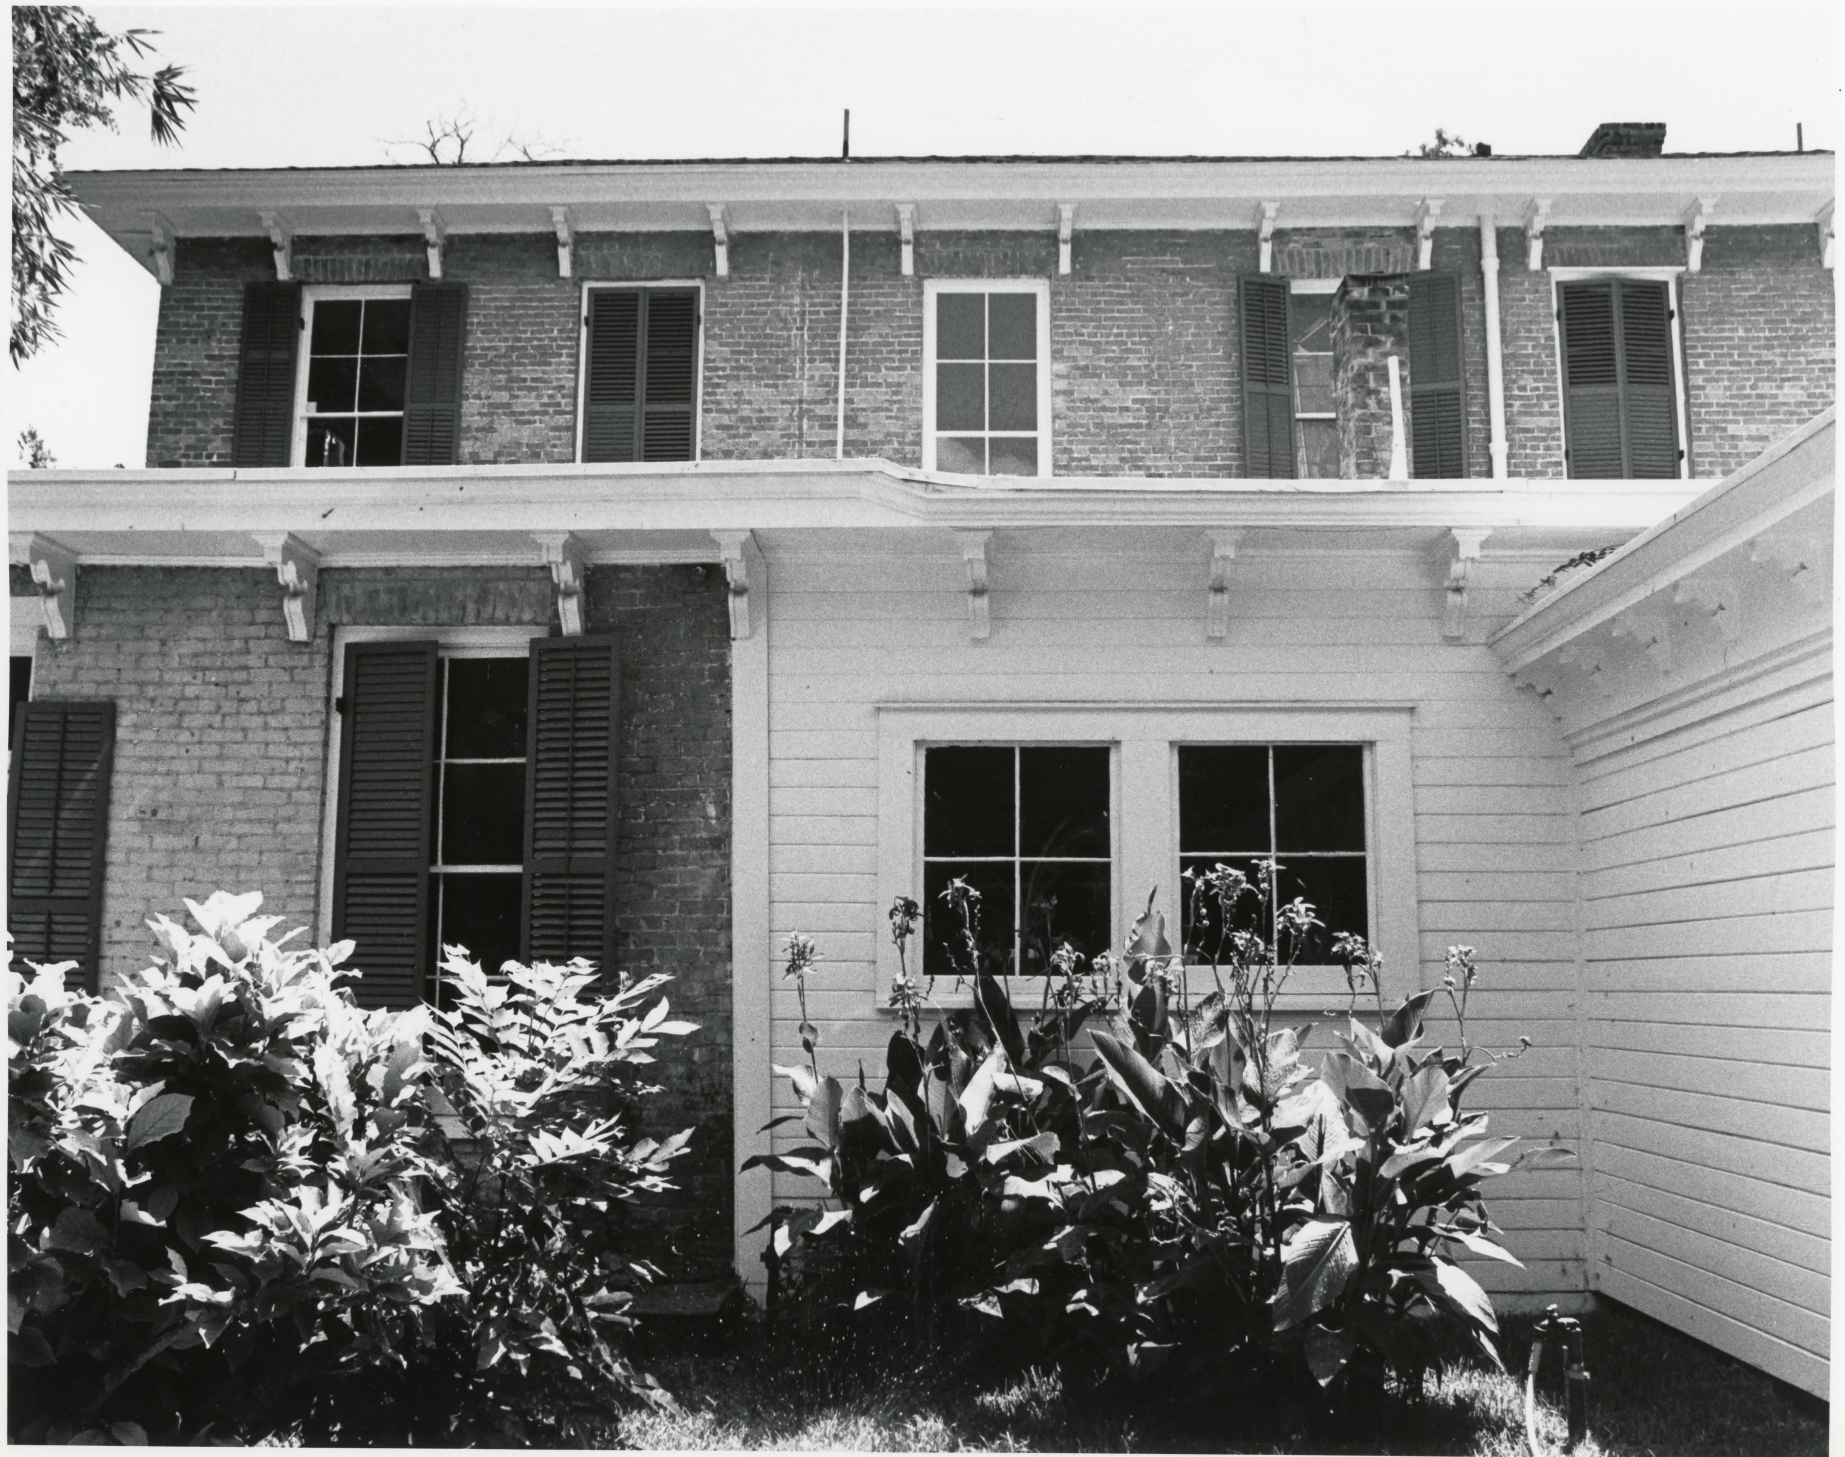
Photo 2 of 5

North (rear) facade, looking south

The north facade contains five bays on the second story of the house; the three bays on the east contain windows; the two on the west have windows which open from the floor. The ground story of the north facade consists of the one-story brick wing on the east, and the one-story frame addition on the west. The brick wing contains a door opening that has been glazed with two, four-light, fixed sashes and a double-hung window. The frame wing contains a pair of side-by-side, four-light window sashes, a pair of arched-light doors at the rear entrance to the house, and a double-hung window to the west.

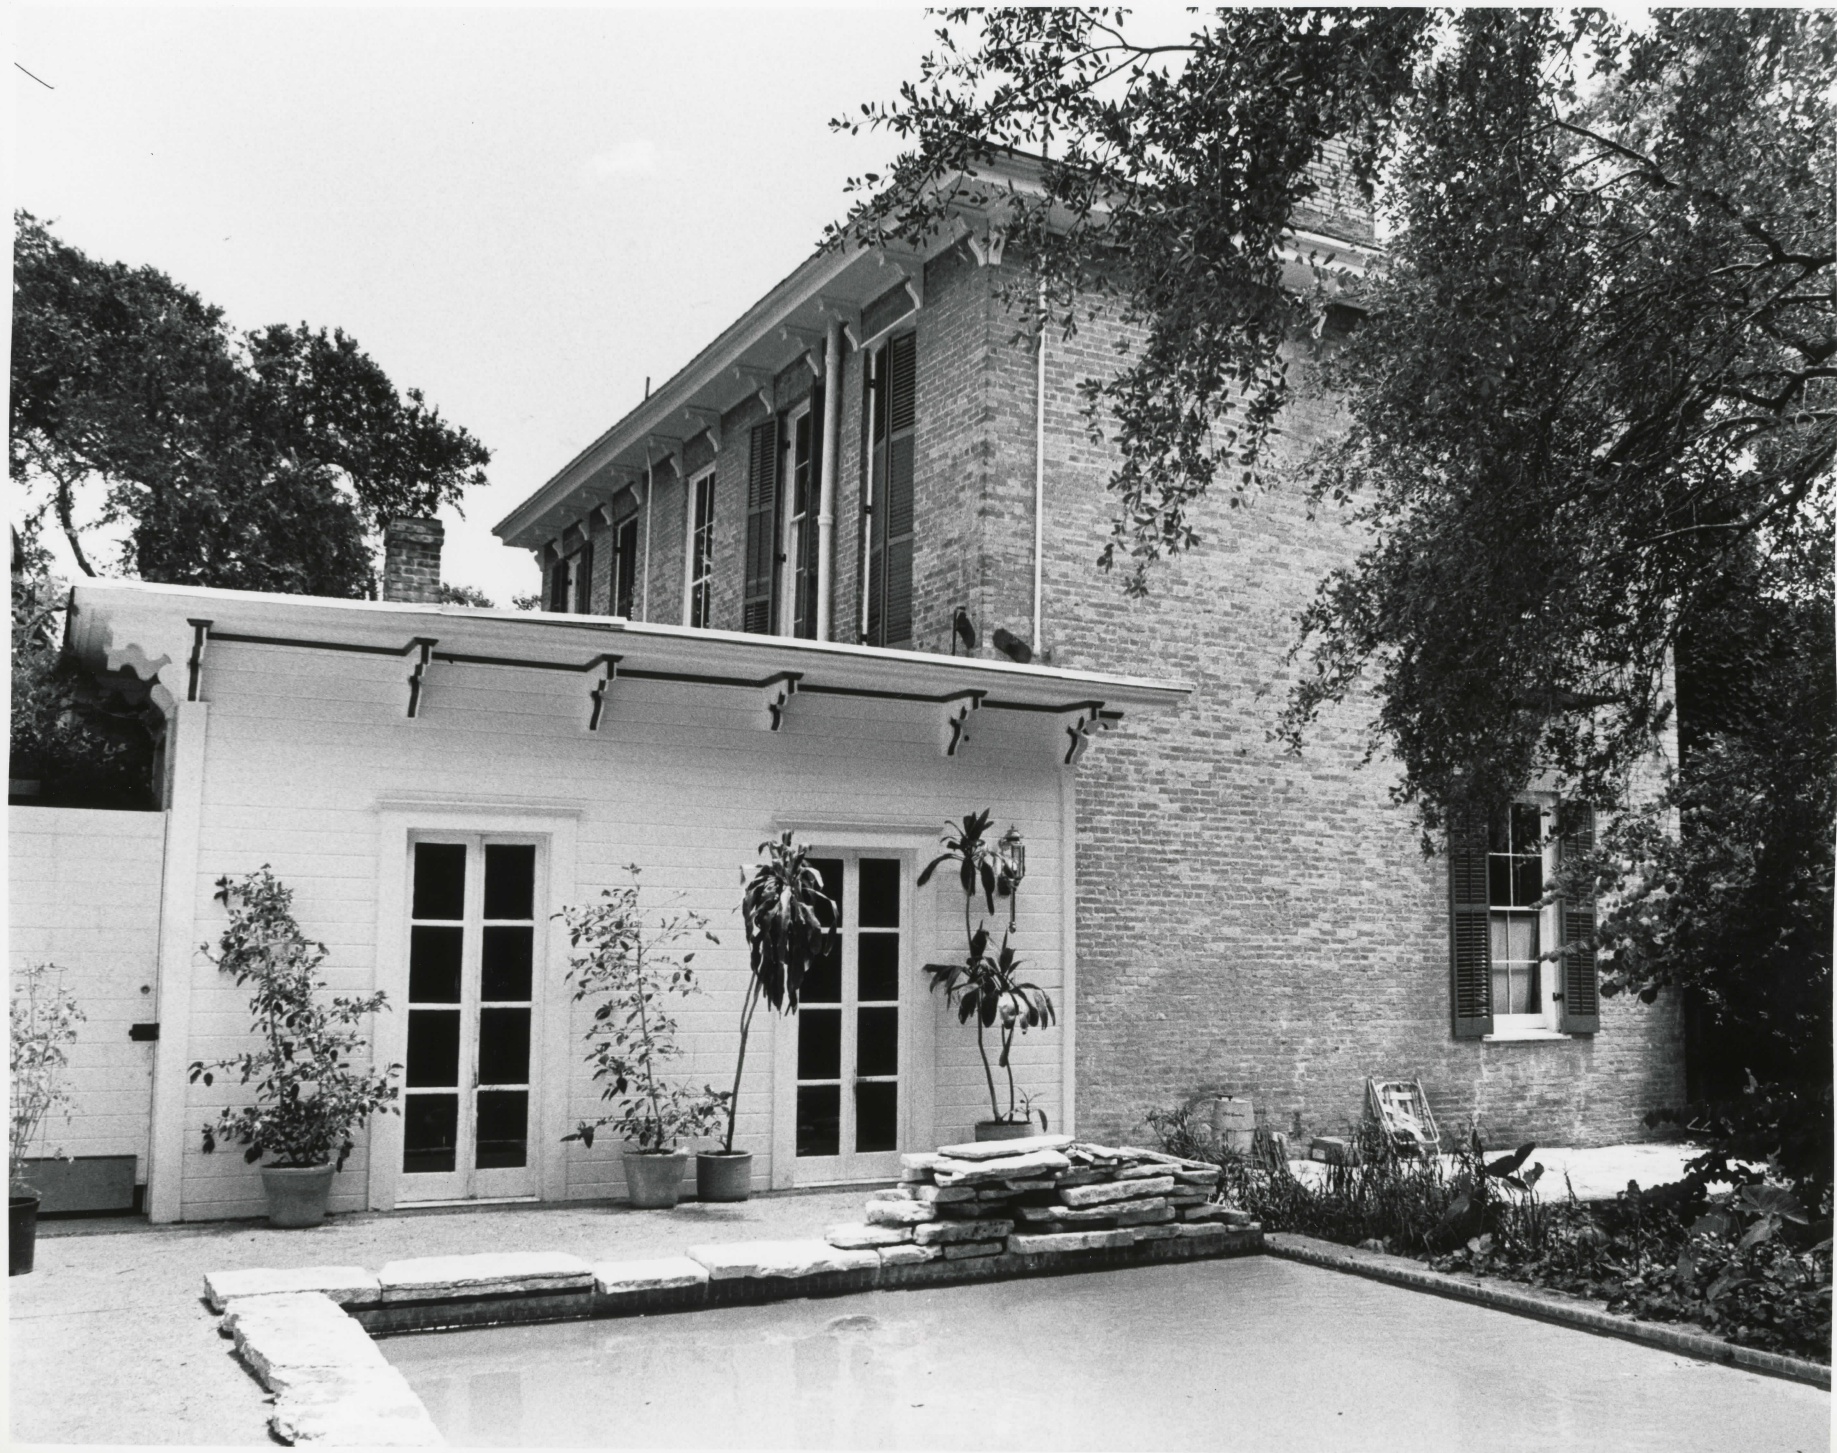
Photo 3 of 5

West facade, looking east, main house and addition
ca. 1912

The west facade consists of one bay on the south side with a window in each story. A frame, one-story addition was added in 1912 to the northwest corner of the house; the west facade of the addition contains two bays, each with a pair of 7 by 1½ foot doors.

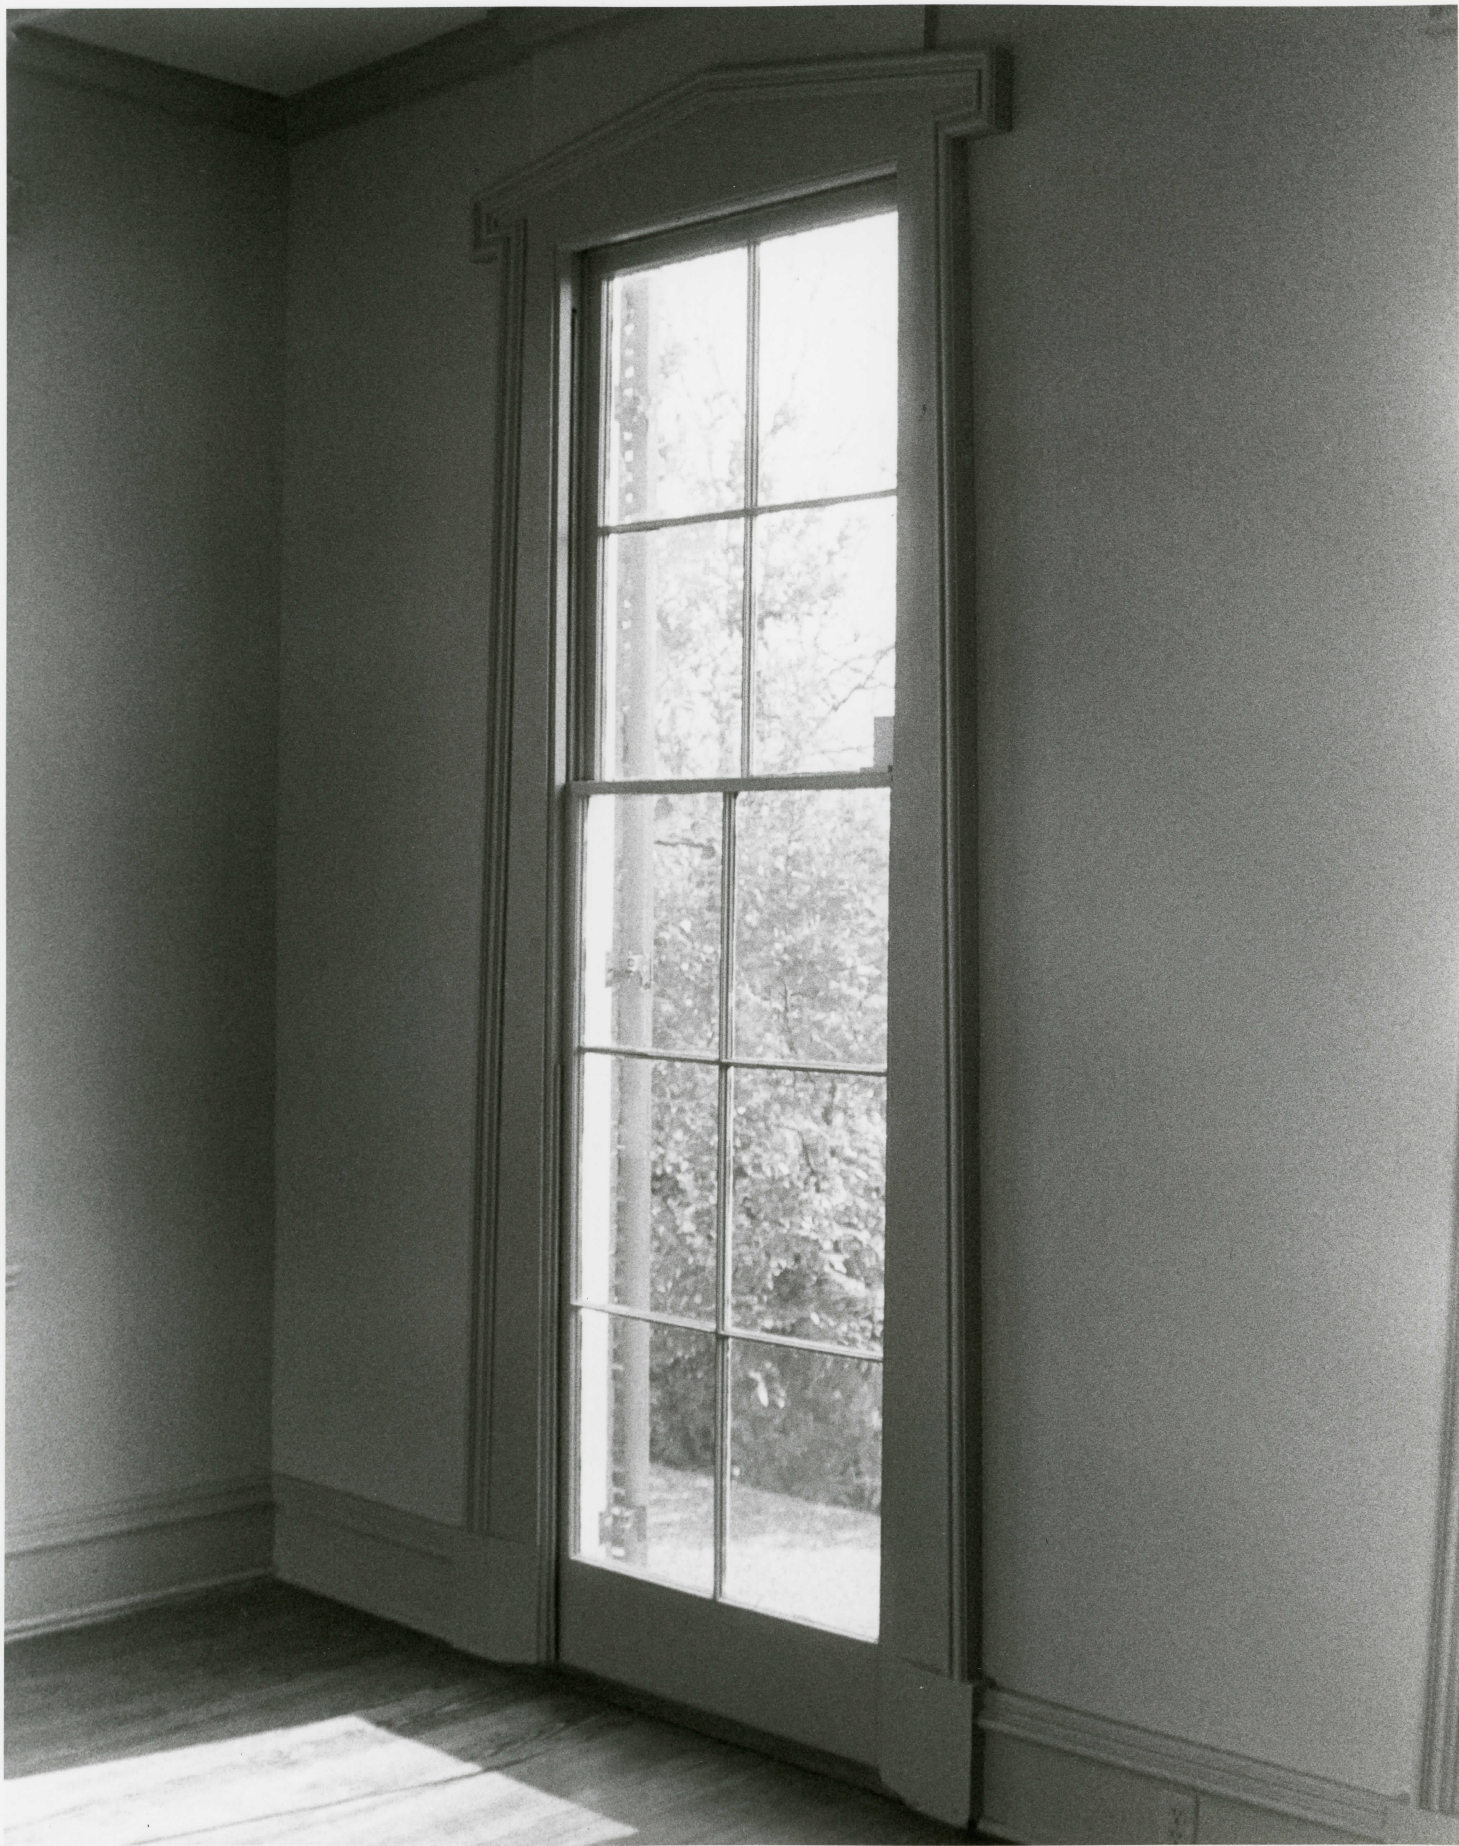
Photo 4 of 5

WINDOW DETAIL
602 HARTHAN

First floor window detail

Fenestration throughout the building consists of 3 by 7 foot openings with four-over-four, double-hung sashes. The windows on the porch and gallery, however, measure 3 by 9 feet and have four-over-six, double-hung sashes. They open from floor level, and allow egress to the porches.

The noteworthy shouldered architraves on the doors and windows are Greek Revival in style, consisting of molded, tapering pilasters surmounted by a molded pediment. All doors into major rooms feature transom sashes: all interior doors are of four cypress panels with walnut molding.

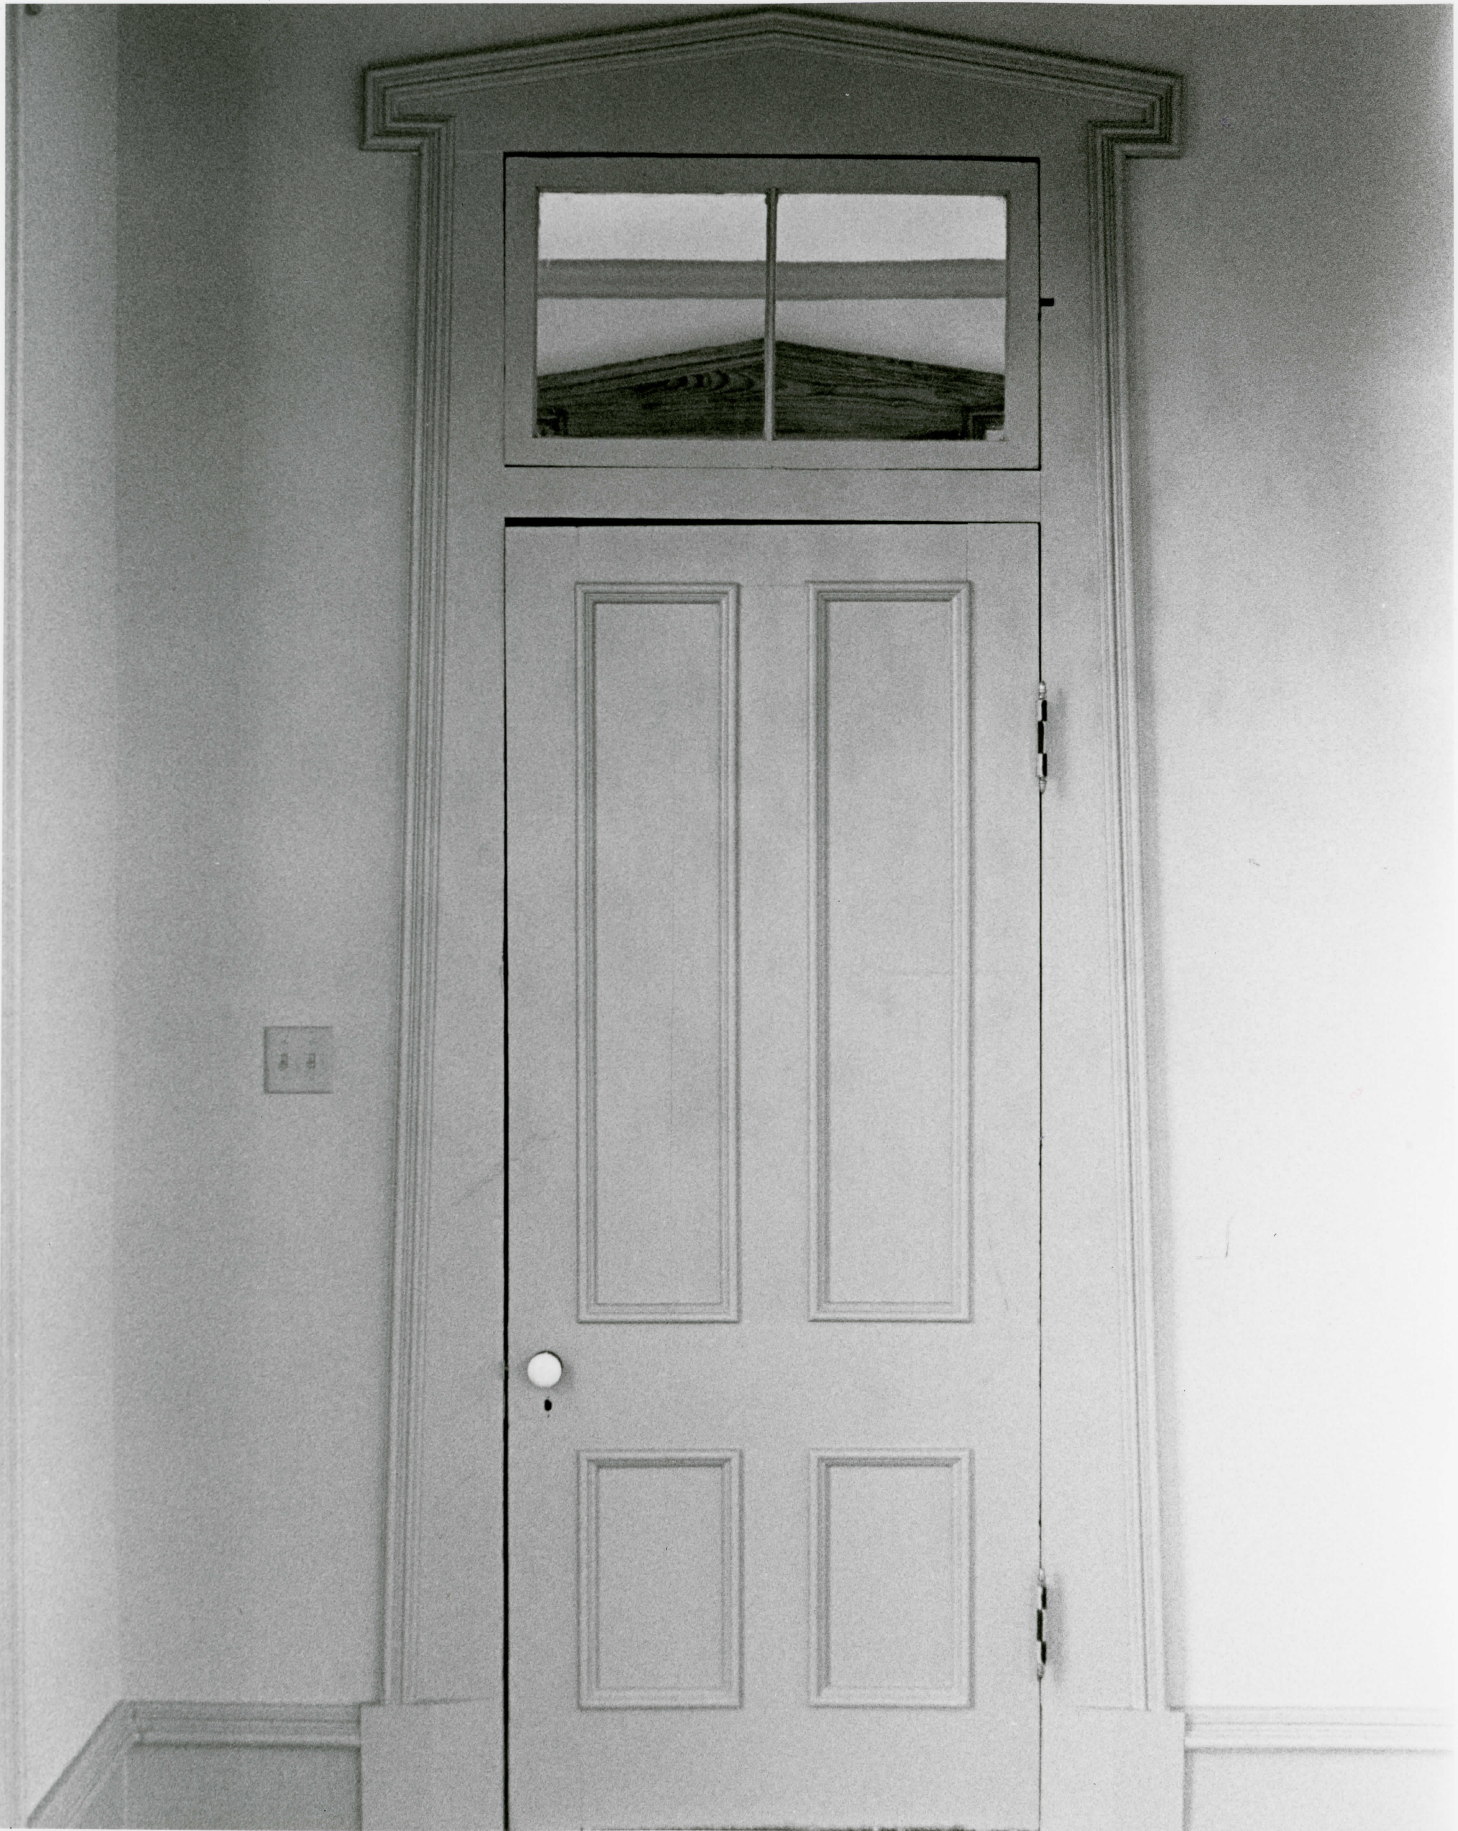
Photo 5 of 5

Interior first floor door detail
