National Register of Historic Places Registration Form

1. Name of Property			
Historic Name: Paris Commercial Historic District (Boundary Increase for Blake & Hinkle Lumber Company) Other name/site number: NA Name of related multiple property listing: Historic Resources of Paris, Texas

Paris Commercial Historic District (boundary increase for Blake and Hinkle Lumber Co.), Paris, Lamar County, Texas

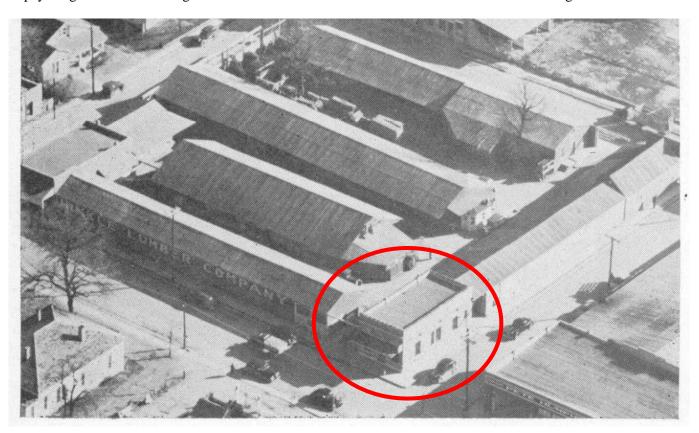
Figure 3 Historic Aerial of Blake & Hinkle Lumber Yard, Looking Northeast

This 1950s aerial photograph of Block 20 shows the office building was completely separate from lumber sheds to the North and East. Only the roof of the adjacent shed on Houston Street abutted the office building's rear elevation, providing a pass-through vehicles and pedestrians. Customers used the back and side doors of the office to pay for goods before exiting onto Houston or 3rd St. Source: Advertisement in 1957 Paris High School Yearbook.

This flat-roofed brick one-part commercial block building was constructed circa 1917 to serve as an office for a lumber yard operation that occupied all of Block 20. Clearly intended to stand out from the wood frame lumber sheds, the building has a unique design for a lumber office (Figures 1-3). The rectangular plan building is situated with the length of the rectangle extending approximately 46 feet east-west along Houston Street, with the width of
