National Register of Historic Places Registration Form

1. Name of Property
Historic Name: Klein Frankreich Rural Historic District Other name: Amandus Stehling Farm/Ranch; George Franz Stehling Farm/Ranch: Feuge Farm/Ranch Name of related multiple property listing: NA

2. Location
Street & number: 3723 to 5083 N. Highway 87; 103 to 260 Old Mason Road, Fredericksburg, TX 78624 City or town: Fredericksburg State: Texas County: Gillespie Not for publication: □ Vicinity: ☑

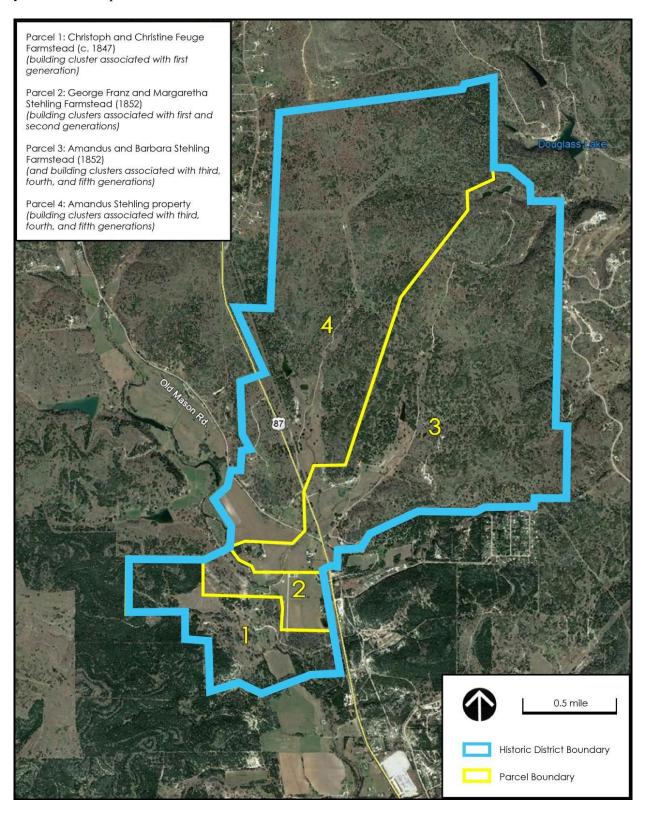
The district is shaped like a rough rectangle with a bulbous "tail" that extends to the southwest (see Boundary and Parcel Map). The district is divided by U.S. Highway 87, which crosses the district at the place where the tail begins. The tail section southwest of the highway comprises about a quarter of the district's land area. It is home to most of the historic built resources and contains the entirety of Parcels 1 and 2 plus small sections of Parcels 3 and 4. This area contains Barons Creek and its fertile bottomlands, with Klein grass fields and grazing pastures distributed on both sides of the creek among the various farmsteads. This area also contains Old Mason Road, which branches northwest off of Highway 87 and passes through a short section of the district.

Parcels 3 and 4 span both sides of the highway. Amandus Stehling's farmstead and several of his descendants' ranch headquarters are found in the smaller parcel portions on the southwest side of the highway along Barons Creek. On the northeast side of the highway, Parcels 3 and 4 largely contain unimproved grazing land for the Stehling family's livestock. This larger, less developed portion of the district is hilly and wooded, with two dirt and gravel ranch roads that run northeast into the ranch from Highway 87. The southernmost road is the primary ranch road. It is the largest at almost 2.5 miles long and continues all the way through the ranch to manmade ponds at the property's northeast corner (Map 12). The secondary ranch road runs about one mile into the ranch to a "camp house" (Resource 15b) before branching off into smaller two-track roads. Elsewhere in this larger ranch section are two non-historic building clusters (both in Parcel 3), an abandoned segment of Old Mason Road just east of Hwy. 87, and more two-track dirt roads that lead to grazing land and several springs and stock ponds.

The district can be understood from the perspective of three original farmsteads settled by Christoph and Christine Feuge (c. 1848), George Franz and Margaretha Stehling (1852), and Amandus and Barbara Stehling (1852), with the oldest extant resource dating to c. 1852. The Feuge and George Franz Stehling farmsteads (Parcels 1 & 2, respectively) contain building clusters associated with the first and second generations, while the Amandus Stehling property is much larger and contains additional farmsteads or building clusters carved out of his holdings by third, fourth, and fifth generations (Parcels 3 & 4). Considered together, these sites represent the evolution of the district from the earliest period of settlement in the early 1850s, through period of significance ending in 1976. The district boundaries encircle all four parcels and follow property lines established by the Feuge and Stehling families during the period of significance (*see Boundary and Parcel Map on following page*).

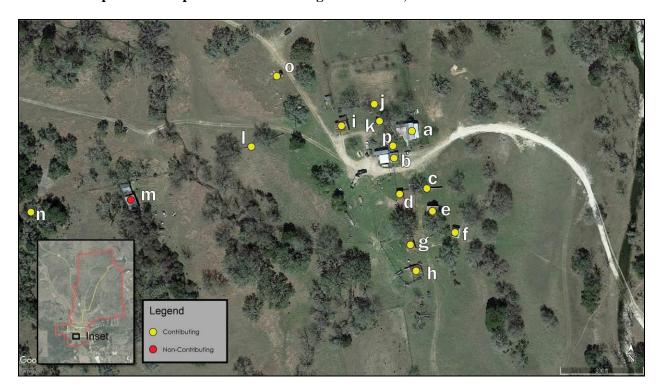
Parcel 1 / Map 2 - Christoph and Christine Feuge Homestead, established c. 1848

Parcel 1 / Map 2 Resources

#	Property Type	Resource	Date(s)	Roof form/ Plan Type	Exterior Materials	Status
2a	Building	Single Dwelling	1901	Side gable	Stone	С
2b	Building	Garage	c. 1935	Front gable	Wood, Metal	С
2c	Structure	Stone Fence	c. 1860	Linear	Stone	С
2d	Building	Log Barn	c. 1860	Front gable	Wood (timber)	С
2e	Building	Single Dwelling	c. 1870	Side gable (saltbox)	Stone	С
2f	Building	Smokehouse	c. 1870	Front gable	Stone	С
2g	Building	Barn	c. 1930	Side gable	Wood	С
2h	Building	Goat Shed	c. 1880/1930	Side gable	Stone, Metal	С
2i	Building	Barn	c. 1900	Front gable	Wood	С
2j	Building	Storm Cellar	c. 1900	Front gable	Stone	С
2k	Building	Wash Shed	1902	Side gable	Wood	С
21	Structure	Stone Fence	c. 1860	Linear	Stone	С
2m	Building	Hay Barn	1980	Front gable	Wood	NC
2n	Object	Grave Marker	1914	Arch top	Stone	С

<u>Garage (2b)</u> – This resource is a front-gabled frame garage with a concrete foundation, horizonal wood siding, and a corrugated metal roof built about 1935. It is located at the rear of the 1901 house (2a). The garage door was replaced by a corrugated metal door.

Stone Fence (2c) – A length of stone fence stretches about 50 feet across a grassy field in the barnyard opposite the homesite. Approximately four feet high, the stones vary in size and are laid in irregular courses with a squared-off, flat top course. Similar stone fences are found throughout the district; however, this example has more formally dressed stones that create smoother, more uniform wall surfaces. All historic stone fences in the district were built about 1860-1870 from limestone found on the ranches.

<u>Windmill (2p)</u> – This windmill is located next to the garage (2b). It is a c. 1935 Aermotor brand windmill with metal blades and a metal tower.

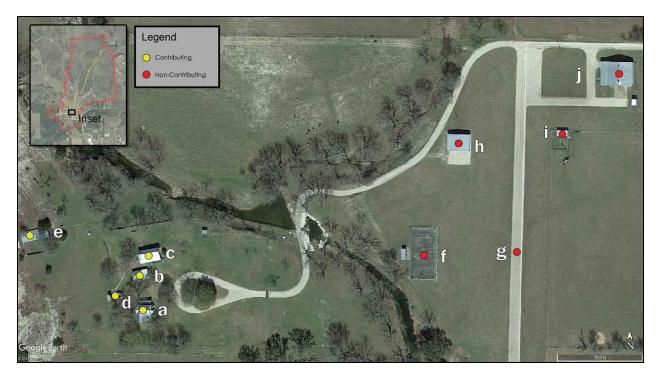
Parcel 2 / Map 3 Resources

#	Property Type	Resource	Date(s)	Roof form/Plan Type	Exterior Materials	Status
3a	Building	Single Dwelling	1889	Side gable	Stone	С
3b	Building	Barn/Guest House	c 1890/1972	Hipped	Stone, Wood	С
3c	Building	Barn/Office	c 1889	Front gable; Shed	Stone, Wood	С
3d	Structure	Water Tank	c 1889/1972	Cylindrical	Stone	С
3e	Building	Sheep & Goat Pen	c 1890	Side gable	Stone, Metal	С
3f	Structure	Tennis Court	c 1972	Flat/Rectangular	Clay	NC
3g	Structure	Airplane Runway	c 1972	Flat/Linear	Concrete	NC
3h	Building	Airplane Hangar	c 1972	Front gable/Arch	Metal	NC
3i	Structure	Cattle Pens	c 1972	Shed/Rectangular	Metal	NC
3j	Building	Airplane Hangar	c 1972	Front gable	Metal	NC

<u>Airplane Hangar (3j)</u> – This is the main hangar building that is situated adjacent to the apron and taxiways. It is a metal building with a broad front-gabled roof and hangar doors on the south elevation. Along the west elevation is a shed-roofed section containing a garage door and pedestrian entrance. The metal roof is punctuated with three large vents along the ridge.

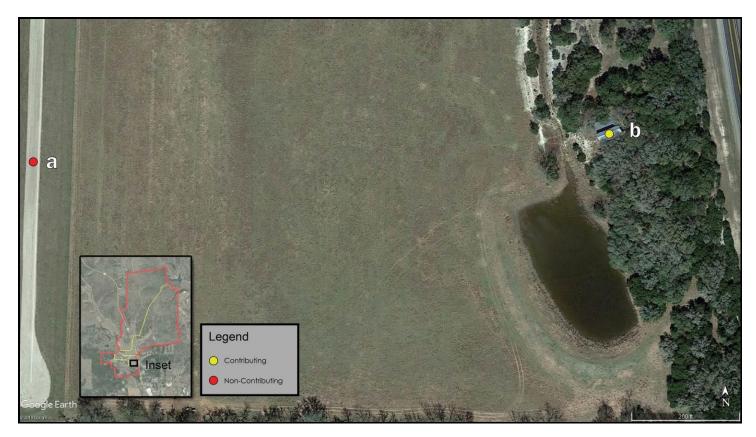
Parcel 2 / Map 4 - George Franz Stehling Homestead, c. 1852

Parcel 2 / Map 4 Resources

#	Property Type	Resource	Date(s)	Roof form/ Plan Type	Exterior Materials	Status
4a	Structure	Airplane Runway	c. 1972	Flat/Linear	Concrete	NC
4b	Building	Barn	c. 1972	Gambrel	Wood	С

Barn (4b) – This barn is situated approximately 215 feet west of Hwy. 87 and several feet N/NE of the pond. It is situated in a thick stand of trees and cannot be seen from the highway. The barn is two stories in height with a metal-clad gambrel roof. The first floor consists of half-timbered limestone rubble walls, while the second floor has framed, vertical-plank walls. The main entrance on the west elevation has wide wood-plank doors both in the center of the first floor and the center of the upper floor for hayloft access. Shed-roofed wings extend from the building on both side elevations, creating open covered areas for equipment storage

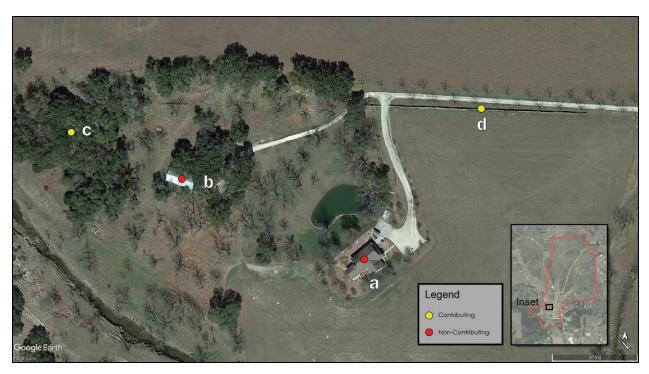
Parcel 3 / Map 5 Resources

#	Property Type	Resource	Date(s)	Roof form/ Plan Type	Exterior Materials	Status
5a	Building	Single Dwelling	1995	Cross gable	Stone	NC
5b	Building	Workshop	2014	Front gable	T-111	NC
5c	Structure	Stone Fence	c. 1860	Linear	Stone	С
5d	Structure	Stone Fence	c. 1860	Linear	Stone	С

Workshop (5b) – The workshop is a non-historic building on a concrete foundation. The front-gabled roof is clad in corrugated metal and the walls are T-111 vertical siding. The building's different elevations contain garage doors, horizontal sliding windows, and a single pedestrian entry door.

Stone Fence (5c) – This stacked limestone fence runs for approximately 530 feet. It is located just south of, and alongside, the entrance drive that approaches this building cluster. The fence height varies from about four and a half to five and a half feet high, and contains multiple courses of flat, stacked limestone stones. Along the top of the fence are larger stones laid vertically at a 45-degree angle. The fence is well-maintained and is in good condition.

Stone Fence (5d) – This stacked limestone fence remnant is located in a wooded area northwest of the house and workshop. It has multiple courses and is topped with a cap of flat stones. The fence is approximately three and a half feet high and 100 feet long, with collapsed, overgrown sections at each end.

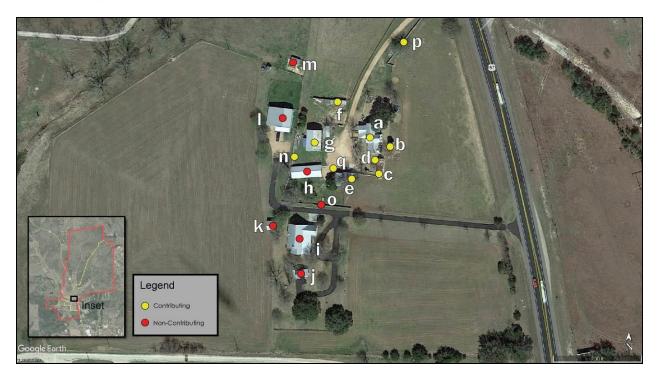
Parcel 3 / Map 6 Resources

#	Property Type	Resource	Date(s)	Roof form/ Plan Type	Exterior Materials	Status
6a	Building	Single Dwelling	c. 1890	Cross gable	Stone	С
6b	Building	Tank House	c. 1890	Square	Stone; Concrete	С
6c	Building	Kitchen/Blacksmith	c. 1860s/1920	Side gable	Wood; Stone	С
6d	Structure	Well & Windmill	c. 1860/1920	Truss tower	Metal; Stone	С
6e	Building	Garage & Workshop	c. 1940	Front gable	Metal	С
6f	Structure	Stone Fence & Shed	c. 1860/1928	Shed; Linear	Stone; Metal	С
6g	Building	Barn	1880s/1930s	Front gable	Wood; Stone	С
6h	Building	Sheep Shed	c. 1955	Front gable	Wood	NC
6i	Building	Single Dwelling	1998	Cross gable	Stone	NC
6j	Building	Barn/Guest House	1920/1989	Front gable	Wood	NC
6k	Building	Shed	2004	Front gable	T-111	NC
6l	Building	Barn/Dwelling	c. 1980	Front gable	Metal	NC
6m	Building	Horse Shelter	c. 1980	Front gable	Wood	NC
6n	Structure	Stone Fence	c. 1860	Linear/T-shape	Stone	С

Barn (6g) – This resource is a c. 1930 two-story barn with a footprint measuring roughly 32 feet across and 50 feet long. It is a frame building built onto c. 1880s limestone fences that were converted to function as the walls and foundation of the barn. The frame walls are clad with wide vertical wood plank walls, many of which are covered by corrugated metal panels. The south elevation is open along its lower level, with several support posts visible. The north elevation is enclosed with limestone walls along its lower level. A boarded-up pedestrian entry door and a window opening with a hinged wood cover are located within the limestone wall. The limestone wall continues along the west elevation. The upper section of wall on the south, north, and west elevations are windowless. The east elevation lacks corrugated metal panels, so the wood siding is visible. This elevation does not have limestone at the lower level. It is open across 2/3 of its length. On the second level, the east elevation has two large sliding doors that roll on a track. The doors are made from the same wide vertical planks. The 1930s barn replaced an older barn on the site that burned.

<u>Sheep Shed (6h)</u> – The sheep shed is an open, gabled shade structure similar to a carport. It is situated along the 70-foot, intersecting section of stone wall found at the midway point of Resource 6n. The wall encloses the shed along its north and west sides, creating a sheltered enclosure. The addition of the metal carport structure detracts from the historic character of the shed.

Gas Pump (6q) – The gas pump is a metal "visual pump" style unit about seven feet tall. It has a cylindrical base sitting on a square concrete pad, a tapered pole-like body, and a glass fuel cylinder on top.

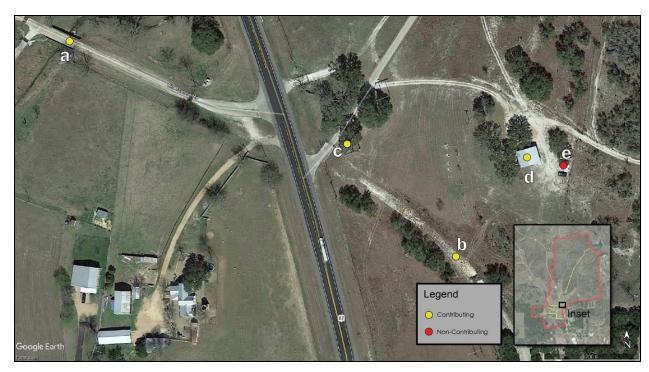
Parcel 3 / Map 7 Resources

#	Property Type	Resource	Date(s)	Roof form/ Plan Type	Exterior Materials	Status
7a	Structure	Bridge	c. 1935 Slab		Concrete	С
7b	Structure	Old Mason Road	c. 1857	Linear	Gravel	С
7c	Structure	Fence; Dipping Vat	1860s/c.1930	Linear	Stone; Concrete	С
7d	Building	Hunting Cabin	c. 1955	Side gable	Concrete block	С
7e	Building	Garage	c. 2000	Gambrel	T-111	NC

<u>Garage (7e)</u> – Behind the hunting cabin is a modern, prefabricated, shed-type garage with a gambrel roof, T-111 type pressed wood siding, and an overhead garage door punctuated with four narrow lights along the top.

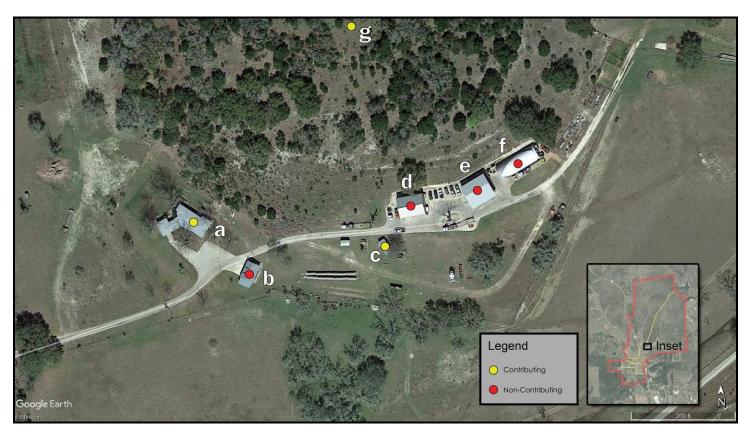
Parcel 3 / Map 8 Resources

#	Property Type	Resource	Date(s)	Roof Form/Plan Type	Exterior Materials	Status
8a	Building	Single Dwelling	1965 Hip S		Stone	С
8b	Building	Workshop/Garage	1977	Side gable	Concrete block	NC
8c	Building	Barn	c. 1970	Shed	Metal	С
8d	Building	Barn	2003	Side gable	Metal	NC
8e	Building	Equipment Shed	2003	Side gable	Metal	NC
8f	Building	Greenhouse	2003	Barrel vault	Metal; Plastic	NC
8g	Structure	Stone Fence	c. 1870	Linear	Stone	С

Stone Fence (8g) – The limestone fence in this cluster is approximately 820 feet in length and about three feet tall. It runs roughly east-west and travels up a small hill.

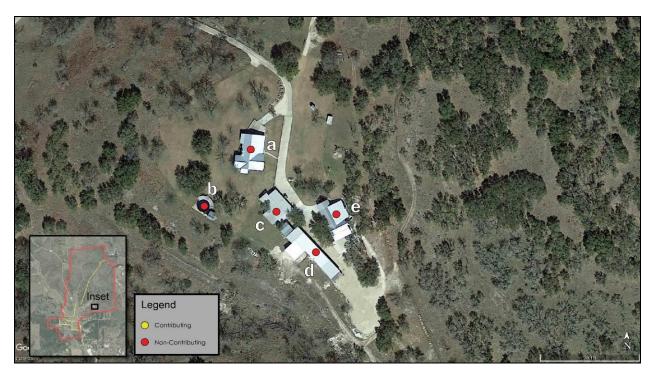
Parcel 3 / Map 9 Resources

#	Property Type	Resource	Date(s)	Roof form/ Plan Type	Exterior Materials	Status
9a	Building	Single Dwelling	1987	Cross gable	Stone	NC
9b	Structure	Swimming Pool	1990	Circular	Plastic; Wood	NC
9c	Building	Garage	1989	Shed	Metal	NC
9d	Building	Garage/Equipment	1989	Shed	Metal	NC
9e	Building	Party House	2007	Front gable	Metal	NC

<u>Party House (9e)</u> - The party house is a metal front-gabled building with an inset entry porch and a large shed-roofed side porch.

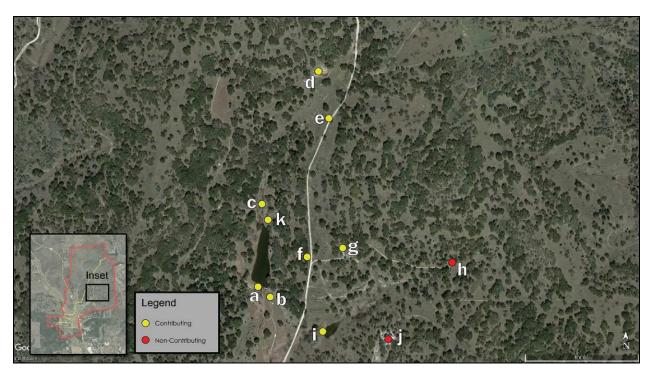
Parcel 3 / Map 10 Resources

#	Property Type	Resource	Date(s)	Roof form/ Plan Type	Exterior Materials	Status
10a	Structure	Dam & Pond	c. 1937	Linear	Concrete	С
10b	Structure	Well & Trough	c. 1940	Rectangular Concrete		С
10c	Structure	Trough	c. 1940	Rectangular Concrete		С
10d	Building	Barn	c. 1950	Side gable Metal		С
10e	Structure	Trough	c. 1940	Rectangular	Concrete	С
10f	Structure	Stone fence	c. 1860	Linear	Stone	С
10g	Structure	Well	c. 1950	Pipes	Metal	С
10h	Building	Wildlife Shelter	c. 1960	Shed	Metal	NC
10i	Structure	Dam & Pond	c. 1930	Linear	Earth	С
10j	Building	Barn/Living Quarters	2017	Cross gable Stucco		NC
10k	Site	Picnic Area	1930s/1950s	Irregular	Stone, Concrete	С

<u>Picnic Area (10k)</u> – This resource is a grassy picnic area situated at the north end of the larger pond (10a). The west edge of the picnic area is delineated by a stone-lined canal that channels spring water from the spring at Resource 10c past the picnic area to the pond (10a). Over the canal is a bridge built in the 1950s from a steel I-beam that was shaped and welded by a family member. Near the bridge are stone steps leading into the canal. Early recreation elements dating to the 1930s and 1940s include a stone fire pit and barbecue pit. The picnic area is situated several feet above the pond's water level and a curved board-form concrete wall serves as a terrace. A metal ladder along this wall provides access to the pond for swimming.

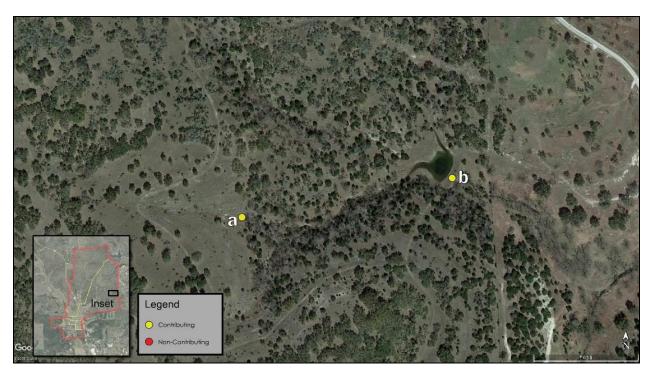
Parcel 3 / Map 11 Resources

#	Property Type	Resource	Date(s)	Roof form/ Plan Type	Exterior Materials	Status
1	1a	Structure	Trough	c. 1930	Rectangular	Concrete	С
1	1b	Structure	Dam & Pond	c. 1950	Linear	Earth	С

<u>Earthen Dam & Pond (11b)</u> – This resource is a small earthen embankment dam located at the eastern edge of the district. It creates a small pond approximately 1/3 acre in size.

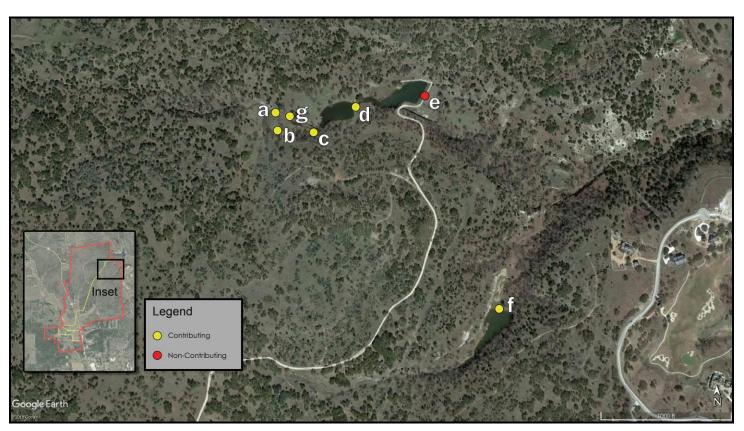
Parcel 3 / Map 12 Resources

#	Property Type	Resource	Date(s)	Roof form/ Plan Type	Exterior Materials	Status
12a	Structure	Dam	c. 1930	Linear Concrete		С
12b	Structure	Trough	c. 1930	Rectangular	Concrete	С
12c	Structure	Stone Fence	c. 1860	Linear	Stone	С
12d	Structure	Dam & Pond	c. 1930	Linear	Concrete	С
12e	Structure	Dam & Pond	c. 1995	Linear	Earth	NC
12f	Structure	Dam & Pond	c. 1970	Linear	Earth	С
12g	Structure	Developed Spring	c. 1930	Rectangular Concrete		С

Map 12 includes resources found near the district's northeast corner at the end of the primary ranch road. The road meanders northwest, following the terrain past grazing areas and clusters of trees, and curving east along the base of a small hill before descending a limestone escarpment. At the escarpment is a series of three dams and two spring-fed, manmade ponds, with the downstream pond at the east where the road crosses an earthen embankment dam. The spring that

<u>Developed Spring (12g)</u> – This developed spring consists of a flat concrete pad with a rectangular depression in the center of it. The spring water wells up into the depression, which can then serve as a trough.

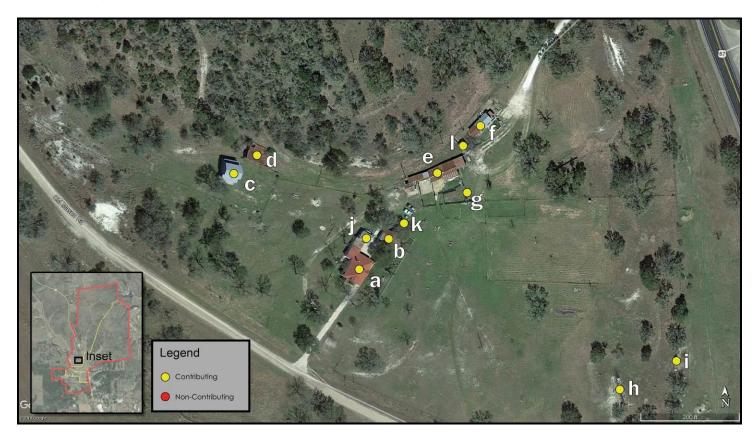
Parcel 4 / Map 13 - Amandus Stehling Homestead, c. 1852

Parcel 4 / Map 13 Resources

#	Property Type	Resource	Date(s)	Roof form/ Plan Type	Exterior Materials	Status
13a	Building	Single Dwelling	1921	Hip	Wood	С
13b	Building	Garage/Storage	1935	Hip	Metal	С
13c	Building	Barn	1972	Side gable Metal		С
13d	Building	Barn	c. 1921	Shed Wood		С
13e	Building	Barn	1928	Linear; Shed Stone; Metal		С
13f	Building	Tenant House	1947	Side gable	Asbestos	С
13g	Structure	Trough & Pens	1942	Rectangular	Wood	С
13h	Structure	Silage Pit	1945	Linear	Concrete	С
13i	Structure	Silage Pit	1947	Linear	Concrete	С
13j	Building	Garage	c. 1935	Hip	Wood	С
13k	Building	Shed	1940s	Gable	Wood	С
131	Building	Vehicle Barn	1947	Gable	Metal	С

<u>Vehicle Barn (131)</u> – This shed is located between resources 13e and 13f. It is a front-gabled building with corrugated metal walls and roof. A sliding, hasp-hung barn door on the front elevation is supported by a rail that extends beyond the edge of the building.

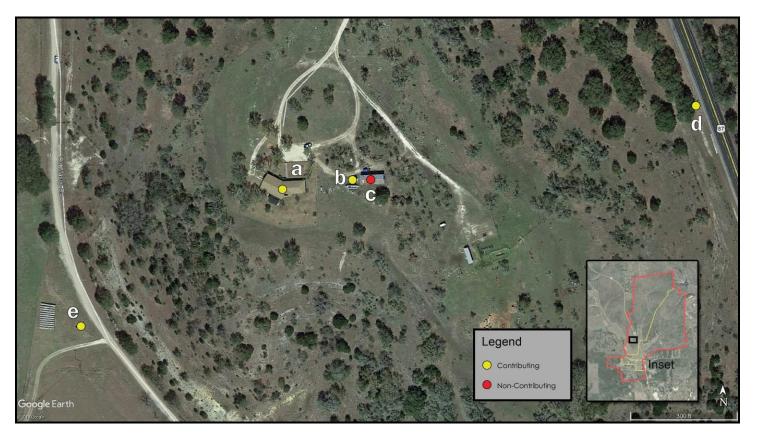
Parcel 4 / Map 14 – Amandus Stehling Homestead, c. 1852

Parcel 4 / Map 14 Resources

#	Property Type	Resource	Date(s)	Roof form/ Plan Type	Exterior Materials	Status
14a	Building	Single Dwelling	1974	Side gable	Stone	С
14b	Building	Well House	1974	Side gable	Metal	С
14c	Building	Workshop	1978	Side gable	Metal	NC
14d	Structure	Livestock Underpass	c. 1940	Flat arch	Concrete	С
14e	Structure	Ruins - Dwelling	c. 1852	Rectangular	Stone	С

Single Dwelling (14a) – This resource is a Ranch style house with a "bent" footprint where the two ends intersect at approximately a 30-degree angle. A shallow inset porch is located at the inside angle. The walls are clad in limestone veneer, and a wide limestone chimney is located at the rear elevation. Two garage doors are found in the west side elevation.

<u>Early Dwelling Ruins (14e)</u> – This resource is the remains of a small building near Barons Creek. It is associated with the Henry Thiele family who lived here by 1850. Based on its size, it was likely a one-room dwelling. Four stacked limestone partial walls remain. Adjacent to the ruin is a low stacked limestone retaining wall about 40 feet in length.

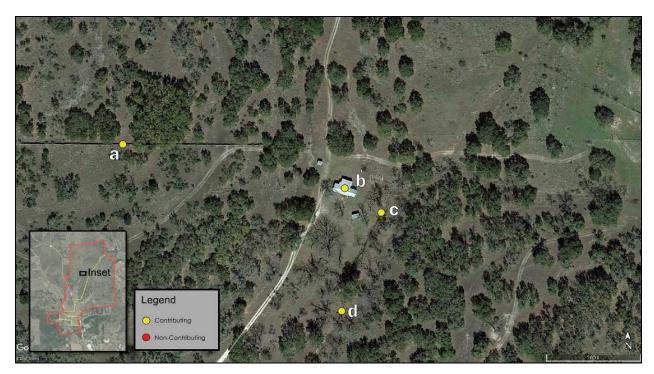
Parcel 4 / Map 15 Resources

#	Property Type	Resource	Date(s)	Roof form/ Plan Type	Exterior Materials	Status
15a	Structure	Stone Fence	c. 1860	Linear	Stone	С
15b	Building	Camp House	1938	Side gable	Painted Boards	С
15c	Structure	Developed Spring	1936	Square	Concrete	С
15d	Structure	Trough	1937	Rectangular	Concrete	С

<u>Spring-Fed Trough (15d)</u> – This trough is located a short distance downstream from the developed spring. The trough is a rectangular, poured concrete structure that extends a few inches above grade.

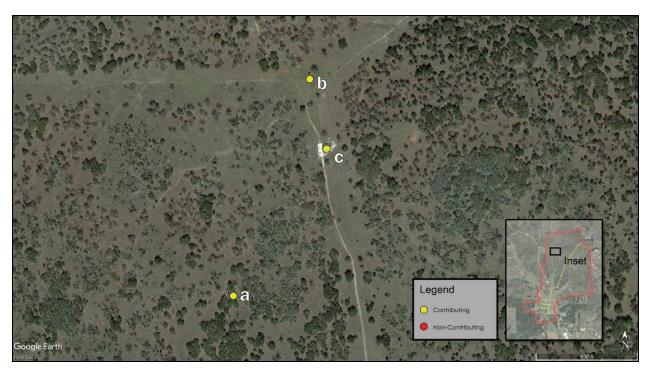
Parcel 4 / Map 16 Resources

#	Property Type	Resource	Date(s)	Roof form/ Plan Type	Exterior Materials	Status
16a	Structure	Spring & Trough	1930	Rectangular	Concrete	С
16b	Structure	Well & Windmill	1951	Truss tower	Metal	С
16c	Structure	Corrals	c. 1980s	Irregular	Metal	NC

Corrals (16c) – Several connected metal bar corrals.

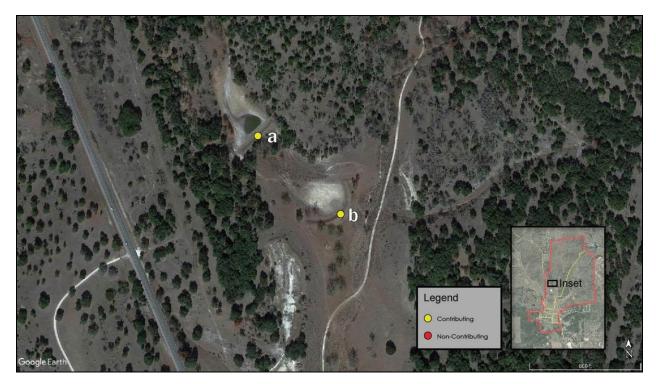
Parcel 4 / Map 17 Resources

#	Property Type	Resource	Date(s)	Roof form/ Plan Type	Exterior Materials	Status
17a	Structure	Dam & Pond	Late 1940s	Linear	Earth	С
17b	Structure	Dam	Late 1940s	Linear	Earth	С

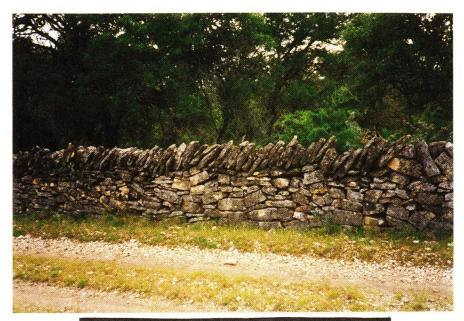
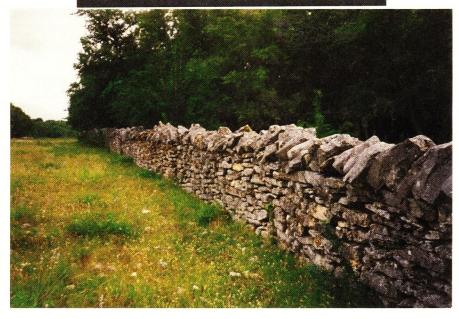
Figures 9-10: Stone Fences on Amandus Stehling Farm built from early 1850s - 1870s before barbed wire became common.

Beautiful rock fences built by Amandus Stehling on his ranch beginning in the 1850s. These fences are still standing proudly and still in use on the Stehling Ranch today, in the year 2020.

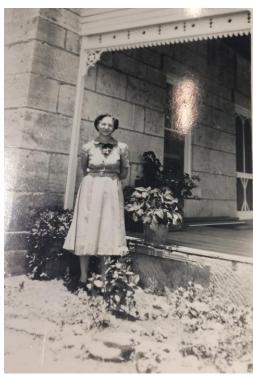
Figure 17: Viola Feuge, great-great granddaughter of Christoph and Christine Feuge, 1901 House c. 1955

"1901" house," as it is known for the date incised in the stone lintel above the entrance, displays exceptional craftsmanship in its precise corners and finely chiseled blocks; each block measures 18" deep and 3' long (Figure 17). The side-gabled house rises a full two stories above the stone foundation and features an attached full-façade front porch supported by wood posts with Victorian-style wood brackets and a decorative wood frieze across the front and sides of the porch. While Christoph Theodore Feuge was known as a stone mason who likely built the 1½-story stone dwelling on his homestead and the two Stehling houses, the precision and refinement of the 1901 may be attributable to his son, Carl's particular skill and talent. Other stone resources built on the Feuge farmstead in the late 19th or early 20th century include a smokehouse and storm shelter (Figure 16). These ancillary buildings also exhibit a high degree of craftsmanship in their stonework. Even the later stone fences and stone barn walls on the Feuge farmstead from this era are finely cut and artistically arranged.

Though they might not have wanted to make their living entirely from the farm/ranches, the current generations of Feuges and Stehlings still have strong ties to the land and the rural lifestyle. Several of the Stehling descendants returned to the country where they built new homes on their parents' and grandparents' farms. Among them are Lucille Stehling Pape, Richard Stehling's daughter, who built a new house on the Amandus/John/Richard Stehling farm in 1998; she and her husband, Robert Pape, also renovated an old grain barn on the site as a guest house. Others who built new houses on the Amandus Stehling farm include Randy Stehling, an architect, and his wife, Michelle, a teacher, and Randy's cousin, Keith Stehling, an insurance agent. Kent Stehling is also an insurance agent but instead of building a new house, he and his wife, Krista, renovated his grandparents' (John and Mary Stehling) c. 1890 house where they currently live and raise sheep and cattle. Hugo Feuge's daughter, Viola, also returned to home to the 1901 stone house when she retired (Figure 17); she occupied the house until her death a few years ago.

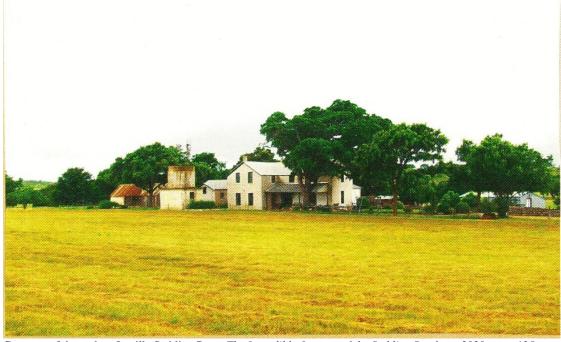
Figure 26: Amandus/John/Richard Stehling Farmstead from U.S. Highway 87. Occupied by Kent and Krista Stehling. From left to right: Dogtrot Workshop/Blacksmith/Wash House, Water Tank and Windmill, c 1890 John Stehling House.

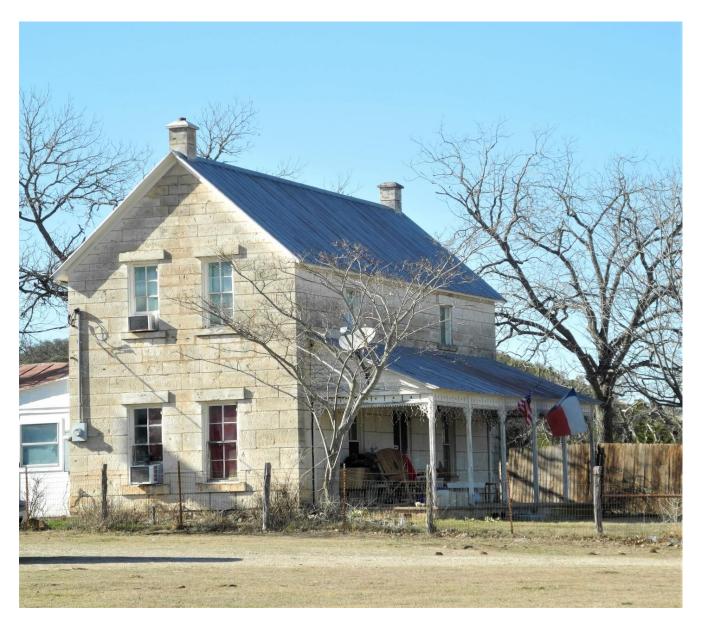
Photo 1: Contributing Building. Carl Feuge House, aka "1901 House," (Resource 2a), quarried limestone house with Folk Victorian porch posts and trim. Photo by Terri Myers, March 10, 2022, camera facing northwest.

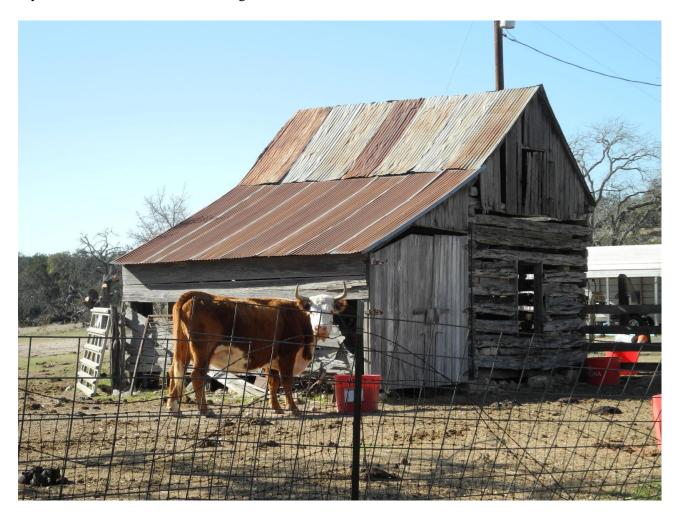
Photo 6: Contributing Building. Multi-purpose (hay, vehicle, equipment) Frame Barn (Resource 2i), c. 1900, Feuge Farm. Photo by Terri Myers, March 10, 2022, camera facing northwest.

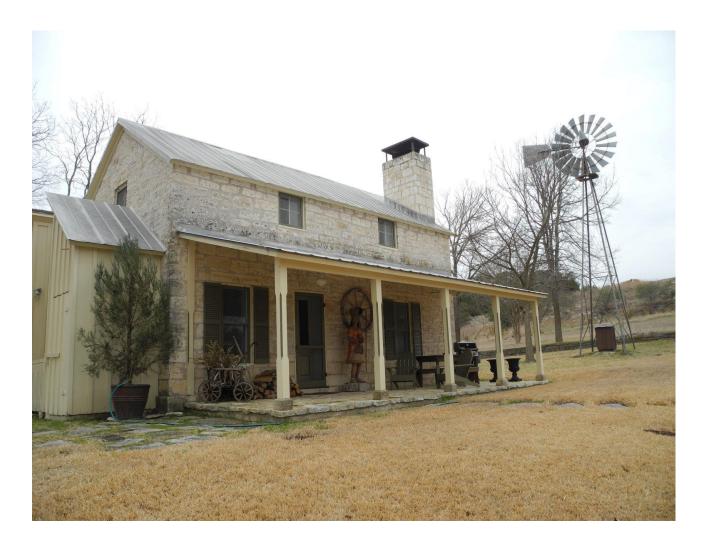
Photo 13: Contributing Building. Joseph Stehling Sr. House (Resource 3a), primary façade, built 1889, George Franz Stehling Farm. Photo by Terri Myers, March 11, 2022, camera facing west.

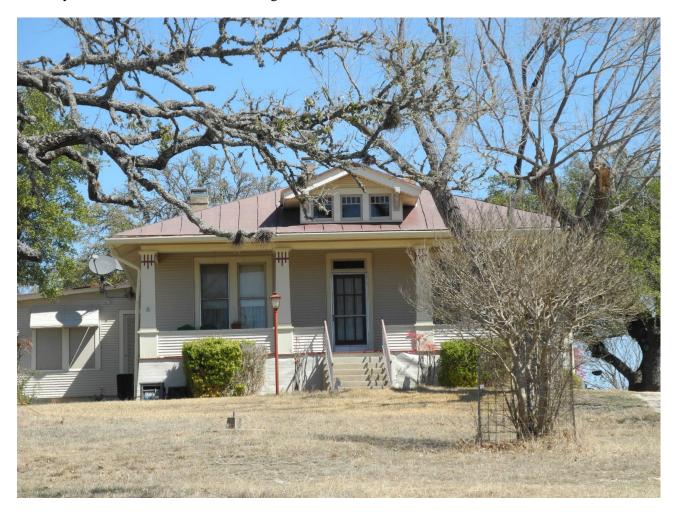
Photo 26: Contributing Building. Paul Stehling House (Resource 13a), built 1921, Amandus Stehling Farm. Photo by Terri Myers, March 12, 2022, camera facing northeast.

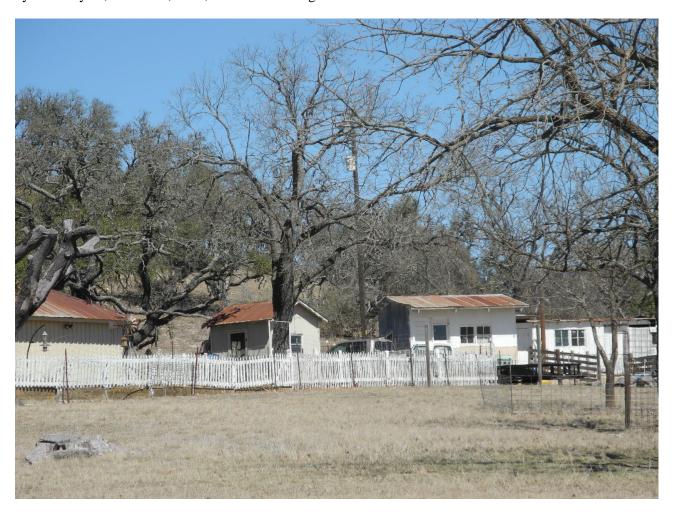
Photo 27: Garage and Sheds (Resource 13b), c. 1935, on Paul Stehling Farm out of Amandus Stehling homestead. Photo by Terri Myers, March 12, 2022, the camera facing northwest.

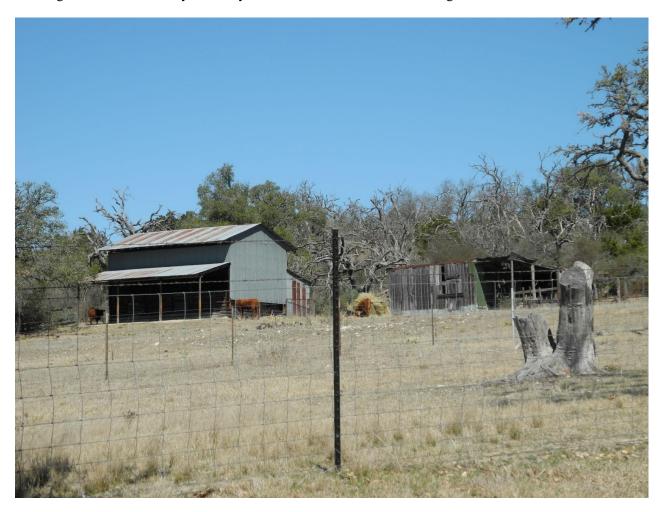
Photo 28: Contributing Buildings. Barns (Resource 13c, 1972, on left; 13d, c. 1921), on Paul Stehling Farm/Amandus Stehling farmstead. Photo by Terri Myers, March 12, 2022, camera facing north.

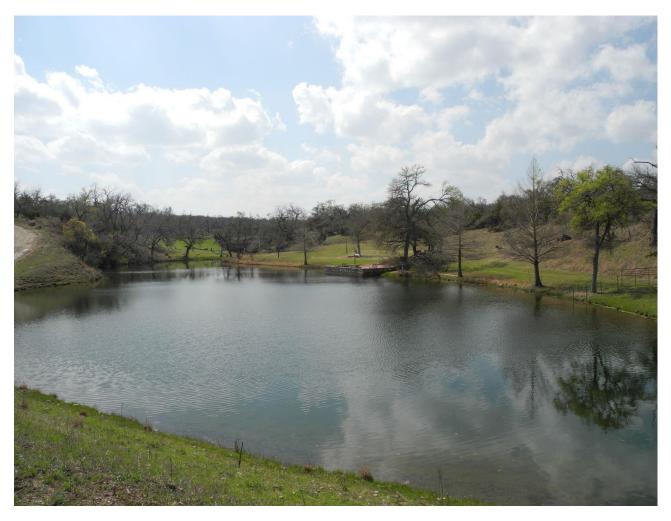
Photo 33: Reservoir behind dam (Resource 10a), c. 1937, Amandus Stehling land east of N Highway 87. Photo by Terri Myers, March 25, 2021, camera facing east.

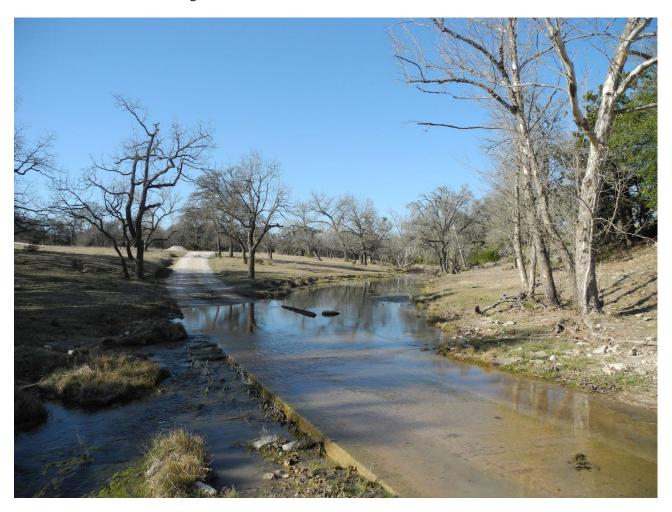
Photo 37: Contextual View. Low-Water Crossing over Barons Creek on Christoph Feuge Farm. Photo by Terri Myers, March 10, 2022, camera facing northwest.

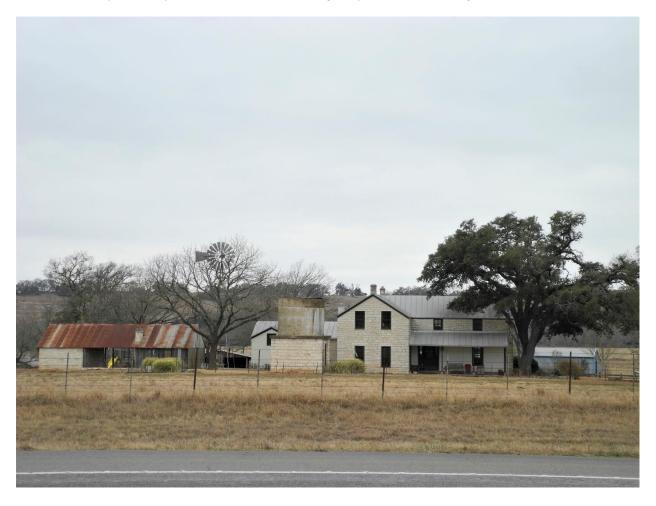
Photo 38: Contextual View. Amandus/John/Richard Stehling Farmstead, est. 1852; Resources shown date to 1870s-1890s. Photo by Terri Myers, March 11, 2022, N Highway 87, camera facing northwest.

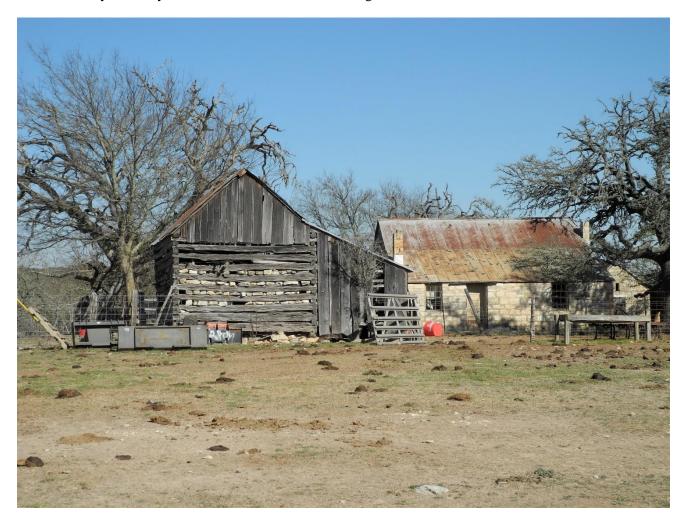
Photo 41: Contextual View. Early domestic and agricultural cluster (log barn c. 1860; limestone house c. 1870), on Feuge Farm. Photo by Terri Myers, March 10, 2022, camera facing south/southeast.

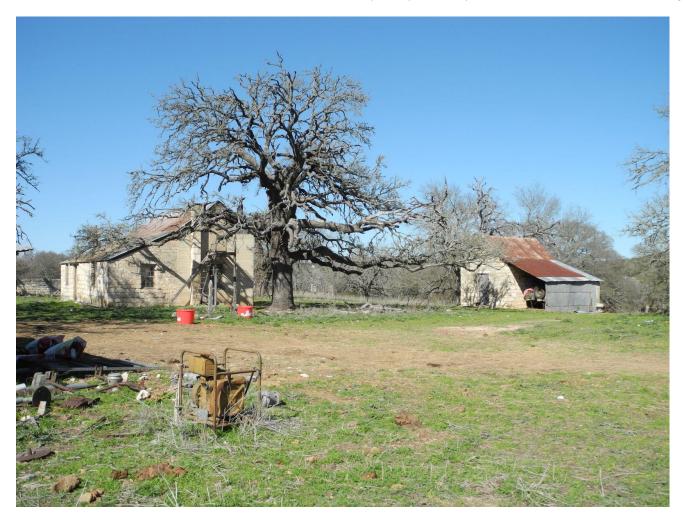
Photo 42: Contextual View. Domestic Cluster. 1½ story stone house (Resource 2e); stone smokehouse with vehicle shed addition (Resource 2f), both c. 1870. Photo taken from barnyard by Terri Myers, March 25, 2021, camera facing north.

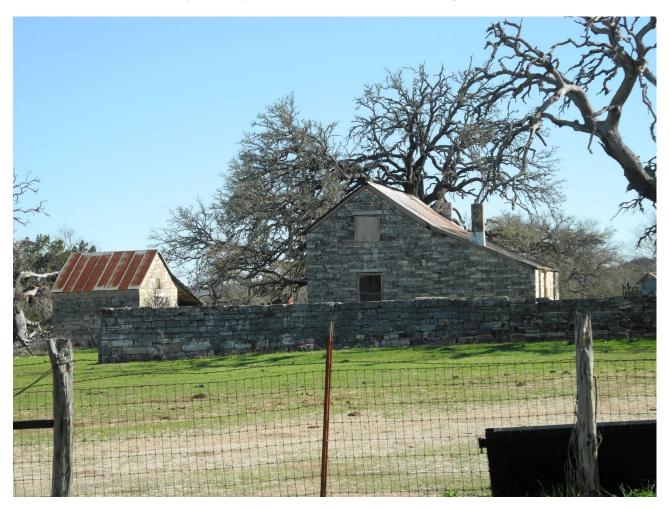
Photo 43: View – Second generation Feuge domestic cluster: 1½ story stone house, smokehouse, and fence (Resources 2e, 2f, and 2c), 1870. Photo by Terri Myers, March 25, 2021, camera facing south.

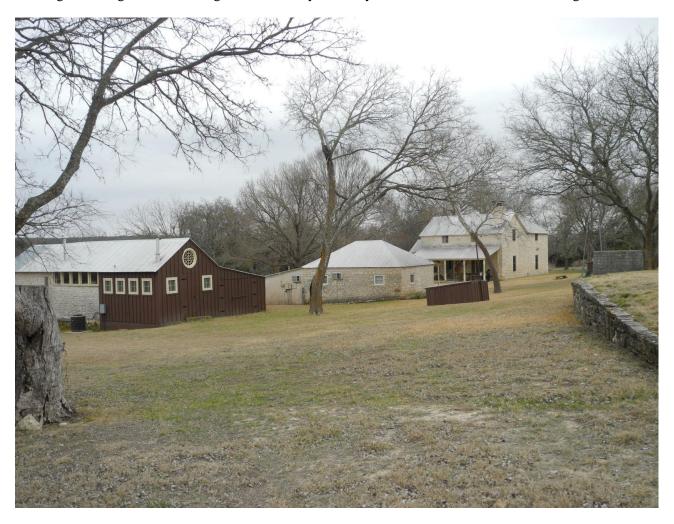
Photo 45: Noncontributing Building. Modern carport and stone wall, Amandus Stehling Farm. Photo by Terri Myers, March 25, 2021, camera facing northwest.

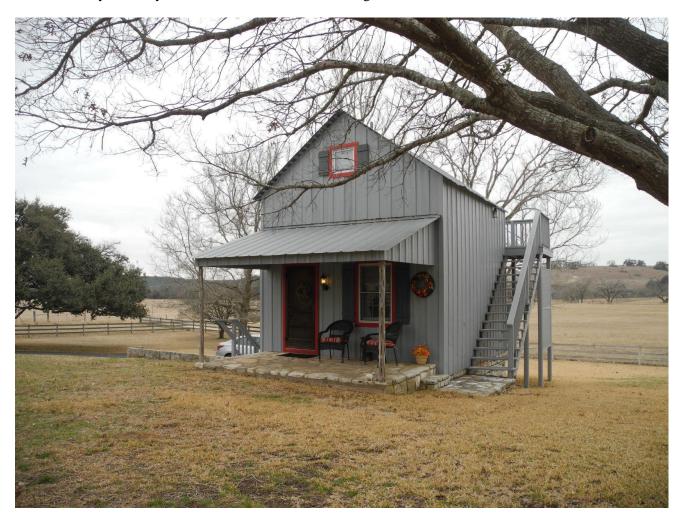
Photo 46: Noncontributing Buliding. Historic age grain barn converted to guest house (Resource 6j), Amandus Stehling Farm. Photo by Terri Myers, March 11, 2022, camera facing north.

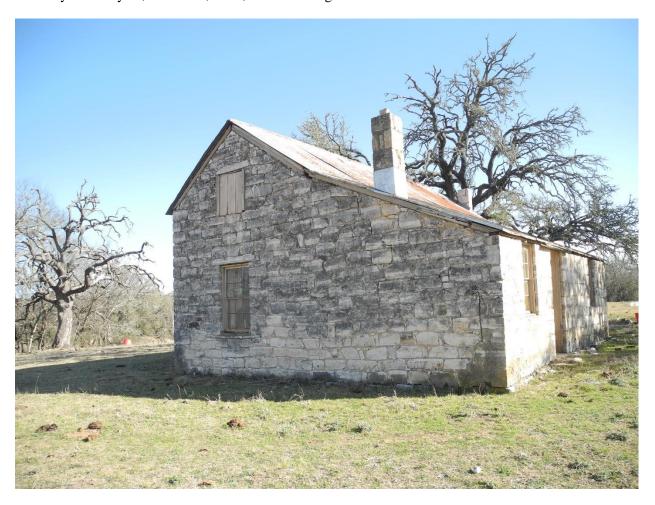
Photo 54: Materials and Methods. Christoph Feuge (Jr.) House, c. 1870, window detail. Cut stone lintels with row of small stones as chinking. Photo by Terri Myers, March 10, 2022.

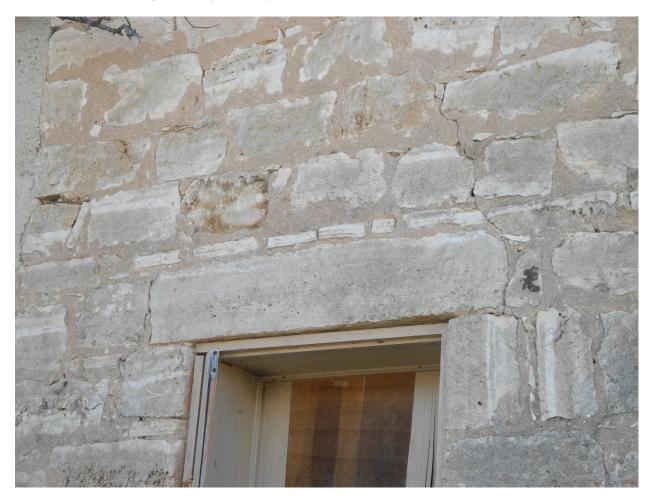
Photo 55: Materials and Methods. Stone remnants fitted to fill gaps in ad hoc fashion. Photo by Terri Myers, March 10, 2022.

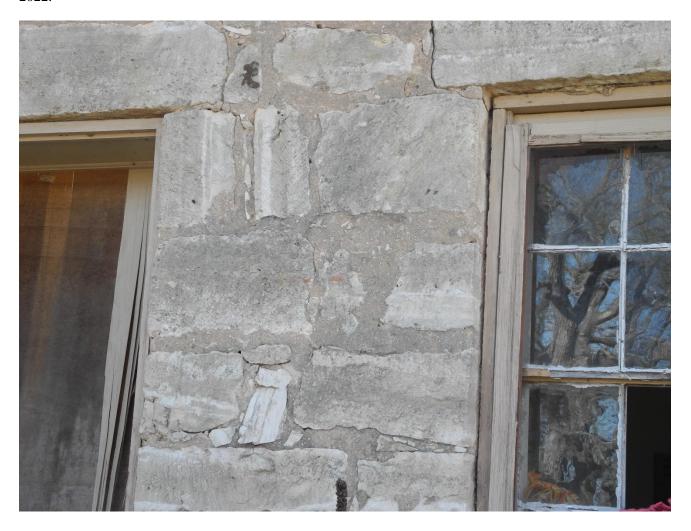
Photo 56: Materials and Methods. Carl Feuge "1901 House." Feuge, a skilled stonemason, built his 2-story stone house next to his father's 1 ½ story stone house. Craftsmanship is evident in its finely chiseled, tightly fitted stone blocks, and razor-sharp edges. Photo by Terri Myers, March 10, 2022.
