United States Department of the Interior
National Park Service
National Register of Historic Places Registration Form

Historic Name: Seward Plantation
Other name/site number:
Name of related multiple property listing: NA

Street & number: 10005 FM 390 E
City or town: Independence State: Texas County: Washington
Not for publication: Vicinity:

Narrative Description (see continuation sheets 7-7 through 7-16)

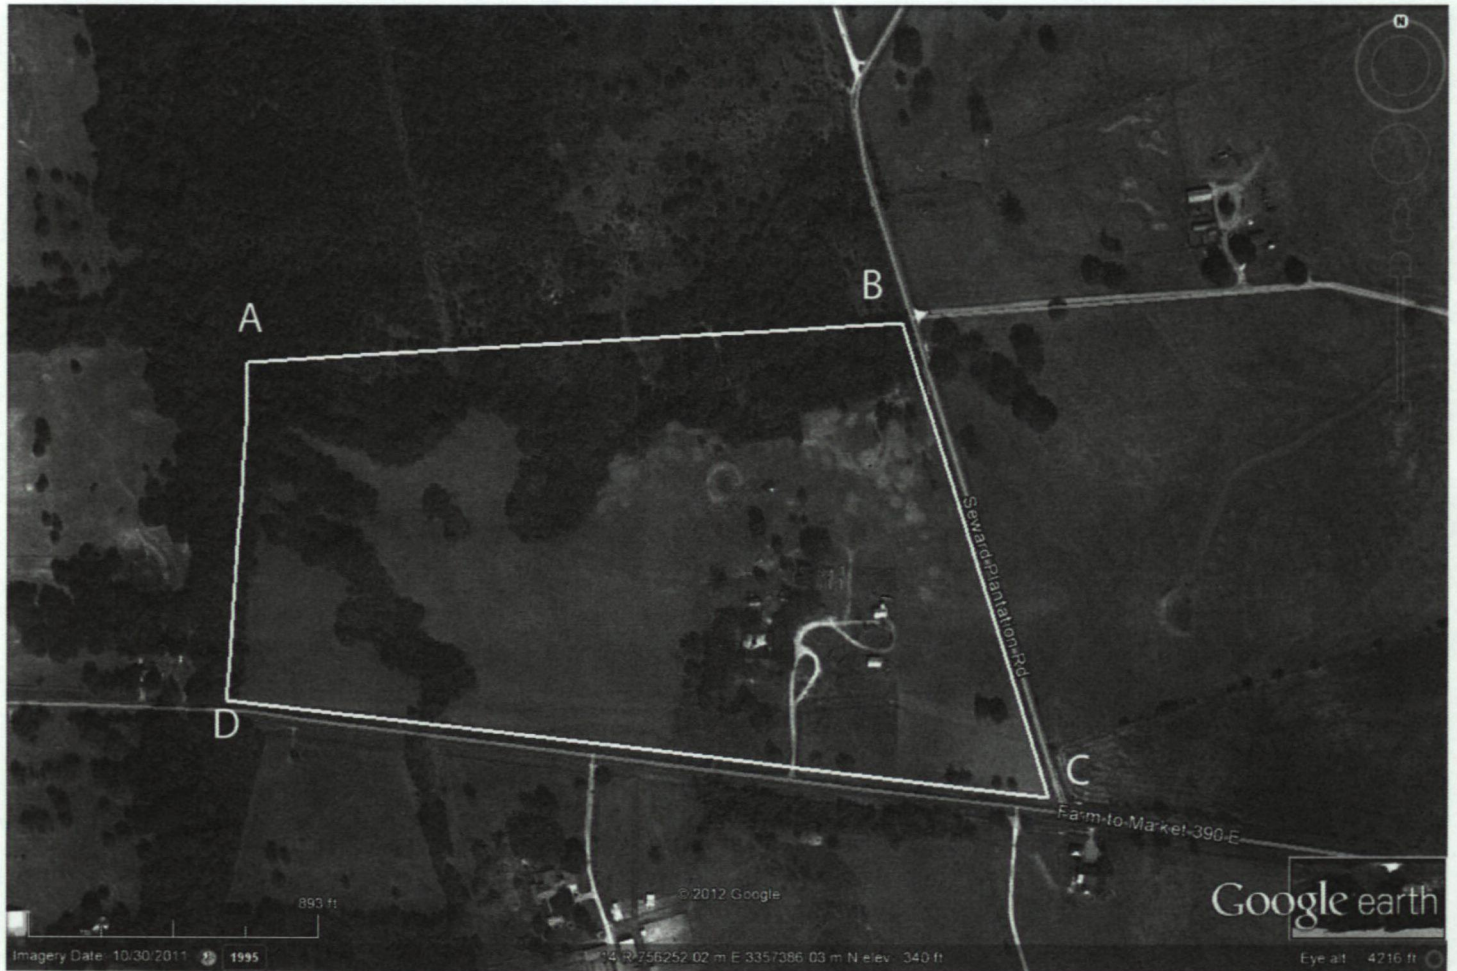
Map 3: Polygon depicts approximate boundaries of the nominated property. Both the west and north boundaries actually follow the natural contours of two branches of Town Branch/Independence Creek. See USGS map submitted with the nomination for additional reference. UTM coordinates for points A, B, C, and D are listed on page 4.

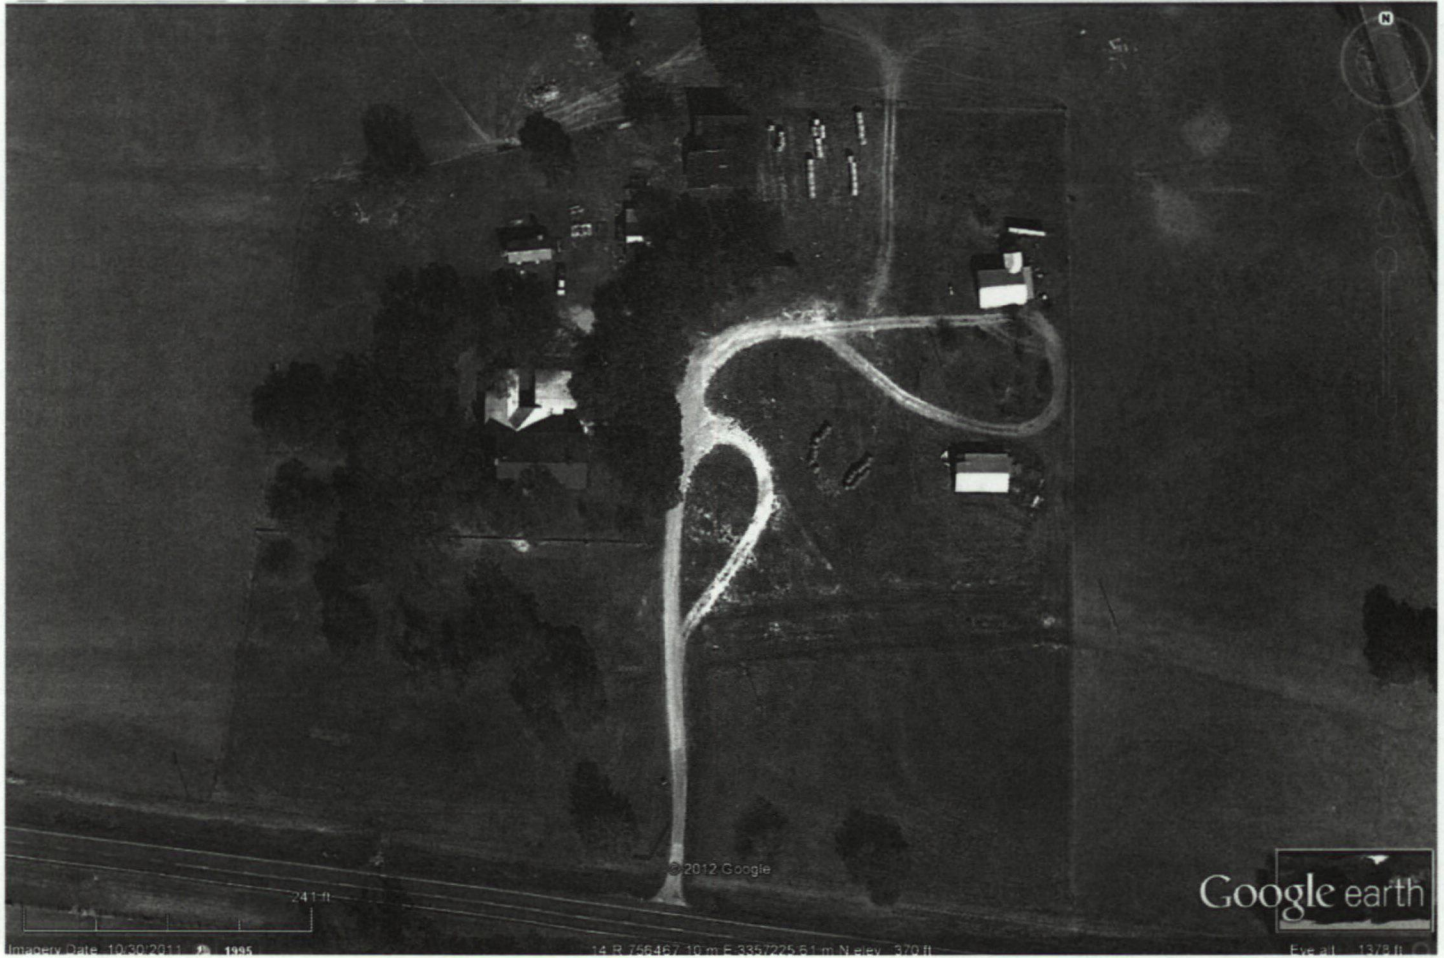
Figure 1: Google Earth aerial view of the residential and service core of Seward Plantation.

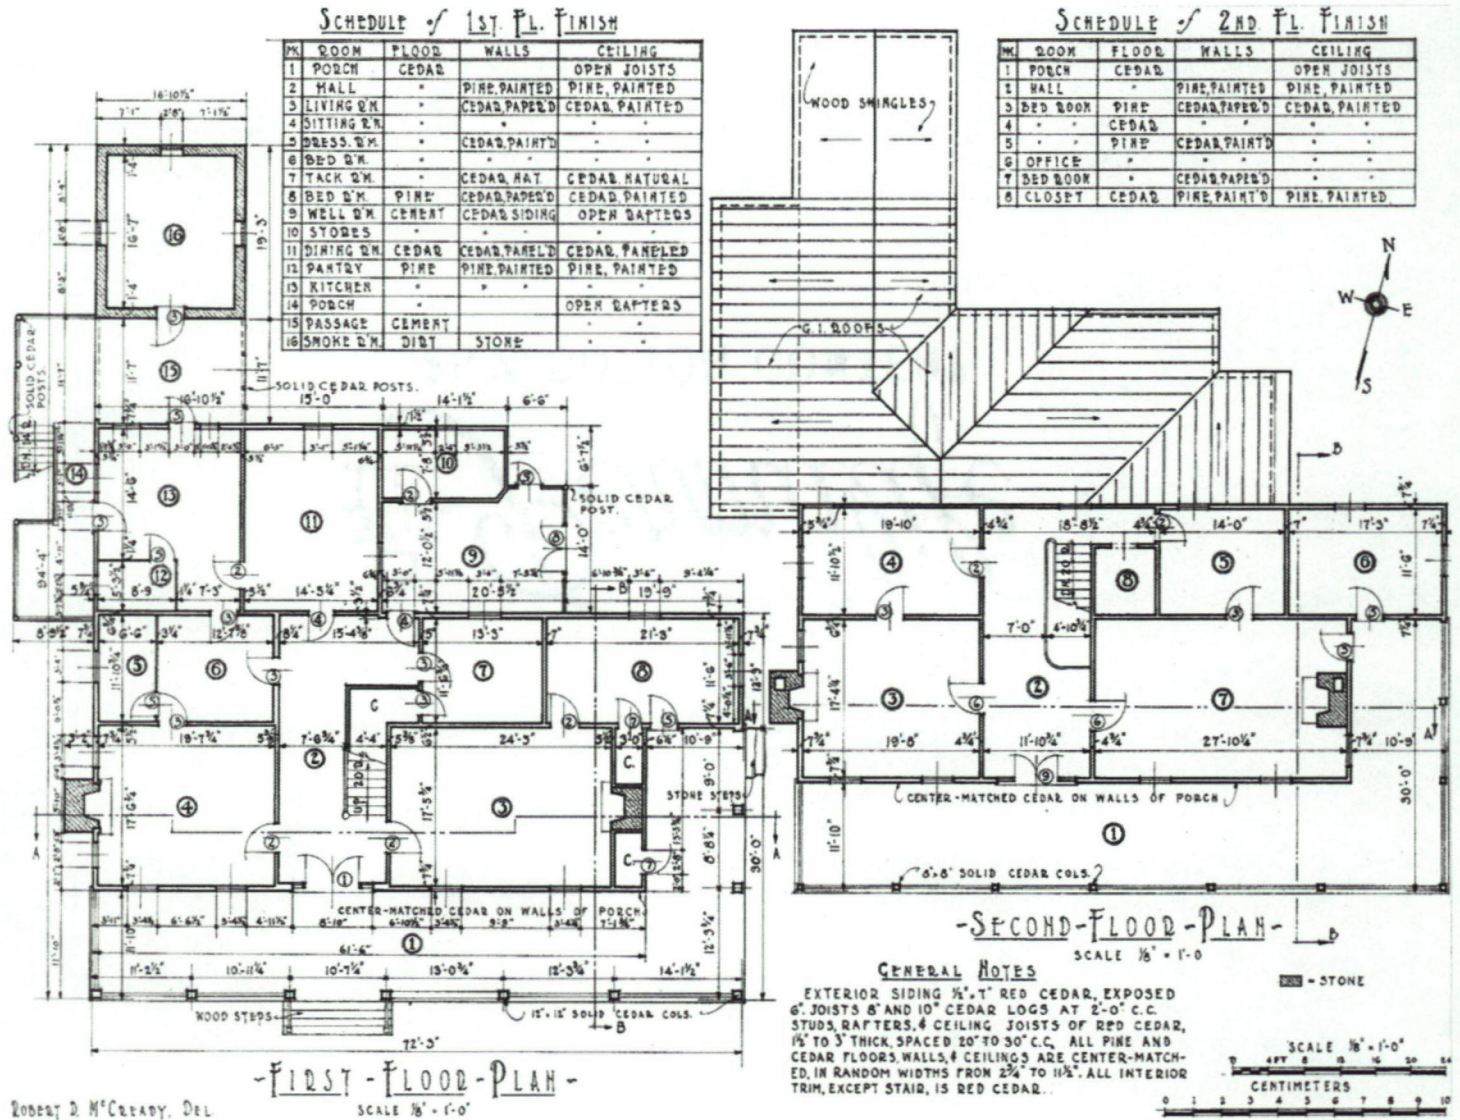
Figure 2: First and second floor house plans prepared by the Historic American Building Survey program in 1934. Survey number HABS TX-33-B-8.

Interior Description: The interior of the house is organized around a central hall, the east side of which holds the stairs to the second floor. Two rooms lie to the west of the hall; three rooms to the east. The dining room, added sometime in the mid- to late-nineteenth century, lies directly north of the entry hall. From the dining room, the well room and storage room are to the east and the kitchen lies directly to the west. To the north of the kitchen, a passageway leads to the formerly detached smoke house.

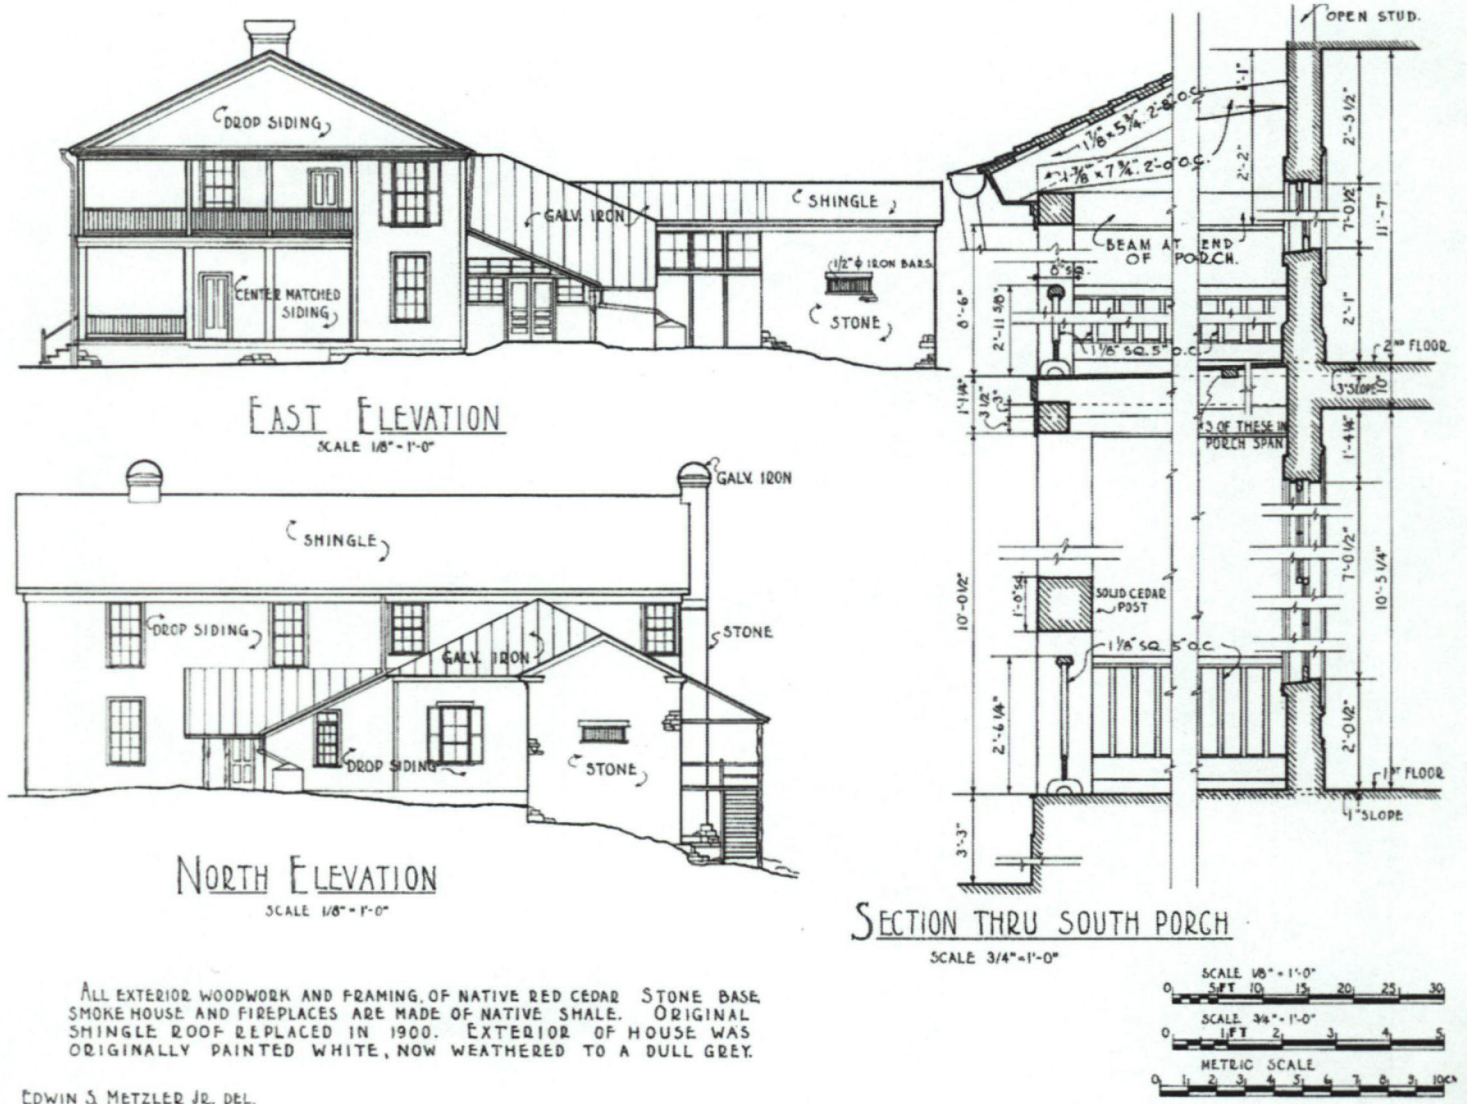
Figure 3: Elevation and section drawings prepared by HABS in 1934. Survey number HABS TX-33-B-8.

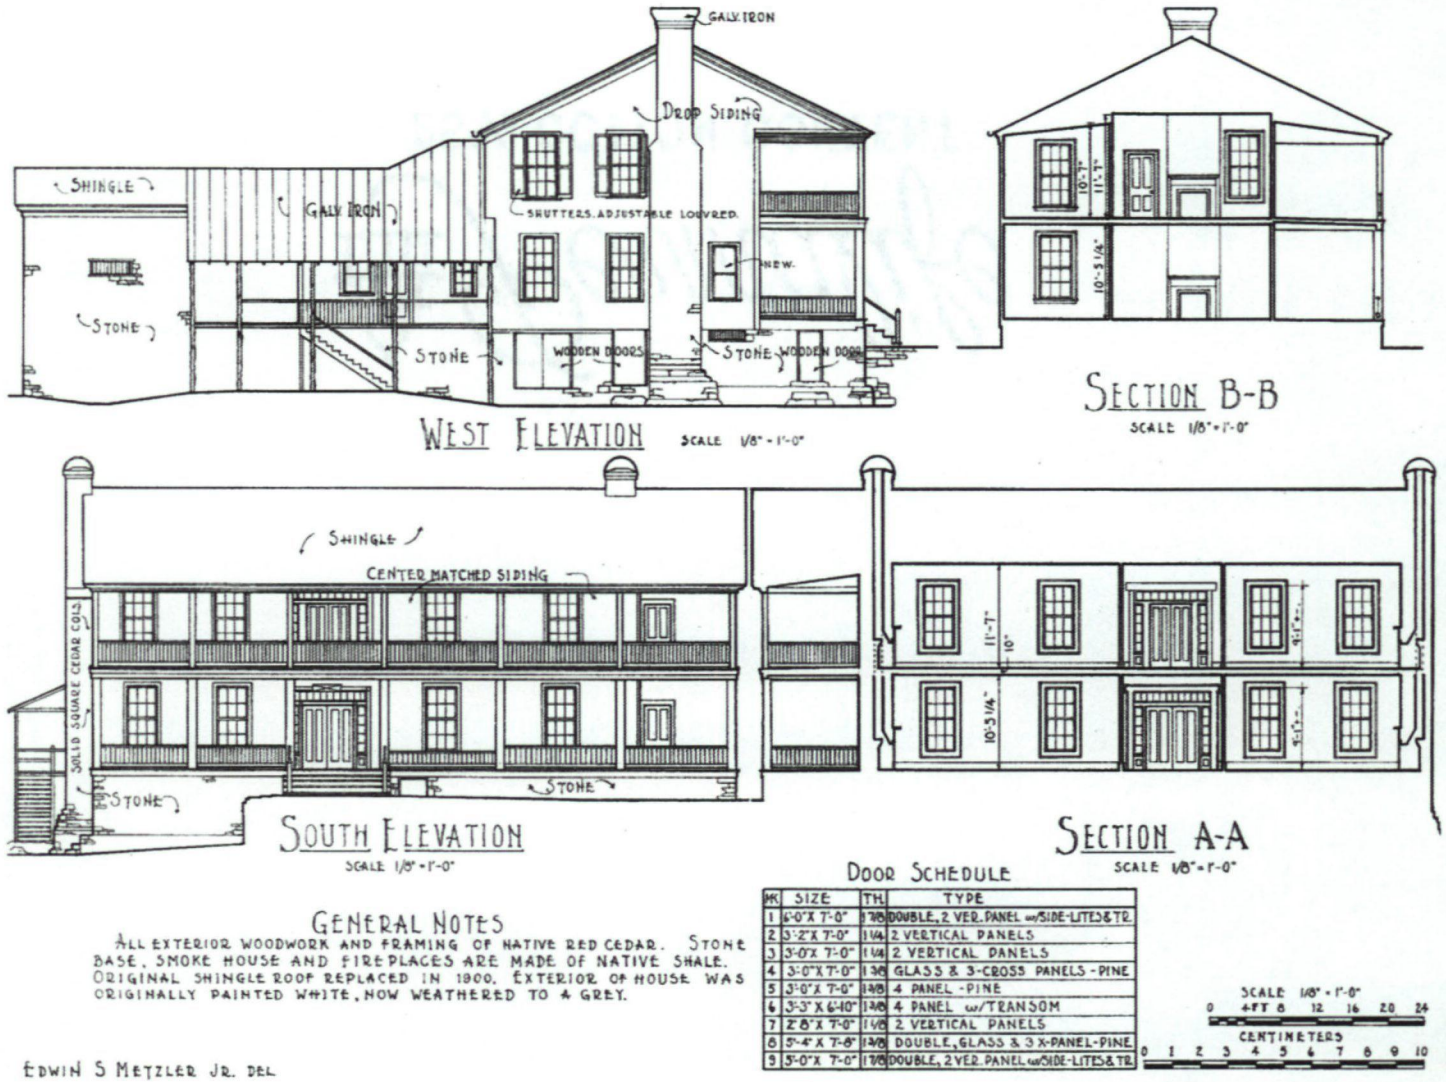
Figure 4: Elevation and section drawings prepared by HABS in 1934. Survey number HABS TX-33-B-8.

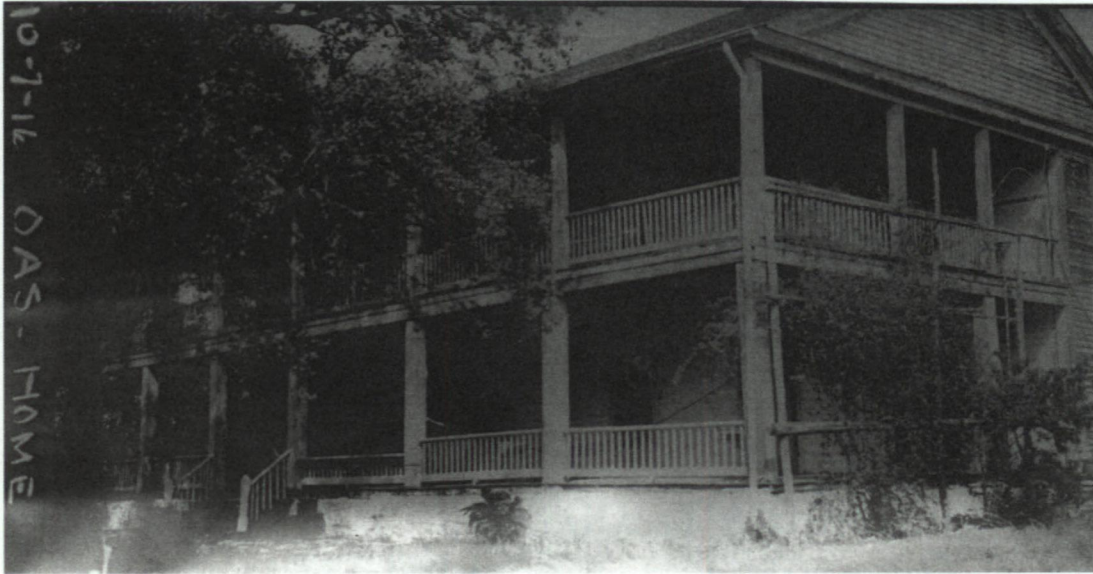
Figure 5: Seward Plantation, Main House, south (main) and east (side) elevations, c. 1916. From the Ward Family collection.

A long, six-bay double gallery extends across the front of the house (south elevation) to provide shade from the hot sun. The first floor gallery is supported by nine 12”x12” solid cedar columns, while the second floor gallery is supported by 6”x 6” solid cedar columns. The galleries are nearly eleven feet deep, are lined by simple wood railings, and are incorporated under the main roof of the house. The side gabled roof is shingled. Unique for the area, the roof is not flush with the walls and ceiling; there is a one-foot gap between the roof plate and the ceiling and walls to allow for continuous ventilation throughout the attic and to discourage condensation and dry rot under the roof. The west chimney, made of native rough-cut shale, stands on the exterior gable end wall; the east chimney is internal, placed in the ridge. The house sits on a native shale foundation. Exterior siding is ½” x 7” red cedar. Rafters and ceiling joists are also red cedar.

The six bays of the south elevation are not precisely uniform in width, varying from just over ten and a half feet wide to almost fourteen feet wide. Fenestration of the bays is identical on the first and second floors. Beginning with the westernmost bay, it consists of the following. The first and second bays each hold a single, double-hung, six-over-six wood window. Five wood steps, framed by the same simple railing of the galleries, lead up to the third bay which holds the wood paneled double entry doors. The doors are topped by a ten-lite, fixed glass transom and flanked by four-lite, fixed glass sidelights (repeated on the second floor). The fourth and fifth bays are identical to the first and second, holding a single, double-hung, six-over-six wood window each. While the roof line and gallery of the sixth bay are flush with the others, the living space is recessed, and so the gallery wraps partially around to the east elevation. The recessed bay contains a wood panel, single entry door. (The room that lies beyond the door on the first floor did not internally connect to the interior of the house until recent times. The room was used for boarders, and did not allow for access to the rest of the house.)

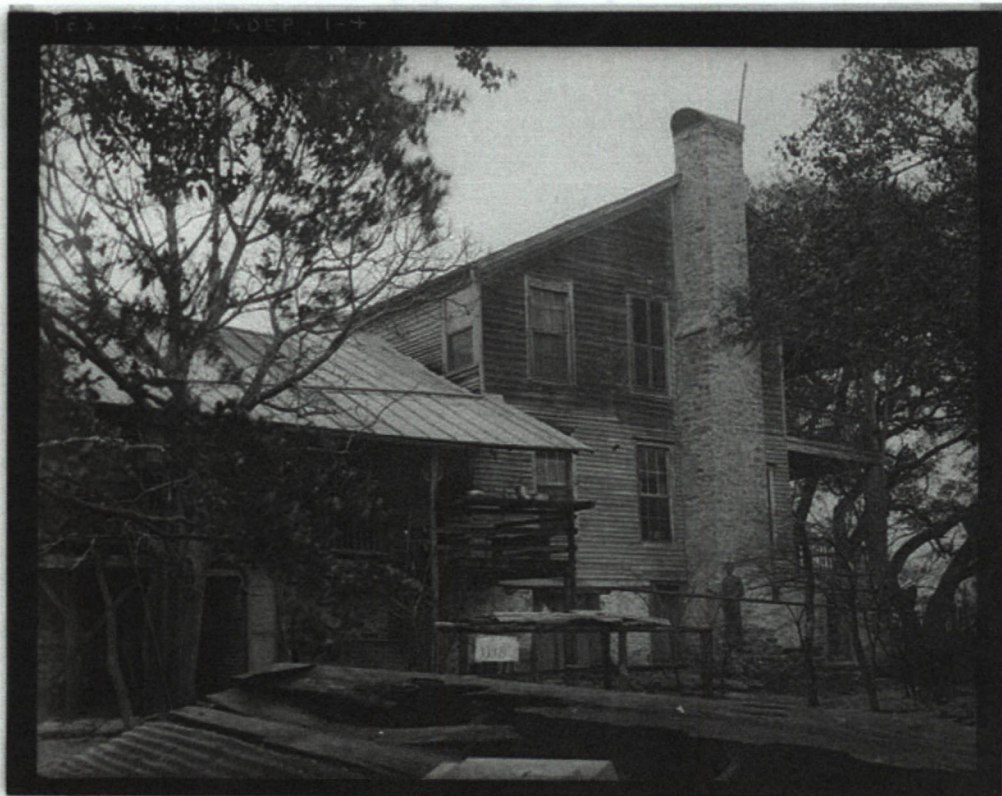
Figure 6: West elevation, Main House, 1934. Historic American Buildings Survey, James I. Campbell, Photographer, March 10, 1934 VIEW FROM NORTHWEST. HABS TEX,239-INDEP,1-4.

The west elevation is a similar mix of materials and forms. Because of the change in grade (it slopes downward from east to west), basement space exists beneath a portion of the western half of the house's main block. Into the native shale foundation are set four wooden doors—a single door to the south of the chimney and a single door and a pair of double doors to the north of the chimney—that provide access to this basement space. Fenestration of the first floor consists of two double-hung, six-over-six wood windows to the north side of the chimney and one double-hung, one-over-one wood window south of the chimney. The 1934 HABS drawings indicate that this window is "new." Second floor fenestration is identical to that on the first, except that it lacks the southmost window. Drop siding extends from the first floor all the way up the gable wall.

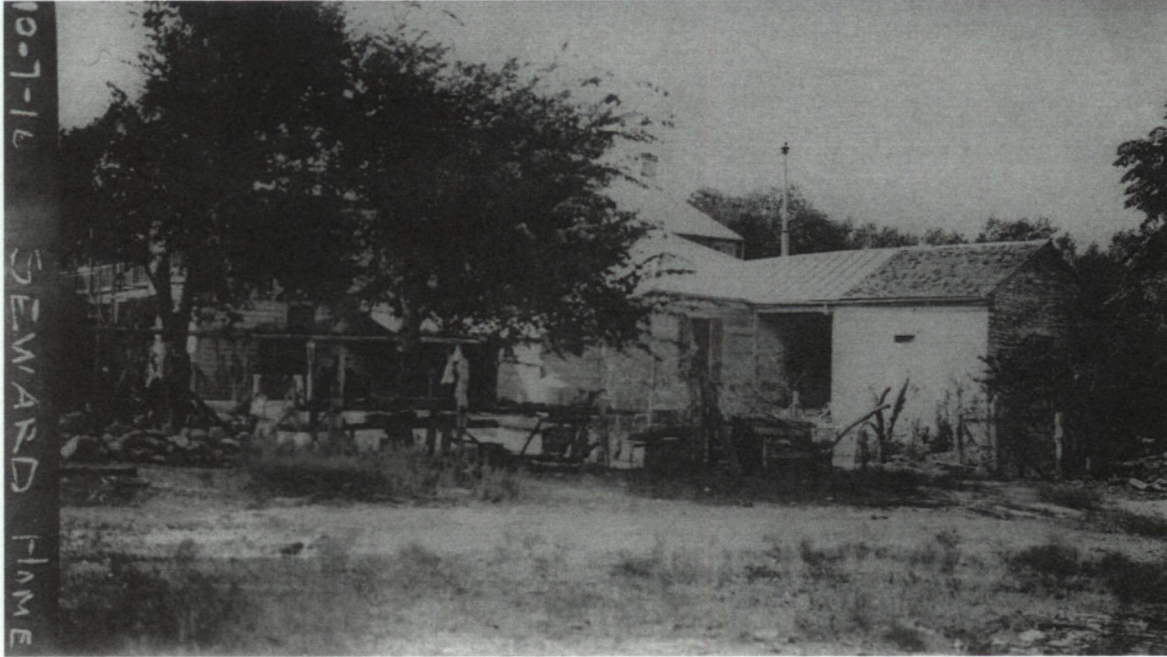
Figure 7: View of the yard and rear of the main house, c. 1916. From the Ward Family collection.

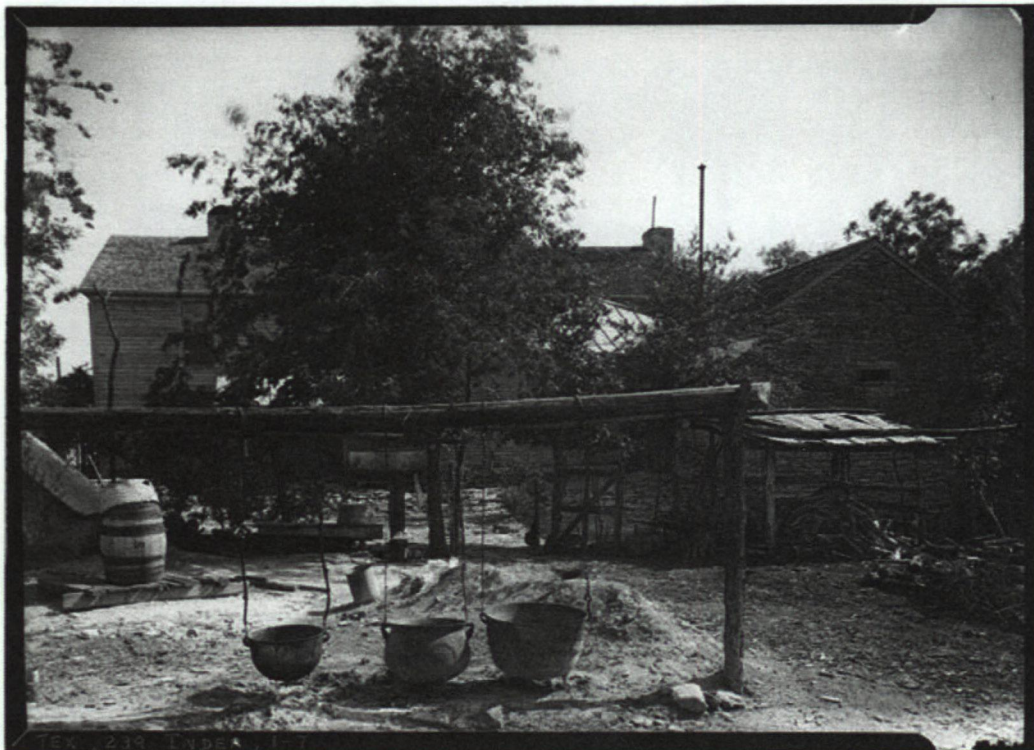
Figure 8: View of the rear yard of the main house, 1936. Historic American Buildings Survey, Harry L. Starnes, Photographer, April 23, 1936. REAR ELEVATION. HABS TEX,239-INDEP,1-7.

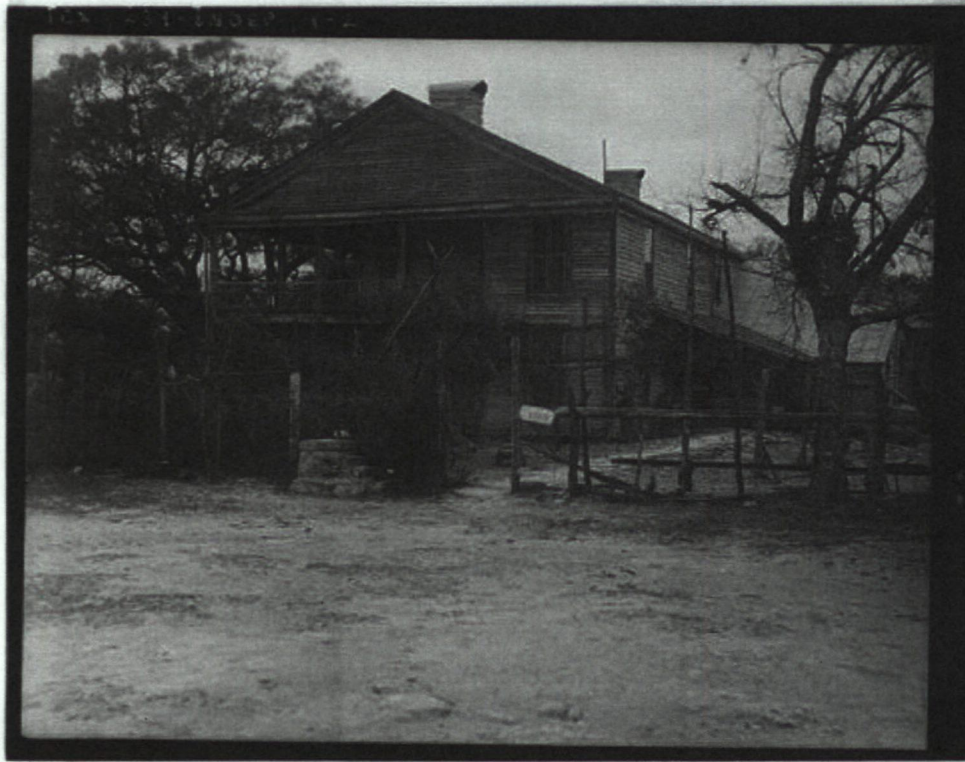
Figure 9: East elevation, main house, 1934. Historic American Buildings Survey, James I. Campbell, Photographer, March 10, 1934. VIEW FROM NORTHEAST. HABS TEX,239-INDEP,1-2.

The east elevation of the house contains four bays under the main gable. The northernmost is the only one not fronted by the gallery and is clad in wood drop siding. Each story of the bay holds a single, double-hung, six-over-six wood window framed by louvered wood shutters. Working southward, the next bay contains no fenestration. The third bay contains a single, wood paneled door on the first floor and a single, double-hung, six-over-six wood window framed by louvered wood shutters on the second floor. The fourth bay simply consists of the open gallery space framed by the solid cedar columns. The gable wall is clad in wood drop siding. The east elevation of the rear additions are a mix of materials and roof shapes. The east wall of the well room is composed primarily of a patchwork of fixed, multi-lite windows of various sizes and vertical wood siding. Entry is provided by panel-and-glazed wood double doors. Horizontal drop siding clads the east wall of the storage room. A single panel-and-glazed wood door provides entry.

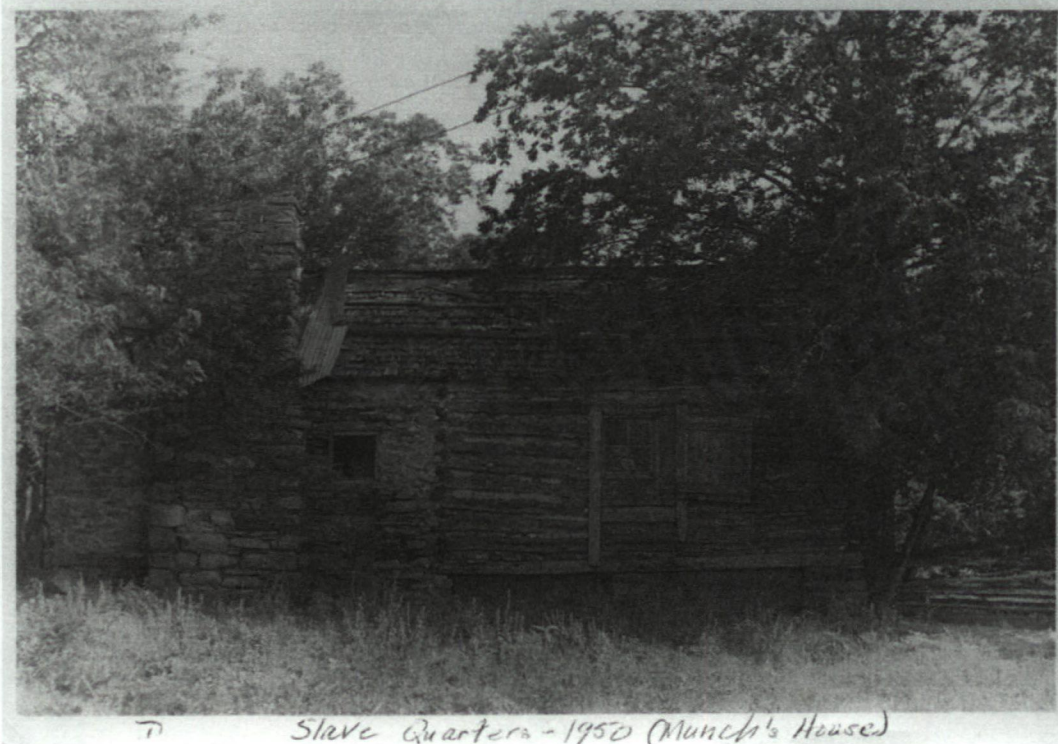
Figure 10: North (rear) elevation of the slave quarters, 1950. From the Ward Family collection.

Description: Located approximately 150 feet directly north of the main house, this dwelling is actually a duplex. The quarters are single-room units and share a common wall. They are currently unified under a modern, corrugated metal, side gable roof. The metal roof covers a much older wood, split shingle roof. Both units sit on a field stone foundation.

The unit on the west is a single-pen log building measuring approximately 17'x17'. It is composed of V-notched cedar planks with wide plaster chinking. A board and batten door with a square four-lite window provides entry on the south elevation. A massive stone chimney stands on west elevation against the gable end. A small square window is roughed in to the north elevation. The interior features a board floor (laid horizontally to the entrance) on cedar joists. A stone hearth dominates the west wall. This unit's four wall log construction is evidence that it was built first.

The east unit is approximately the same size. The south elevation is composed of vertical board and batten walls and entry is provided by a wood, four panel door. The east elevation is also board and batten construction and bears a double-hung, four-over-four wood window. A massive stone chimney stands against the north elevation. The north wall is composed of stone instead of wood. On the interior, the wood plank floor lays perpendicular to the entry, on cedar joists. A large stone hearth dominates the north wall. The east unit's west wall is the west unit's east wall constructed of cedar logs. This dates construction of the east unit to after that of the west, though it is unclear when this occurred. A 1950 photograph illustrates that it dates to at least that time.

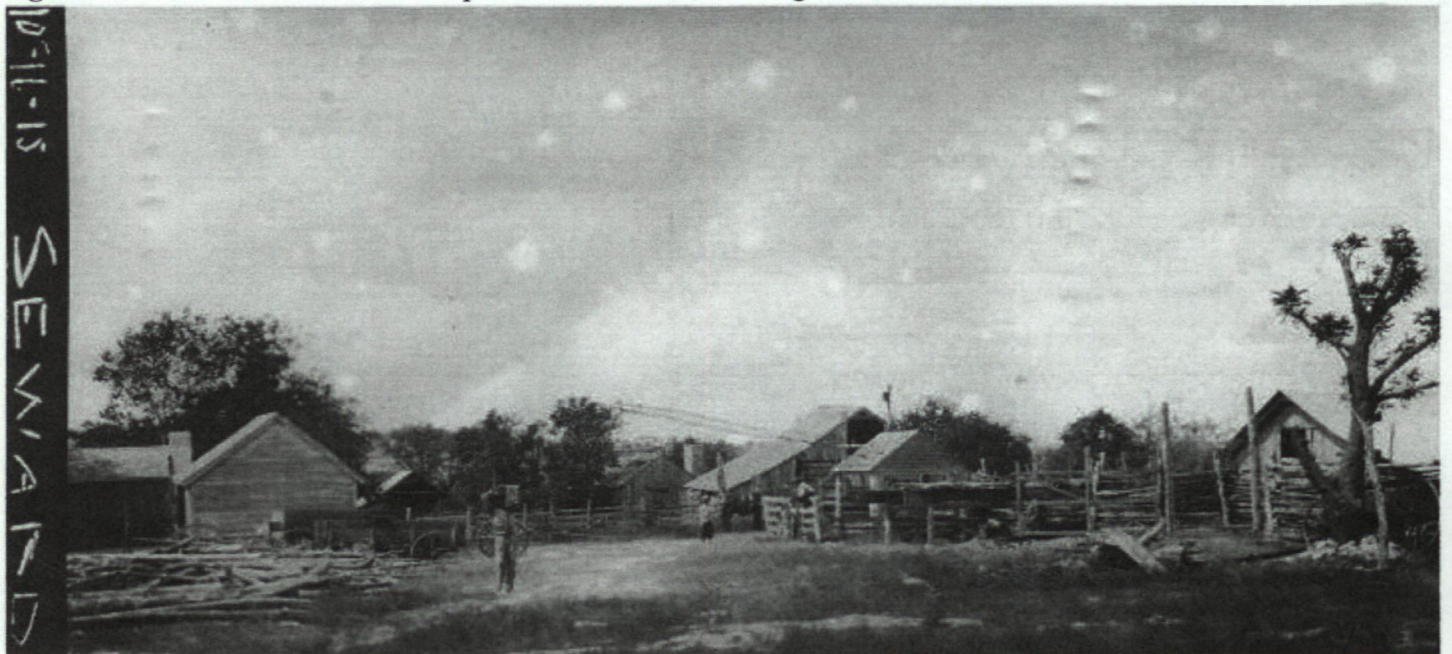
Figure 11: View of the service complex from the east, looking west, c. 1915.

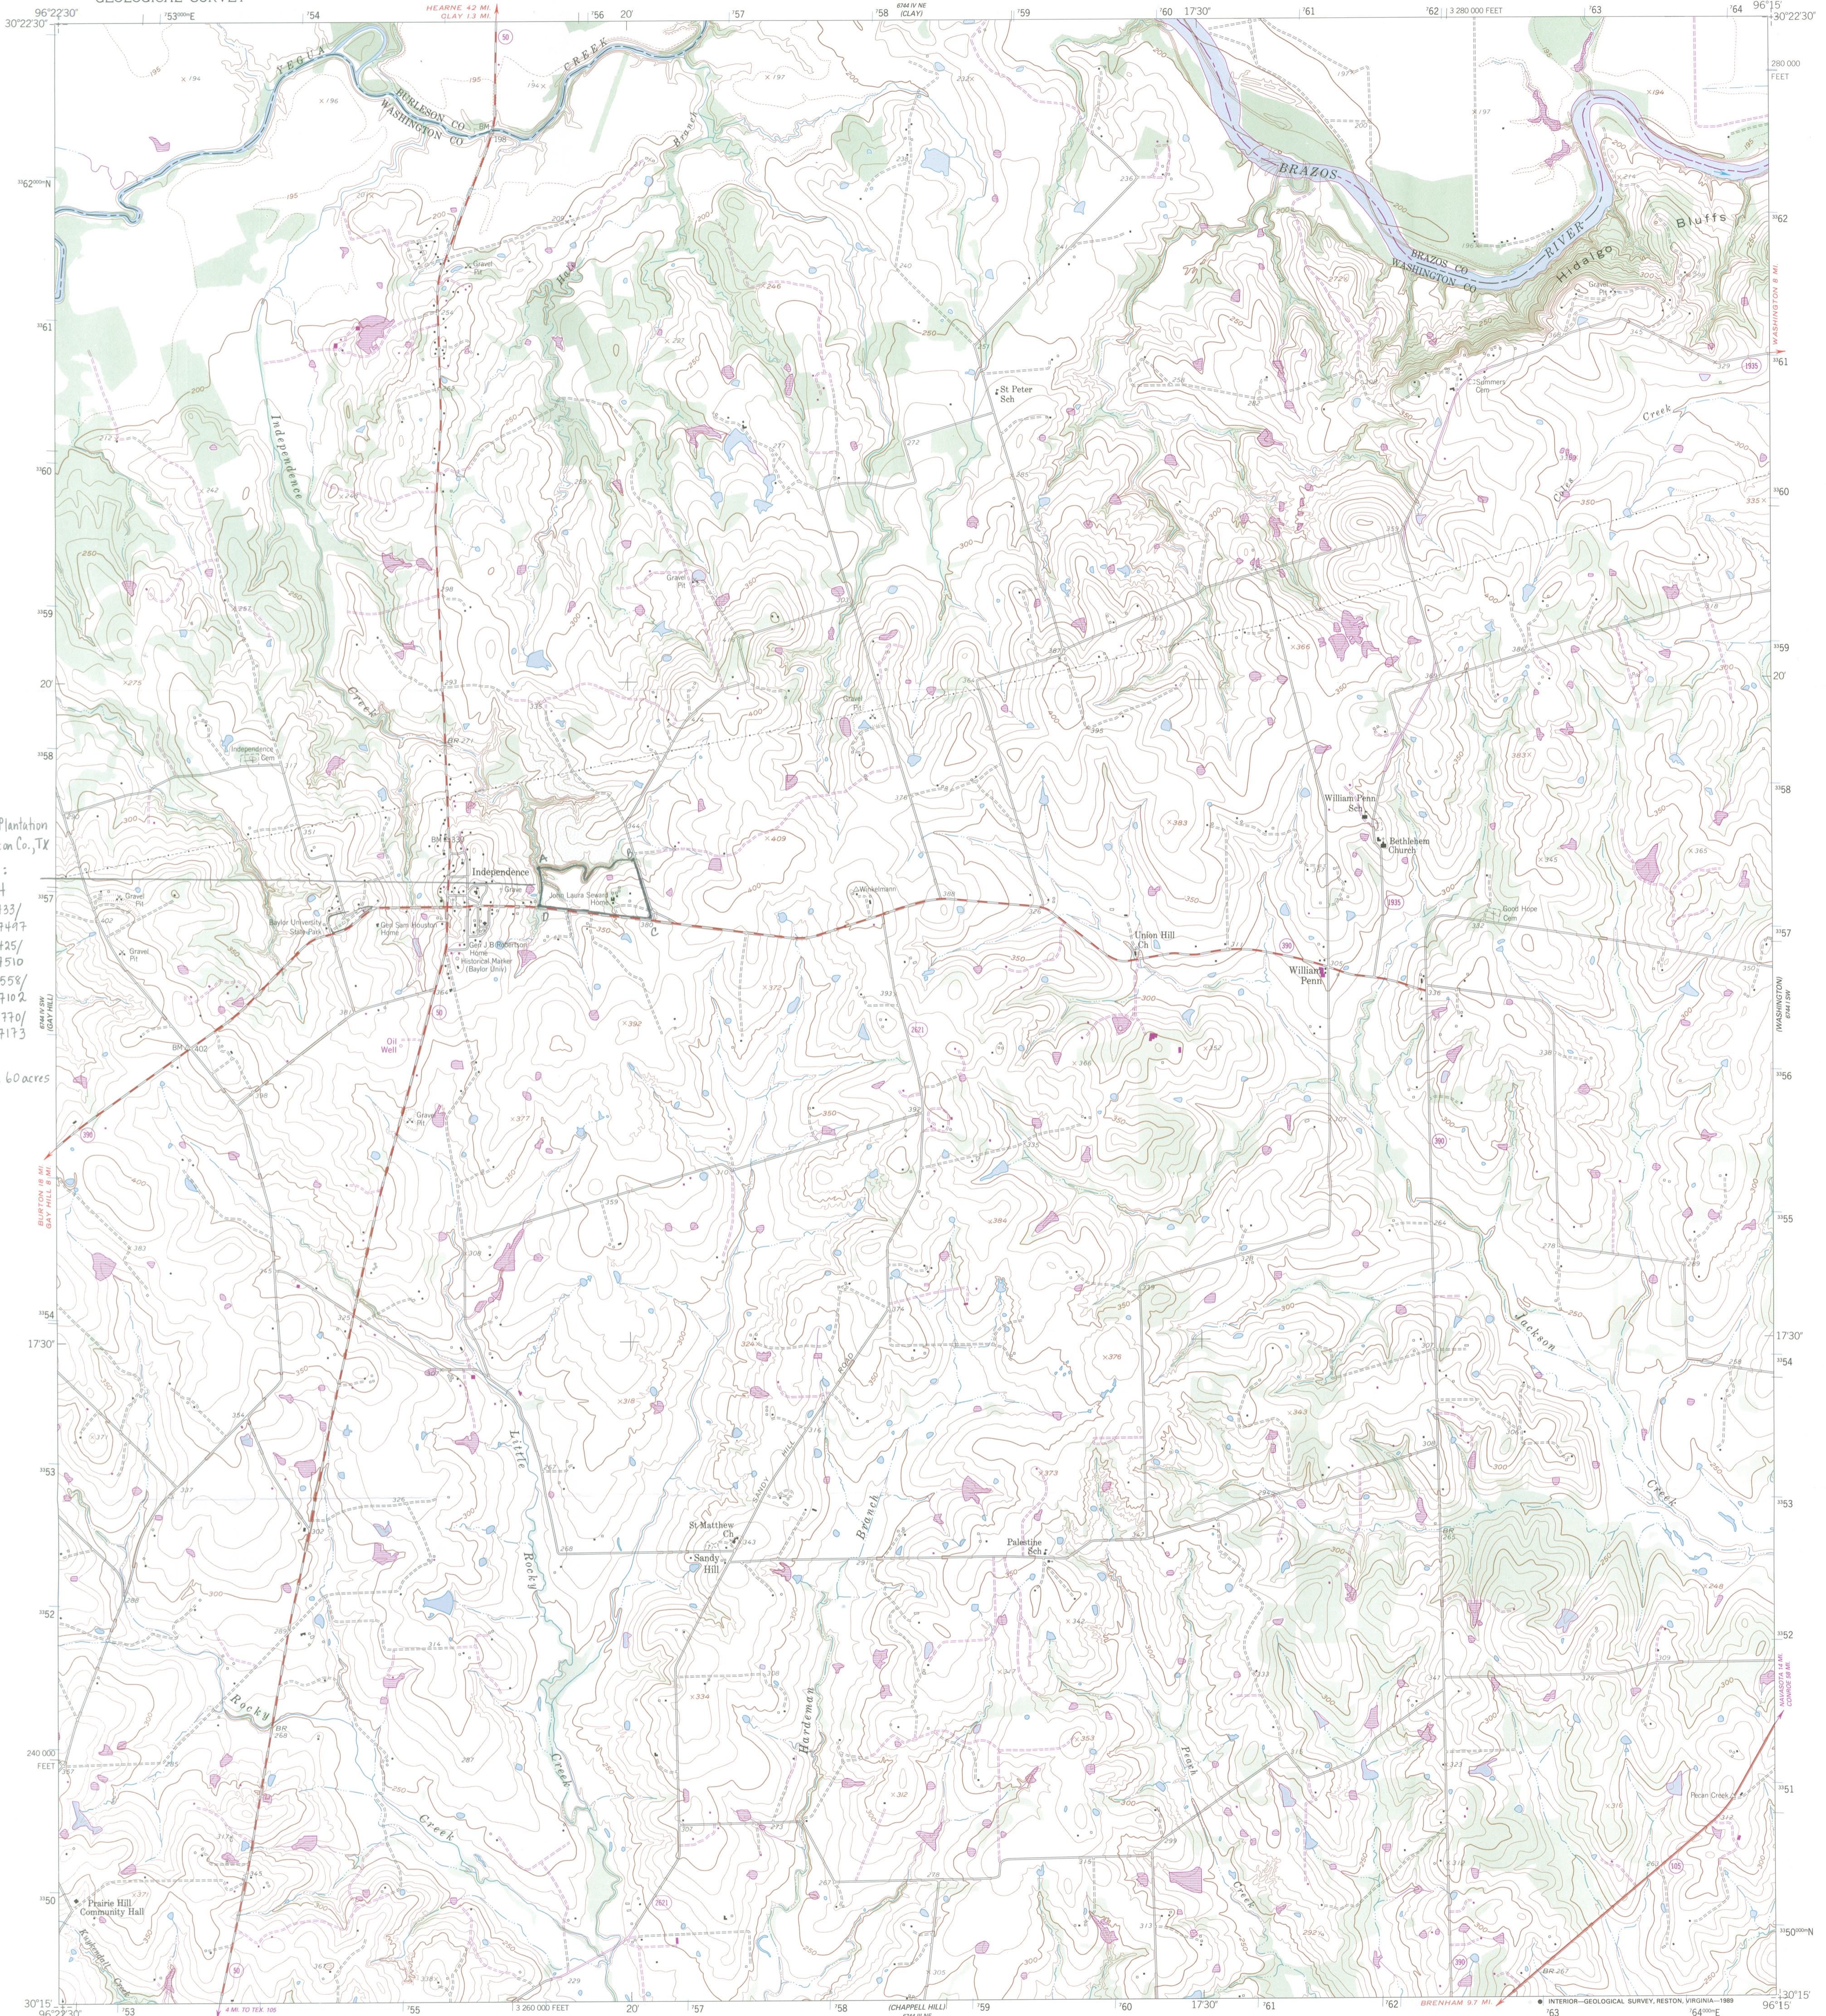
Seward Plantation
Washington Co. TX
UTM:
Zone 14
A. 755733/
3357417
B. 756425/
3357510
C. 756558/
3357102
D. 755770/
3357173
Approx. 60 acres
