United States Department of the Interior  
National Park Service  
National Register of Historic Places Registration Form

Historic Name: Glen Rose Downtown Historic District  
Other name/site number: N/A  
Name of related multiple property listing: N/A

Street & number: Properties surrounding courthouse square, bound by Vernon, Walnut, Bernard, & Elm; 100 block, 201, & 205 SW Barnard St.  
City or town: Glen Rose State: Texas County: Somervell  
Not for publication:  Vicinity:

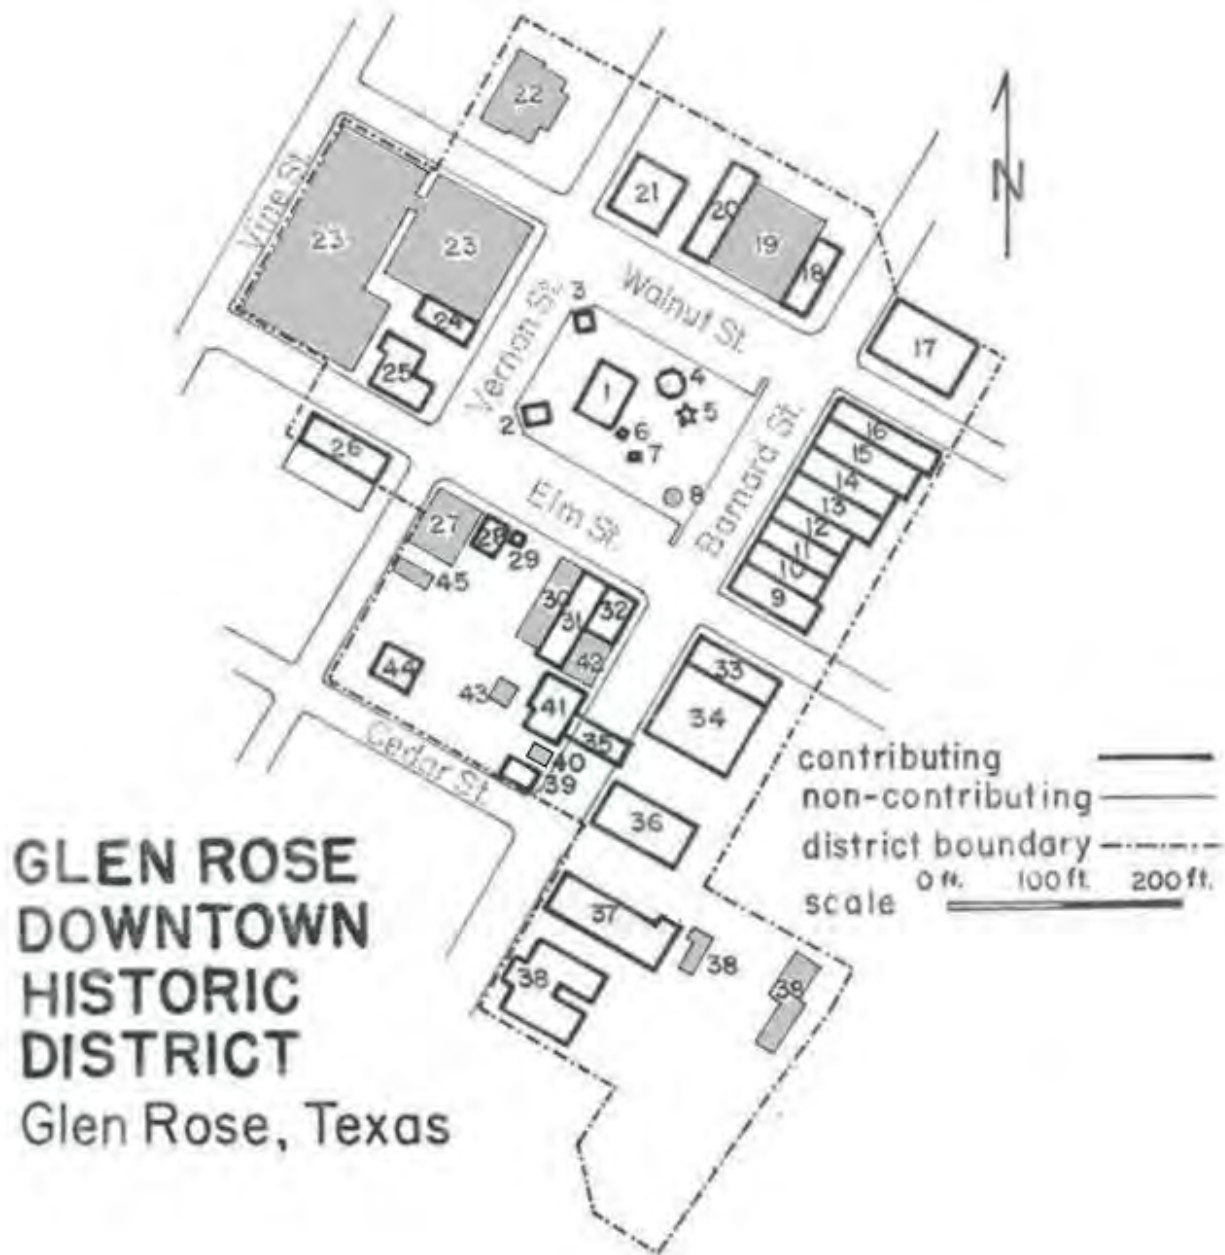
Map 4: Sketch map depicts contributing and noncontributing properties within the district. The identification numbers correspond to those used in the Inventory Table on Pages 10-12.

*Noncontributing properties are shaded gray.*

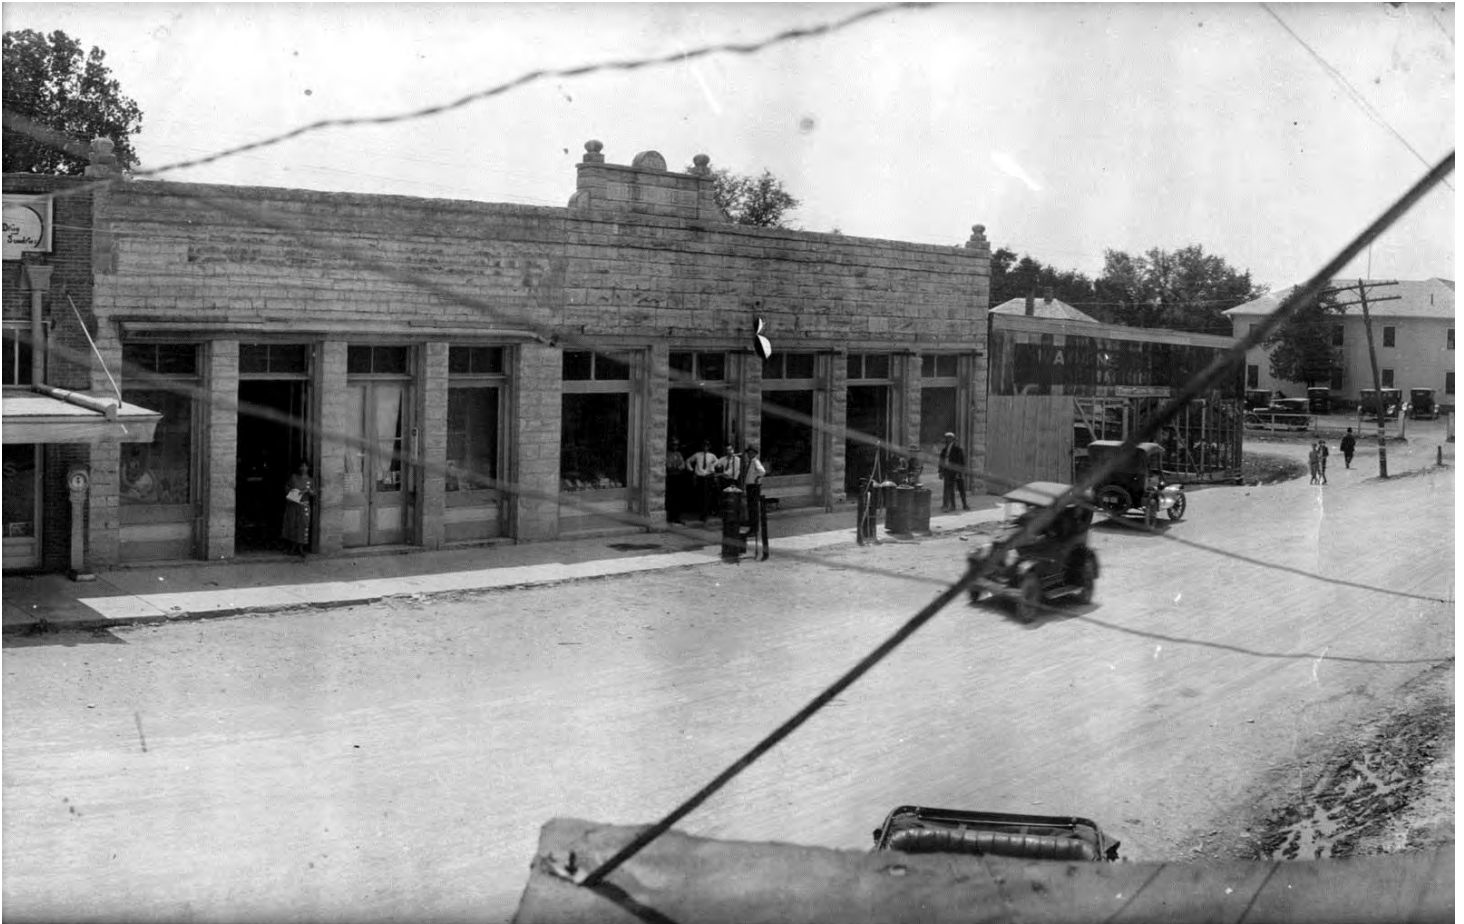
Milam Building and Southwest Barnard Street, Glen Rose, Texas, 1925.

South from 101 West Elm Street to the edge of the Corner Drug Store Building (100 Southwest Barnard Street), the complete front of the Milam Building (103-105 Southwest Barnard Street), and part of the Snyder Sanitarium (205 Southwest Barnard Street) in 1925. Courtesy of Somervell County Historical Commission, Glen Rose, Texas.

The front of the southwest end of the Milam Store Building was modified considerably in 1962 in order to accommodate the sales needs of a commercial tenant. Vertical steel posts replaced two of the stone supports; this allowed three large fixed plate glass windows resting on 1-foot 4-inch-tall narrow pinkish-grey brick pedestals to flank a large single glass entry door with fixed glass sidelights, all framed in aluminum. Above the display windows, sidelights, and single entry

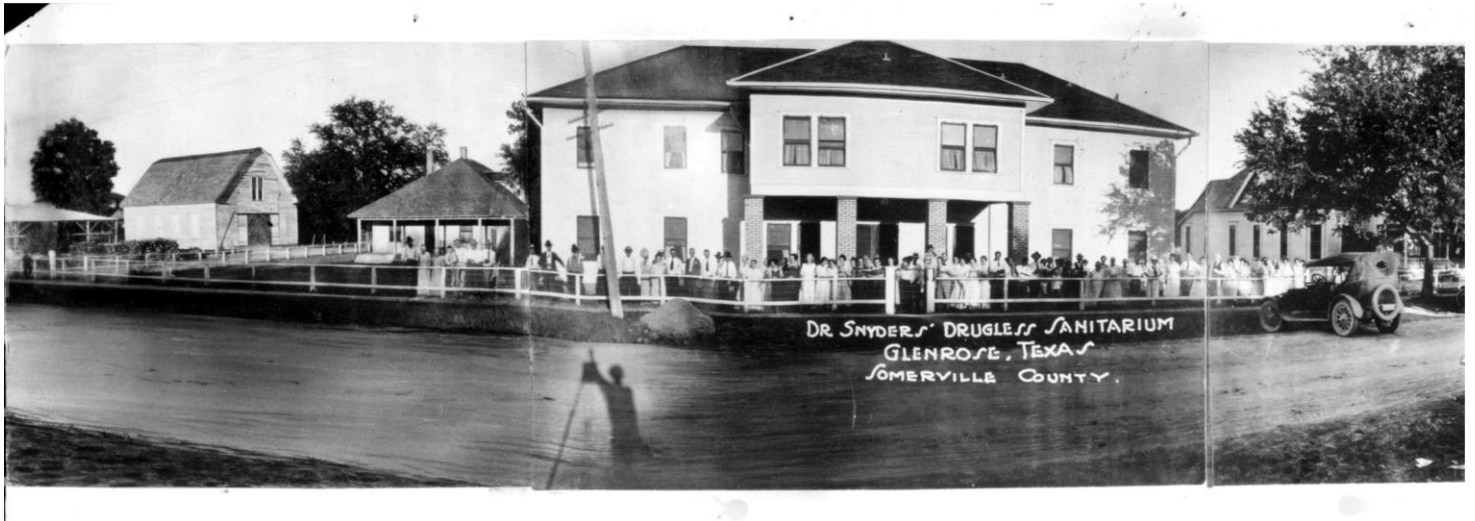
Snyder Sanitarium, Glen Rose, Texas, ca. 1920.

Southwest from Southwest Barnard Street to a full front view of the Snyder Sanitarium (205 Southwest Barnard Street) about 1920. This view shows buildings that formerly stood on either side of the two-story wood-frame sanitarium. Courtesy of Paluxy Valley Archives and Genealogy Society, Glen Rose, Texas.

The Snyder Sanitarium, constructed in 1919 as a health facility, is a two-story Craftsman style wood frame building with a U-shaped plan. Constructed on a pier-and-beam foundation, the wooden structure was erected by the Williams Lumber Company for local healer George P. Snyder. It was designed to provide thirty-five rooms for patients plus treatment and support areas. Originally a separate building housed a kitchen and dining room. The sanitarium measures 80 feet 5 inches across and each of the two wings are 62 feet 4 inches long. The two-story wood-frame building has beveled wooden siding, much of it remaining from original construction (protected for many years beneath now-removed asbestos siding). On both floors the building has large one-over-one wooden sash windows to facilitate ventilation during the years before air conditioning. The exterior is painted a pale pastel yellow with grey-painted shutters. The hipped roof is covered with grey composition shingles. Four square brick posts support a 29-foot 6-inch-long front porch with a hipped roof. Beneath is a double-door entry with each door having twelve fixed panes of glass. After the Snyder Sanitarium ceased to serve medical needs of health seekers, the structure was converted to become a large bed-and-breakfast business. At that time a new dining room was added to the side of the southwest wing. Also during the 1980s and 1990s, two modern supporting wooden outbuildings were erected on the grounds closer to the Paluxy River to serve hospitality functions. These subsidiary buildings, with no historical connections to the sanitarium, measure 95 feet 7 inches by 27 feet 5 inches and 44 feet 2 inches by 21 feet 2 inches, and are painted, trimmed, and roofed similarly to the historic structure.

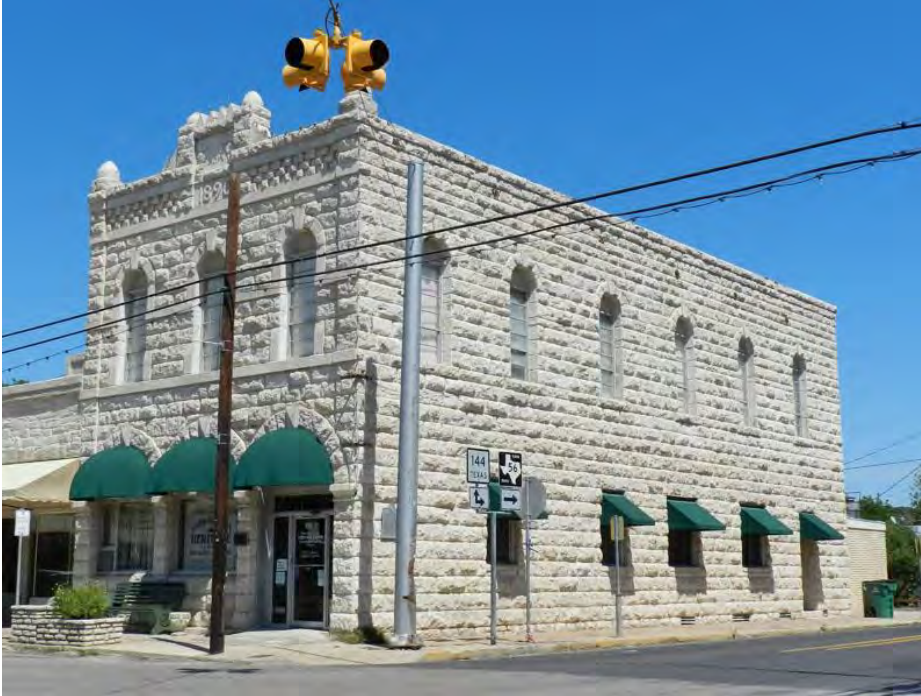
**Photo 2: Property # 9 (Contributing)**

A.P. Humphrey Saloon (currently Somervell County Heritage Center), 100 N.E. Barnard Street  
Oblique view of facade and southwest side  
Camera facing: East

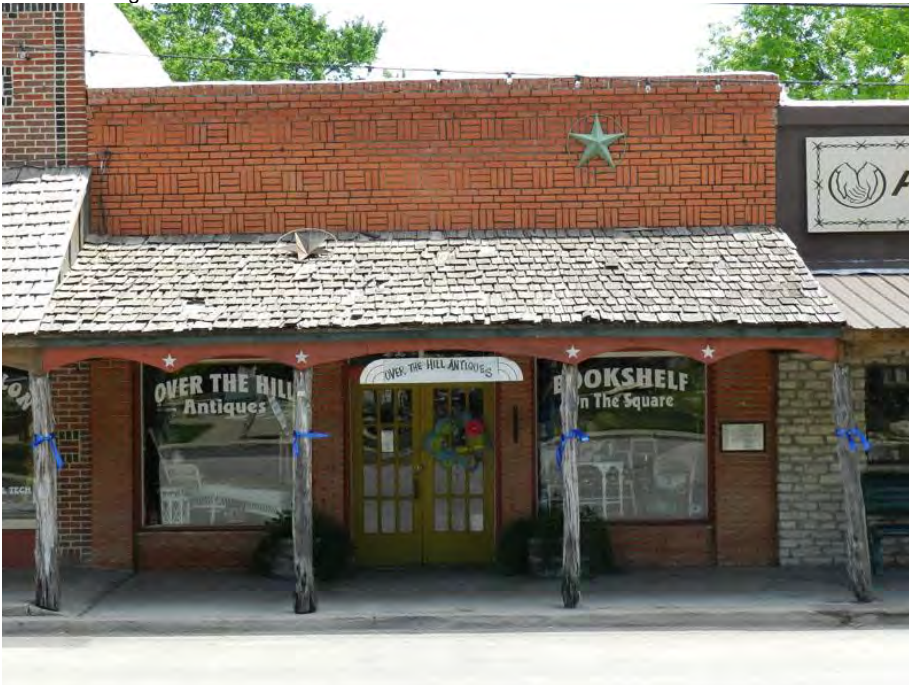
**Photo 3: Property # 12 (Contributing)**

Don Hill's Variety Store Building (currently Over the Hill Antiques and Bookshelf on the Square), 108 N.E. Barnard St.  
Northwest elevation  
Camera facing: Southeast

The commercial building at 108 Northeast Barnard Street was one of four adjacent Glen Rose structures that burned in a fire in late 1926. Charles W. Hill rebuilt the building in 1927 on the site where he and then his daughter and son-in-law, Lillie Hill Campbell and Clarence Campbell, had operated a general store. Then son Don C. Hill purchased the property from his sister, and for almost five decades Don and his wife, Vivian Hill, operated a variety store there. The store became a particular attraction for local children. Local resident Dorothy Gibbs remembered from her girlhood during the 1930s, that she and others went to Don Hill's for merchandise ranging from toys to candies. From her child's perspective, Gibbs felt that "He had everything in the world." After Don and Vivian Hill closed out their business enterprise in the mid-

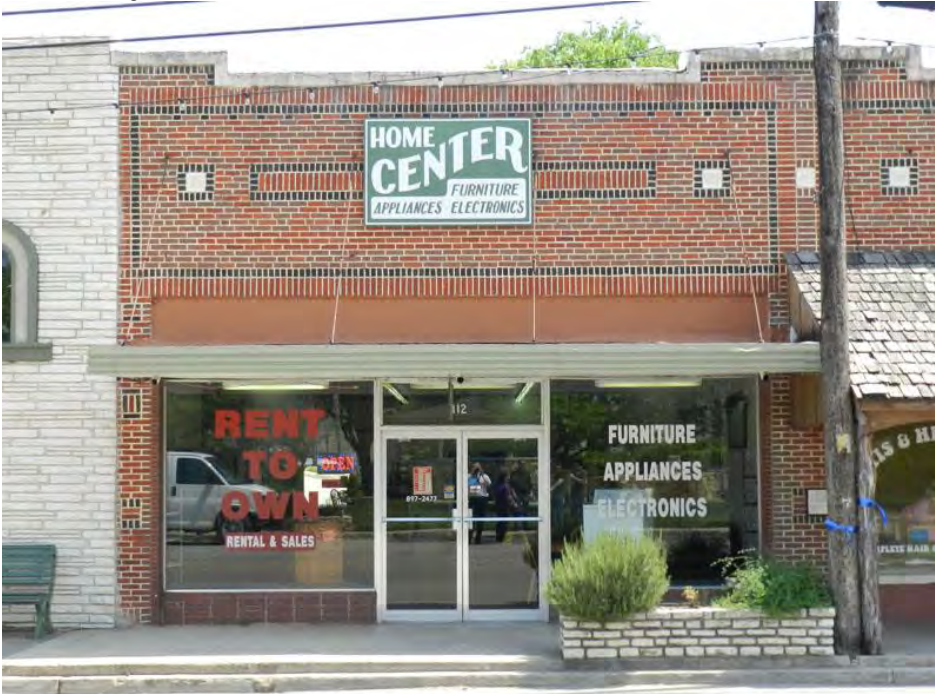
**Photo 4: Property # 14 (Contributing)**

Gresham and Company Dry Goods Building Southwest Half (currently The Barnyard Antiques and Decor), 112 N.E. Barnard St.  
Northwest elevation  
Camera facing: Southeast

The Gresham and Company Dry Goods Building Southwest Half stands on the site of the 1883 wooden building that formerly housed the E.H. Martin Saloon. After the voters of Glen Rose voted to prohibit the sale of alcoholic liquors in 1899, the saloon closed, and within a comparatively short time Harriet Abby Gresham expanded her late husband's pre-existing dry goods store next-door at 114 Northeast Barnard Street into the adjacent building at 112 Northeast Barnard. The building housed the southwest half of Gresham's at 112 Northeast Barnard until it burned in the fire in late 1926 that destroyed three other businesses on the southeast side of the courthouse store. The Gresham family rebuilt at the same site concurrent with reconstruction next-door at 110 Northeast Barnard Street. This collaboration led to the two buildings sharing the same decorative brick facade. Gresham and Company continued to run its dry goods business in the building into the 1980s. After that time the building provided space for other commercial enterprises including the Blue Bonnet Cafe. In 2012 the interior of the building was renovated for commercial use. This work included removing a modern lowered ceiling that exposed the fully intact pressed metal ceiling installed in 1927. Plaster repair at this time also temporarily revealed a bricked-up double-door-sized opening toward the rear that formerly connected the two halves of the Gresham and Company dry goods store. Currently The Barnyard Antiques and Decor occupies the location.

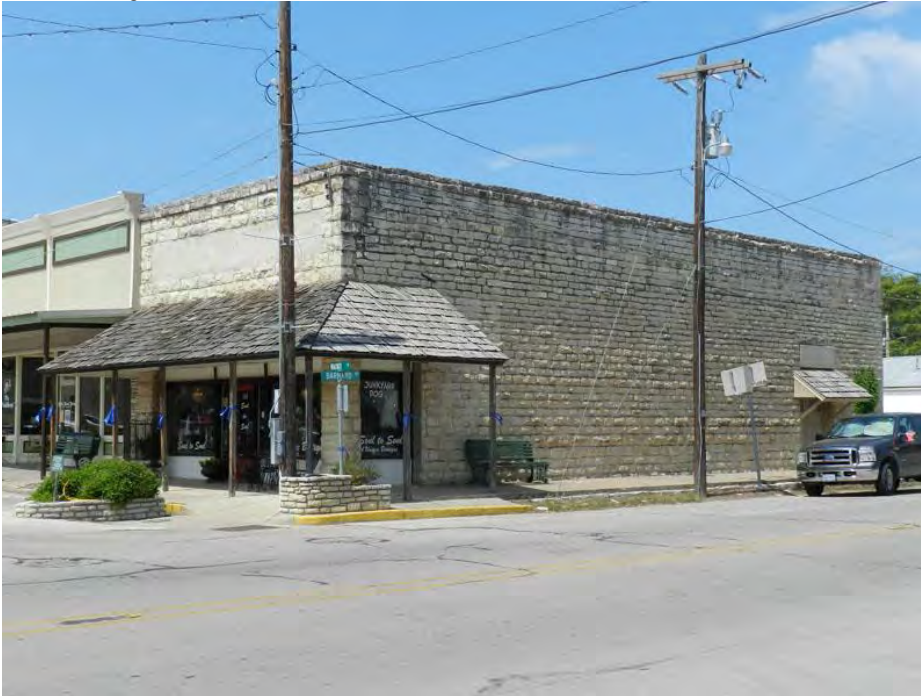
**Photo 6: Property # 18 (Contributing)**

Bryan's Dry Goods Building (currently The Barnyard Antiques and Decor), 100 W. Walnut St.  
Oblique view of facade and southeast side  
Camera facing: Northwest

The Bryan’s Dry Goods Building is an ashlar limestone three-bay One-part Commercial Block located on the corner of Northwest Barnard Street with West Walnut Street fronting onto the Somervell Courthouse Square. The rectangular building, which measures 25 feet 10 inches wide and 69 feet 7 inches long, has a flat roof that drains toward its rear. The front of the three-bay building has a flush single-door entry with side lights flanked by plate-glass display windows. In the past the building had a wooden and corrugated galvanized sheet awning across its front. At some date after 1987 a replacement wooden awning with square lumber posts and a shake shingle covering was installed on the front and on the southwestern end of the Barnard Street side to shade display windows and to provide shelter for pedestrians from inclement weather. Locally quarried ashlar limestone stonework in the building is laid in regular courses, with larger blocks in the lower courses and with a coping stones in the parapet. Stonework was carefully executed, with mortar joints that were struck and with the stones comprising the corners being smoothed to give the edges a sharp appearance. For its early years the upper portion of the facade uniformly had an ashlar surface, but sometime after 1940 a rectangular panel was smoothed and plastered in order to be painted with the business name. The side of the building facing Northeast Barnard Street has a single plate-glass display window at the front and a double-doorway entrance near the rear. This opening as recently as the 1950s had taller doors and a transom, but the transom was enclosed, shorter doors were installed, and a shed-style canopy with shake shingle covering was installed above to provide shelter. The southern corner of the building has a free-standing limestone pilaster that allows there to be a plate-glass display window that faces the busy Northeast Barnard Street. Along this southeast side of the building is a concrete sidewalk that is edged in rectangular pieces of limestone, the last remaining visible limestone curbs in the downtown commercial district. Near the cornice on the side are holes and iron studs for former electric service insulators. The limestone rear of the building, covered with protective cementacious stucco, has a boarded up single-door entry on the right and shows evidence to the left of two former sash windows that have been enclosed with masonry.

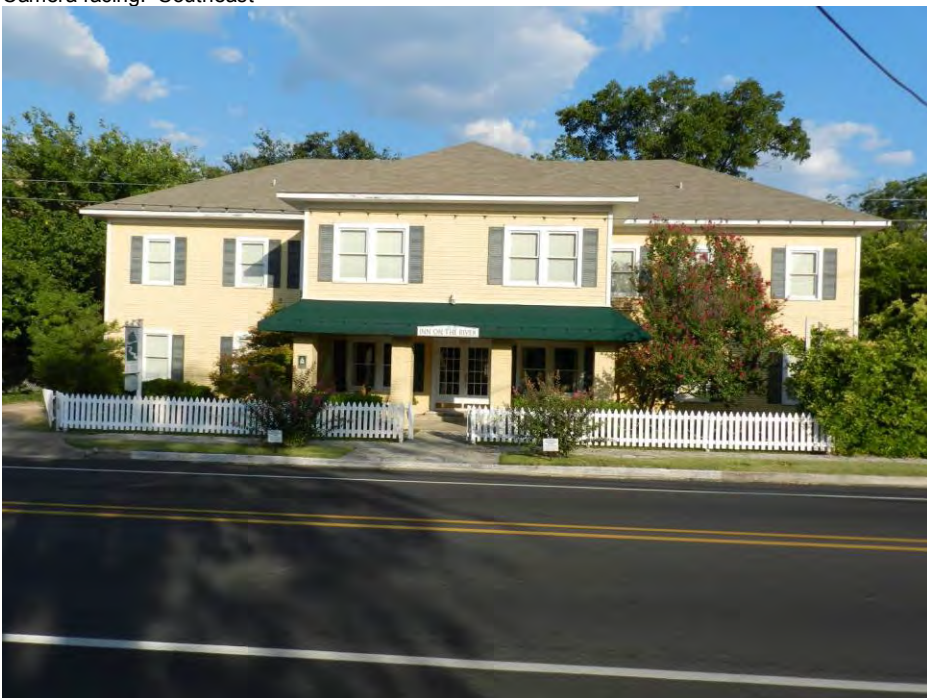
**Photo 11: Property # 38 (Contributing)**

Snyder Sanitarium (currently Inn on the River), 205 S.W. Barnard St.  
Northeast elevation  
Camera facing: Southeast

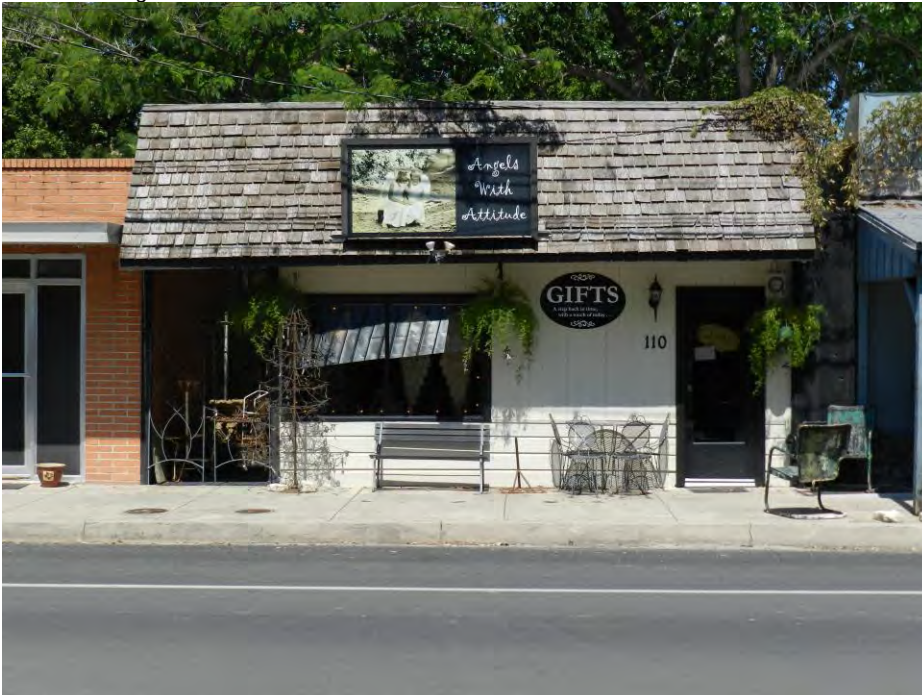
**Photo 13: Property # 40 (Noncontributing)**

Ernst Insurance Building (currently Angels with Attitude), 110 S.W. Barnard St.  
Southwest elevation  
Camera Facing: Northwest

siding. The exterior is painted a cream color trimmed in dark brown. Like the adjacent Vogue Beauty Shop (Property #39), the Ernst Insurance Building fronts on a solid foundation at the side of the street, but its rear is supported on vertical concrete piers set in a concrete footings in the bed of Connell Branch. Although the Ernst Insurance Building lies about 2 feet from its adjacent Miles Building (Property #41), there is a wider 4-foot 8-inch gap between it and the Vogue Beauty Shop (Property #39) on the other side. In this space an open deck on wooden supports has been laid so that one can walk between the two buildings to a larger diagonal deck built onto the rear of the former insurance building. The current occupant of the commercial building uses this open deck area for displaying yard furniture and outdoor decor items that can be exposed to the elements.
