NATIONAL REGISTER OF HISTORIC PLACES
INVENTORY - NOMINATION FORM

COMMON:
Ysleta Mission

AND/OR HISTORIC:
Mission de Corpus Christi de la Ysleta

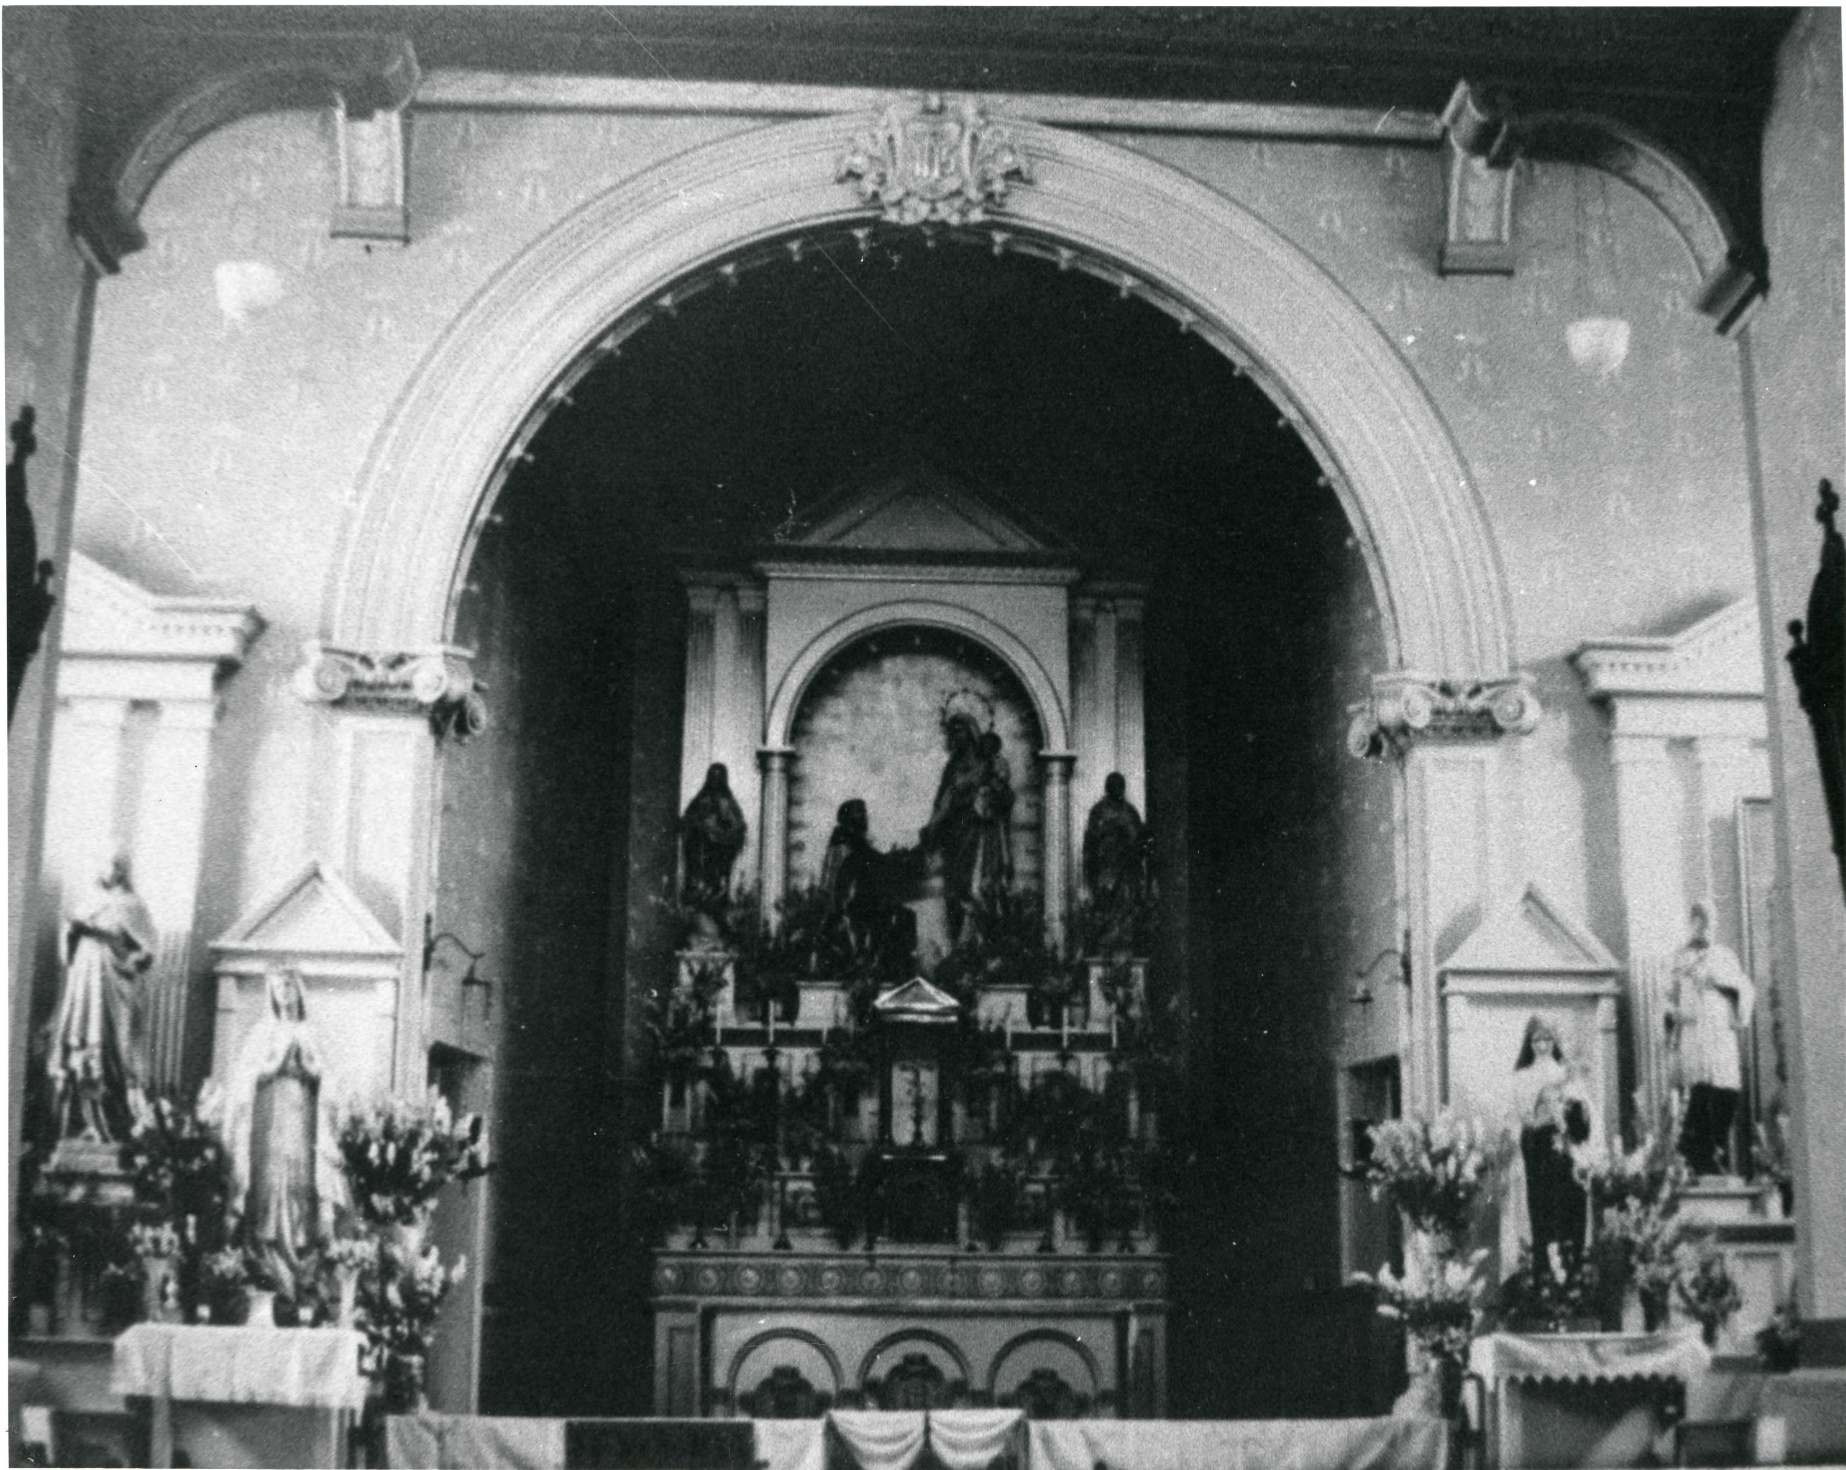
①

Main altar

Interior furnishings, including altars, ceiling rafters and their console supports, and all woodwork are executed in a late classical revival style which dates from the 1907 reconstruction.

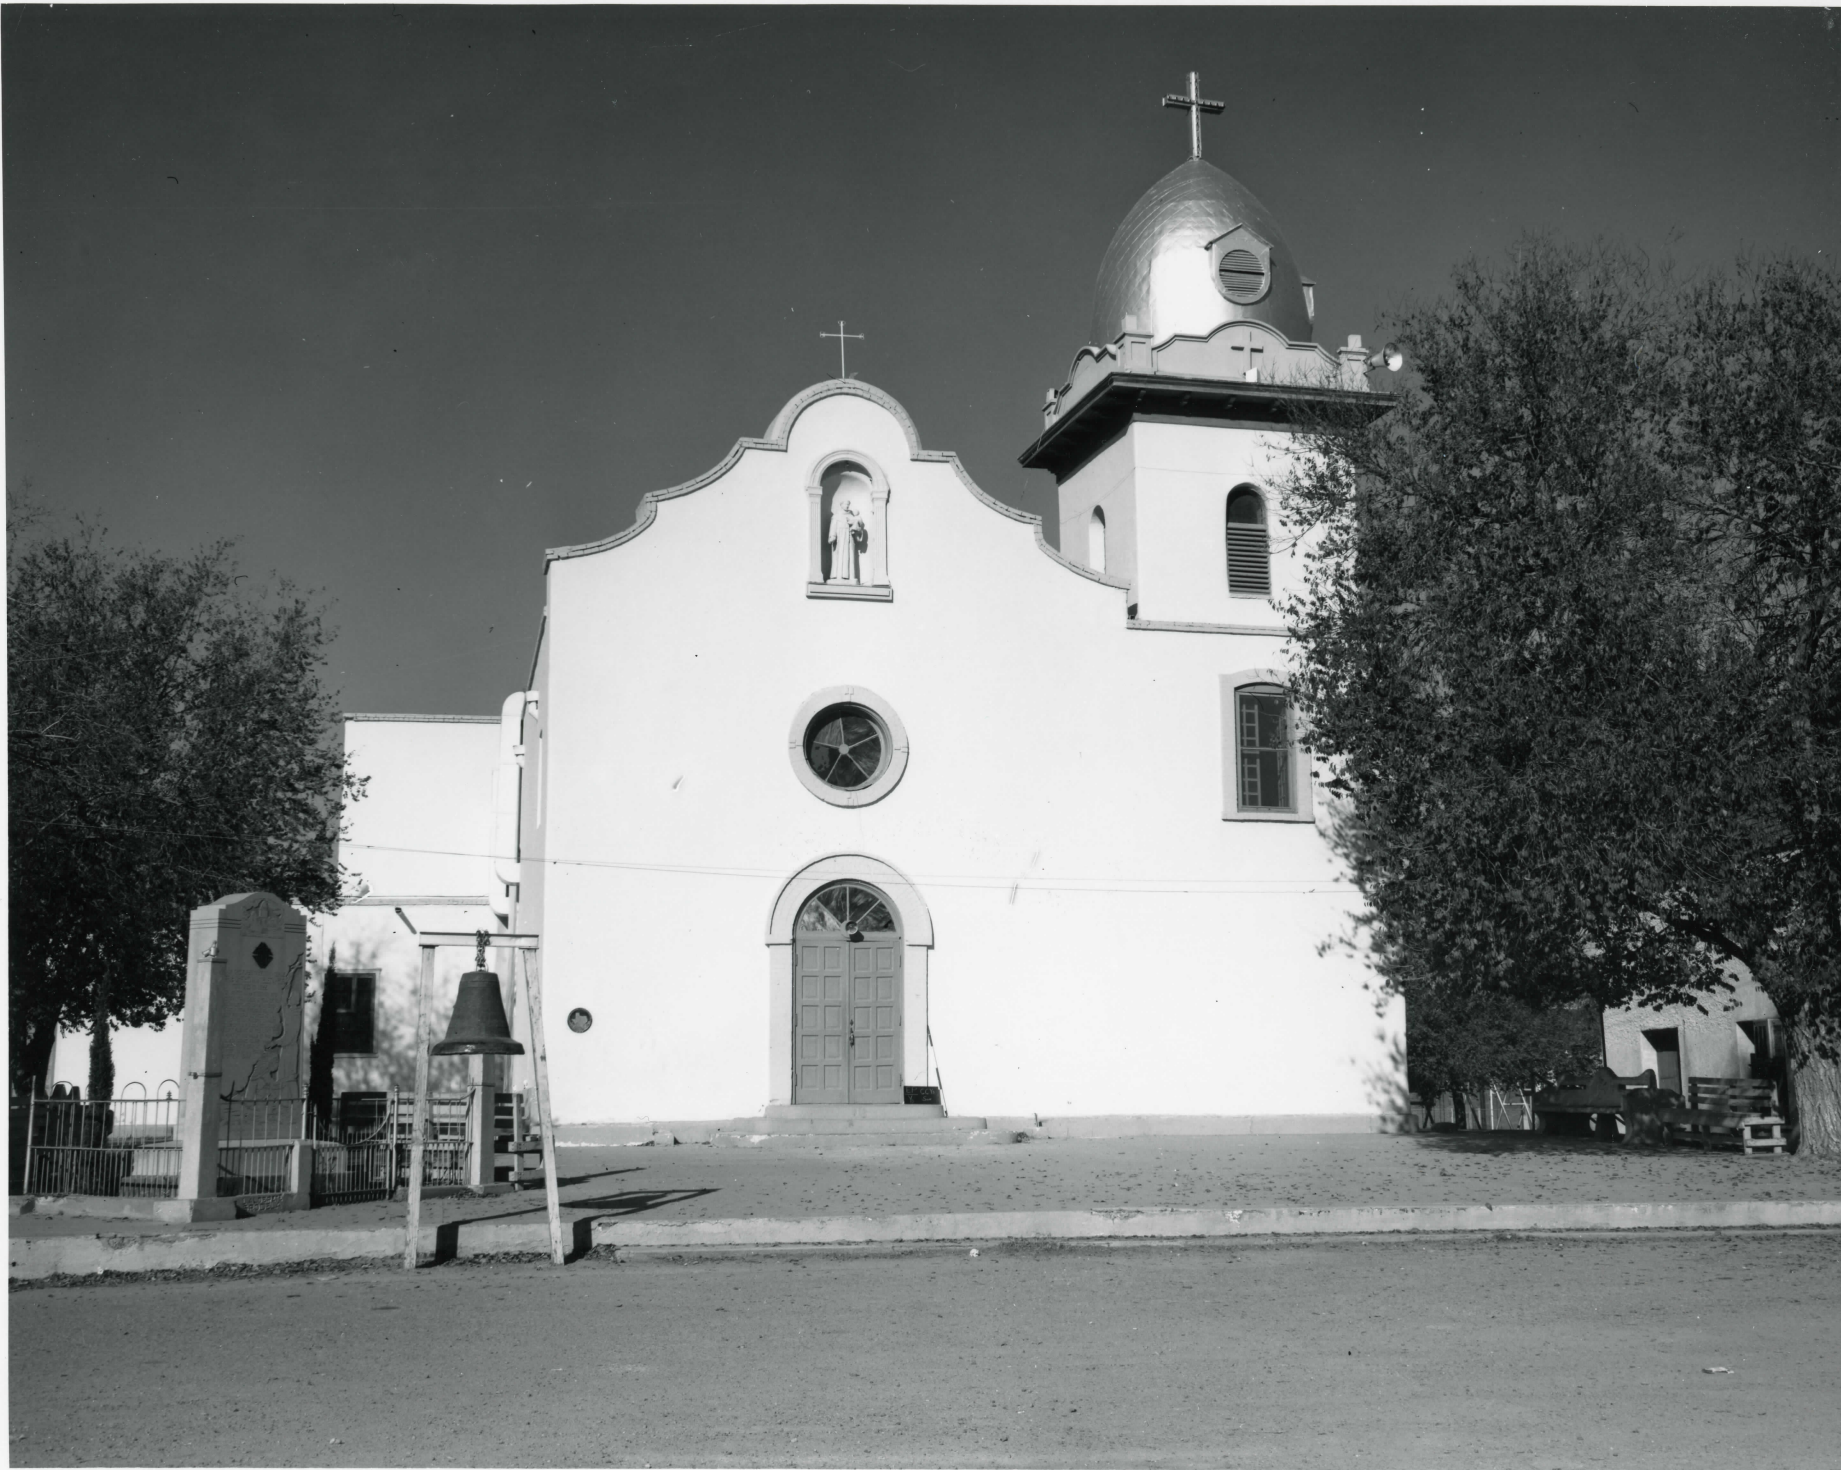
oc. El Paso City, Texas
(South) main facade
from the plaza.

1. NAME			
COMMON:		Ysleta Mission	
AND/OR HISTORIC:		Corpus Christi de la Ysleta	
2. LOCATION			
STREET AND NUMBER:			
US highway 80			
CITY OR TOWN:			
Ysleta			
STATE:		CODE	COUNTY:
Texas		048	El Paso
			CODE
			141
3. PHOTO REFERENCE			
PHOTO CREDIT: Texas State Historical Survey Committee			
DATE OF PHOTO: Fall, 1971			
NEGATIVE FILED AT: Texas State Historical Survey Committee			
108 W. 15th Street, Austin, Texas 78711			
4. IDENTIFICATION			
DESCRIBE VIEW, DIRECTION, ETC.			
(2) (South) main facade from the plaza

The principal facade has a three-story tower with wooden, late Victorian style architectural decoration. The pre-1907 tower was, according to an 1880 photograph, wider, of burned brick, and four stories high with a masonry, bee-hive shaped dome. The entrance facade in the same photograph shows a roundal window above the door, no fanlight over the door, and two niches in the irregularly shaped gable.

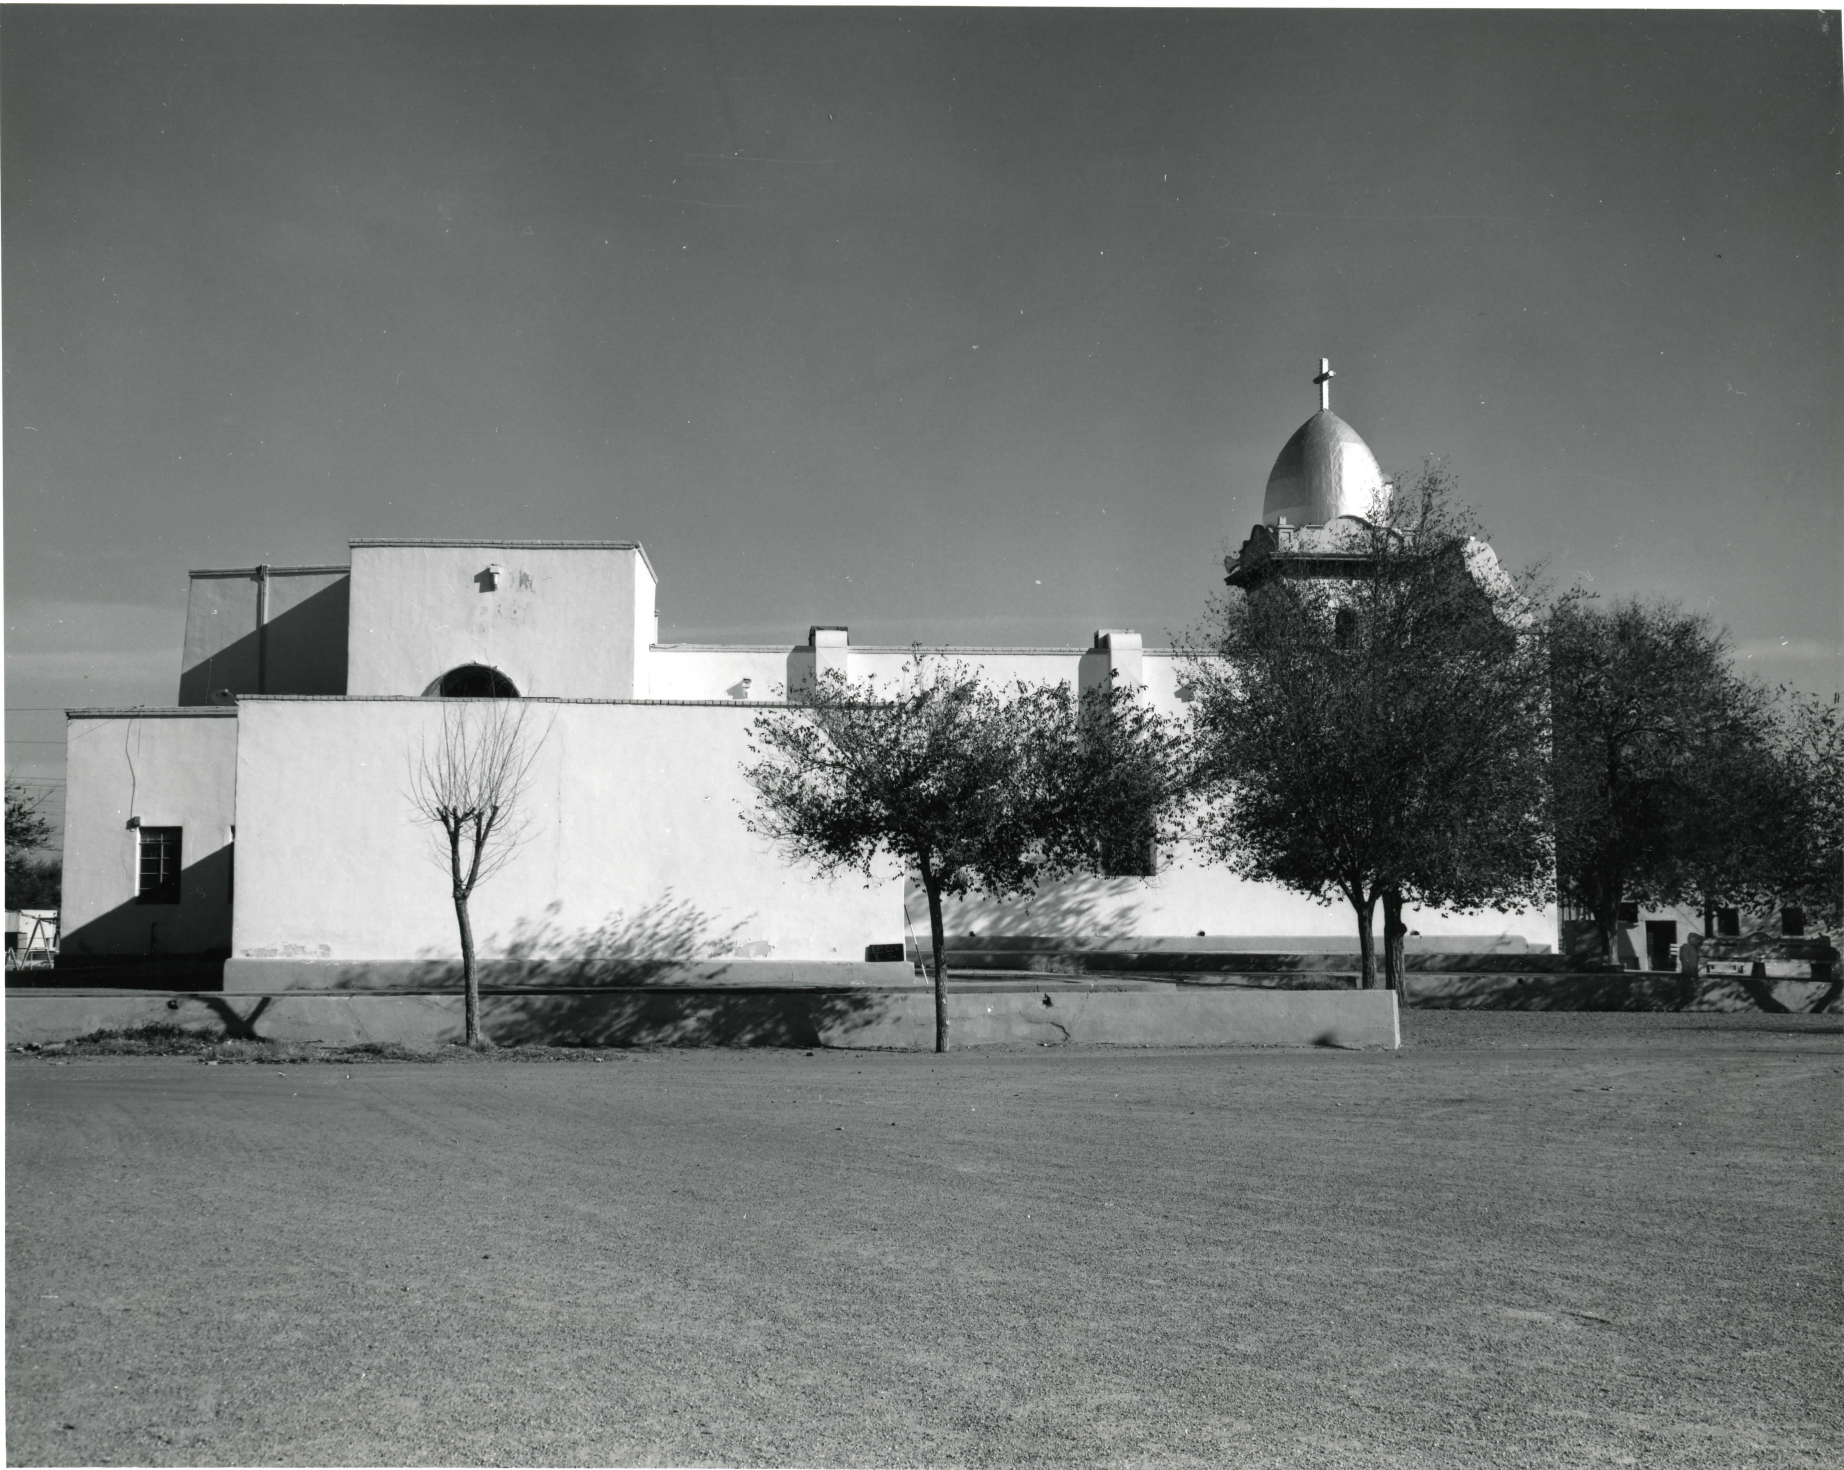
3

West facade

1. NAME			
COMMON:		Ysleta Mission	
AND/OR HISTORIC:		Corpus Christi de la Ysleta	
2. LOCATION			
STREET AND NUMBER:			
US highway 80			
CITY OR TOWN:			
Ysleta			
STATE:		CODE	COUNTY:
Texas		048	El Paso
			CODE
			141
3. PHOTO REFERENCE			
PHOTO CREDIT: Texas State Historical Survey Committee			
DATE OF PHOTO: Fall, 1971			
NEGATIVE FILED AT: Texas State Historical Survey Committee			
108 W. 15th Street, Austin, Texas 78711			
4. IDENTIFICATION			
DESCRIBE VIEW, DIRECTION, ETC.			
<p>③</p> <p style="text-align: center;">West facade</p>

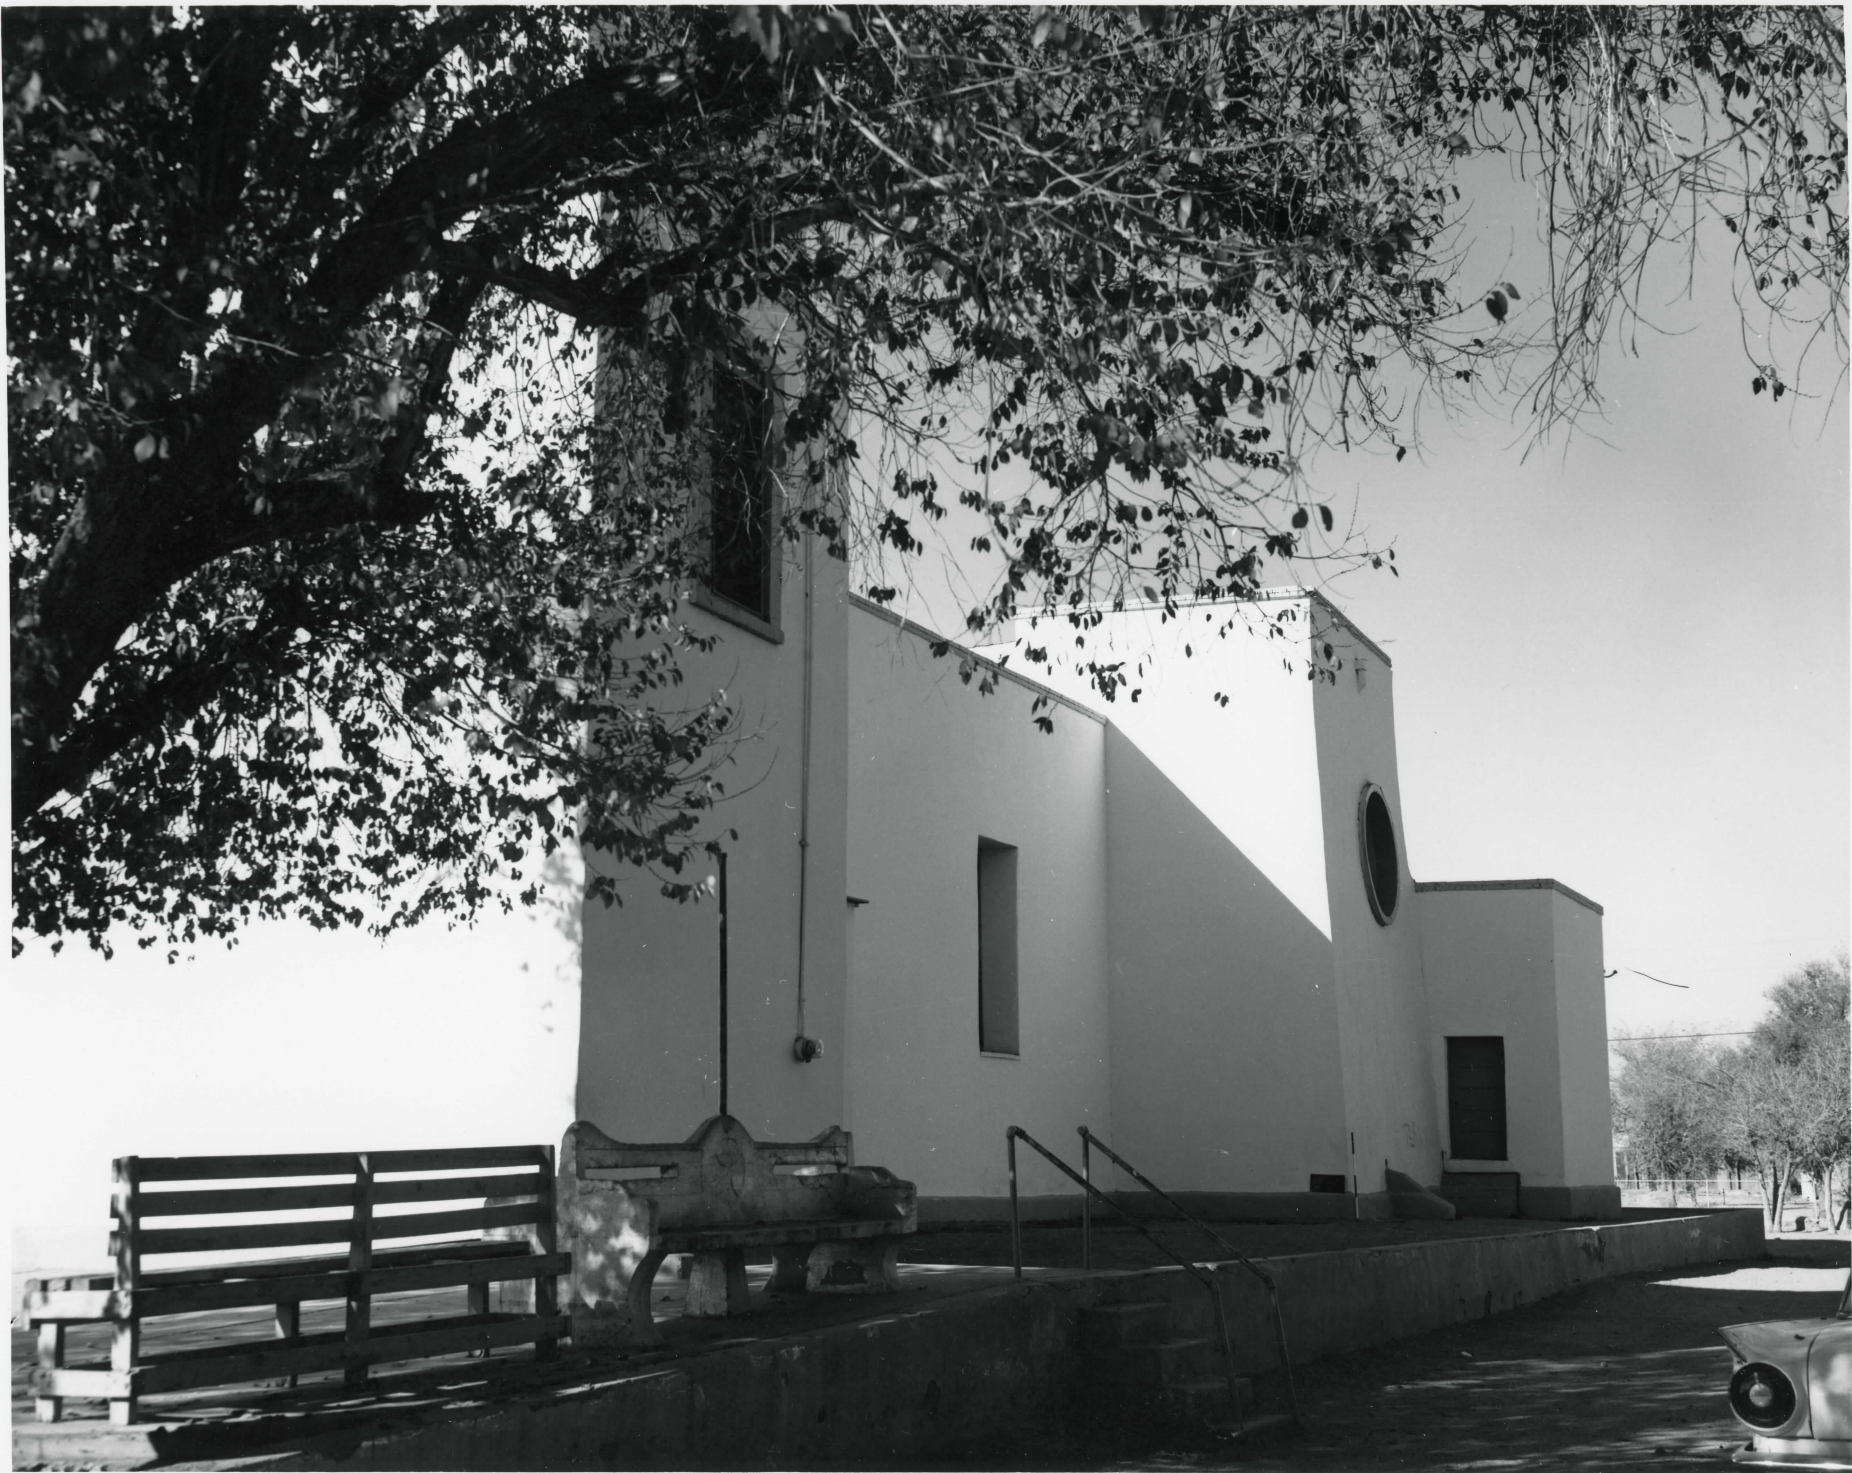
(4)

East facade showing transept.

④ East facade showing transept

The transept and sacristy have battered walls and a slightly irregular cruciform shape which shows a strong stylistic relationship with the eighteenth century Spanish Colonial architecture of the New Mexico mission field. This exterior rear portion of the mission church contrasts sharply with the 1907 reworking of the main facade.

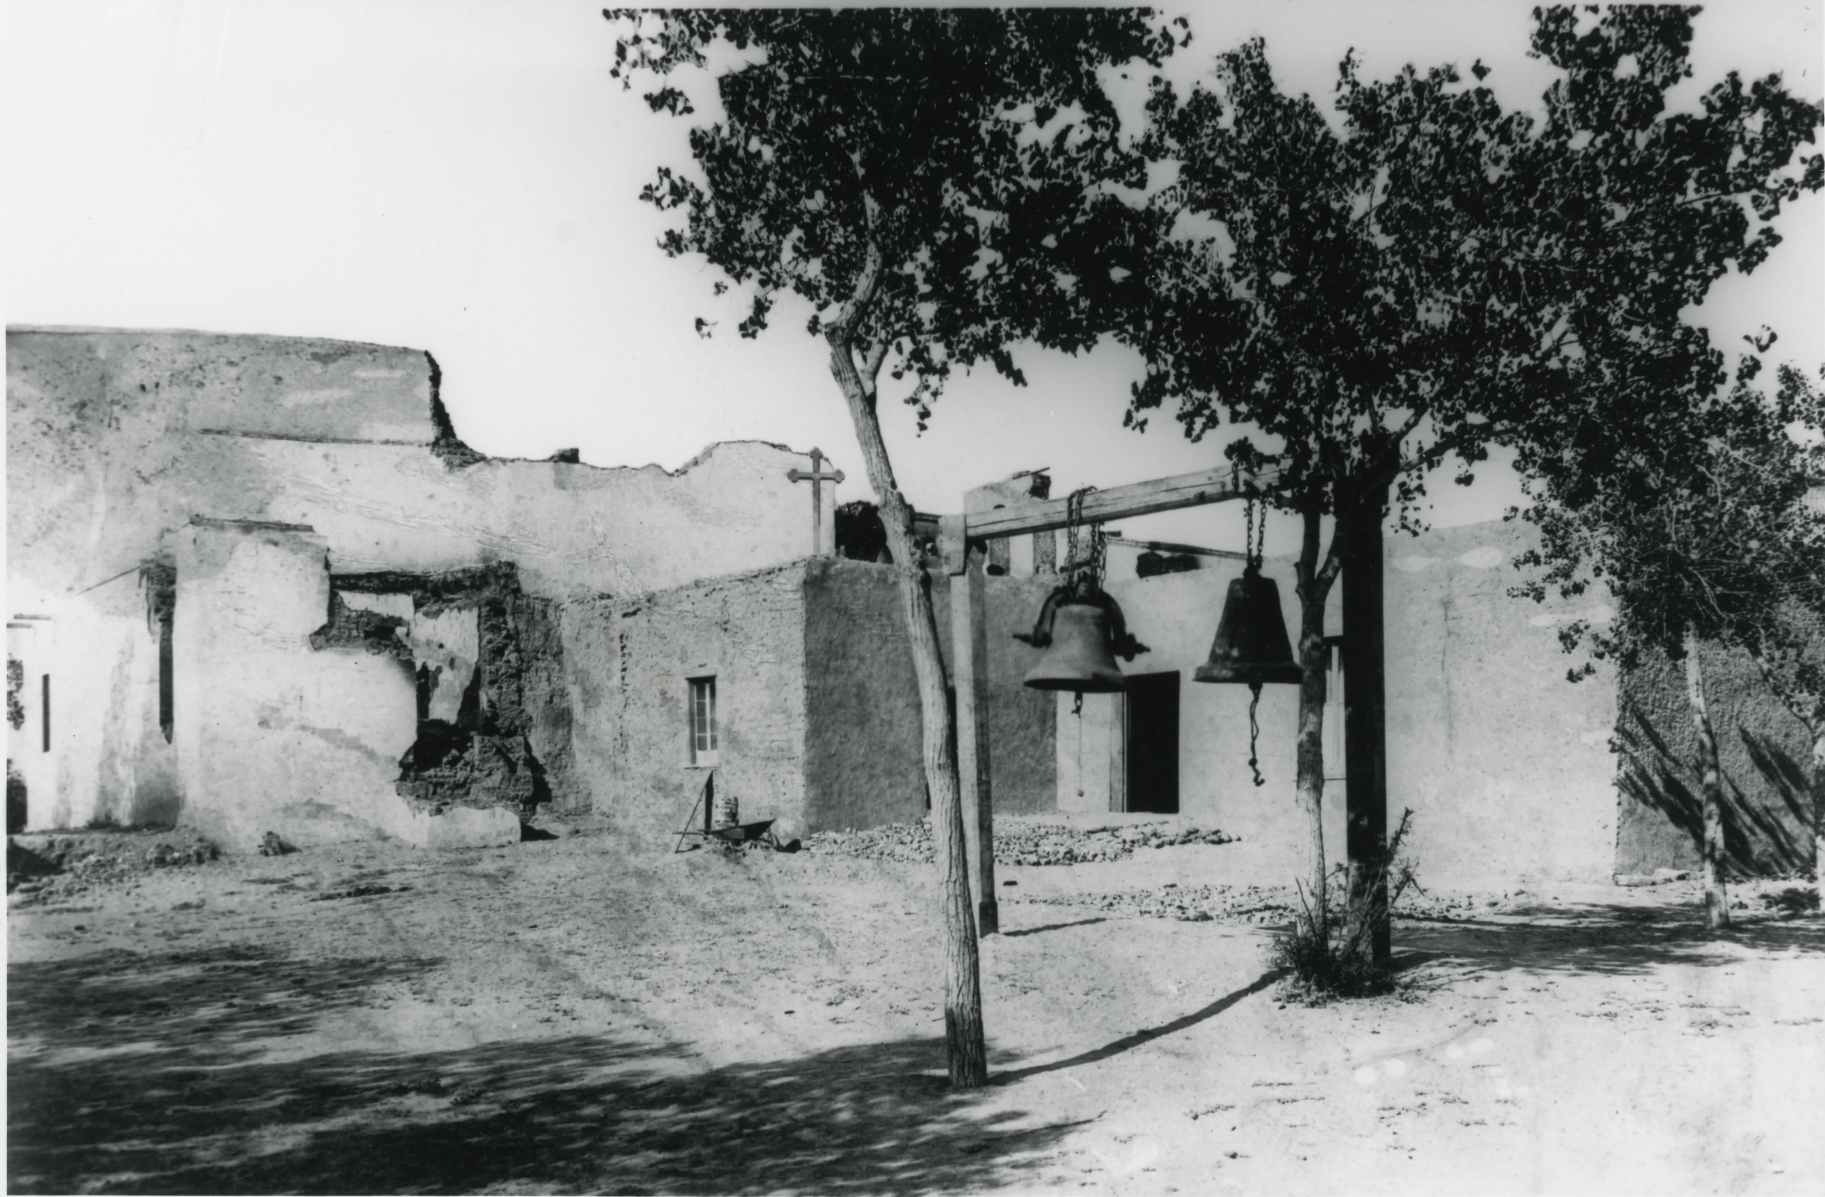
"Ruined walls of the
Mission. While it was
being rebuilt, services
were held in the sacristy
which was the only part
of the building not damaged
by the 1907 fire."

TITLE: Ypelta Mission - Photo of ruined walls,
damaged by the 1907 fire

View from the west (?)

DESCRIBE VIEW, DIRECTION, ETC.
(5) Caption in Calleros' The Mother Mission states: "Ruined walls of the Mission. While it was being rebuilt, services were held in the Sacristy which was the only part of the building not damaged by the 1907 fire."

In 1907, most of the church was destroyed by fire. In an effort to rid the belfry-tower of bats, a sexton placed several buckets of sulphur and other chemicals in the tower overnight. The chemicals ignited during the night and destroyed most of the structure. Only the sacristy remained unscathed. A few of the relics, including the old mission bell and a statue of Christ which had been brought from Spain, were saved. The church was rebuilt almost immediately, utilizing the original sacristy and the remaining walls.

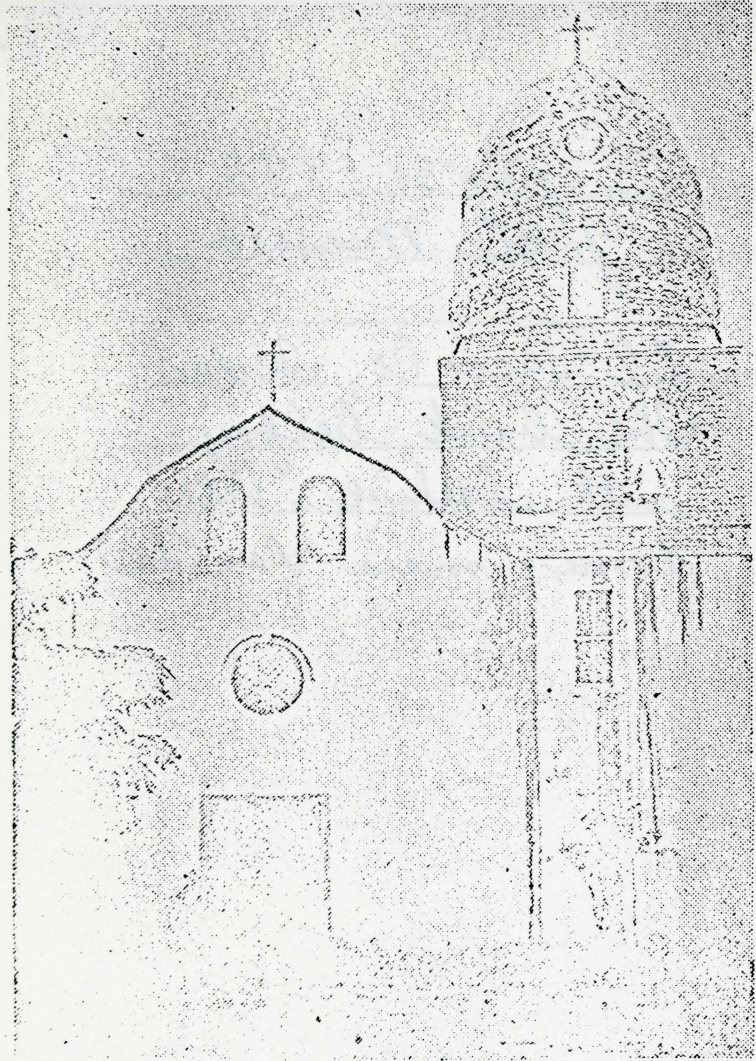
(1.)

Earliest available photograph of the Mission, taken about 1880.

The brick belfry
with beehive-like

dome; main facade

DESCRIBE VIEW, DIRECTION, ETC.
The brick belfry with beehive-like dome was constructed between 1860 and 1880. South or main facade.

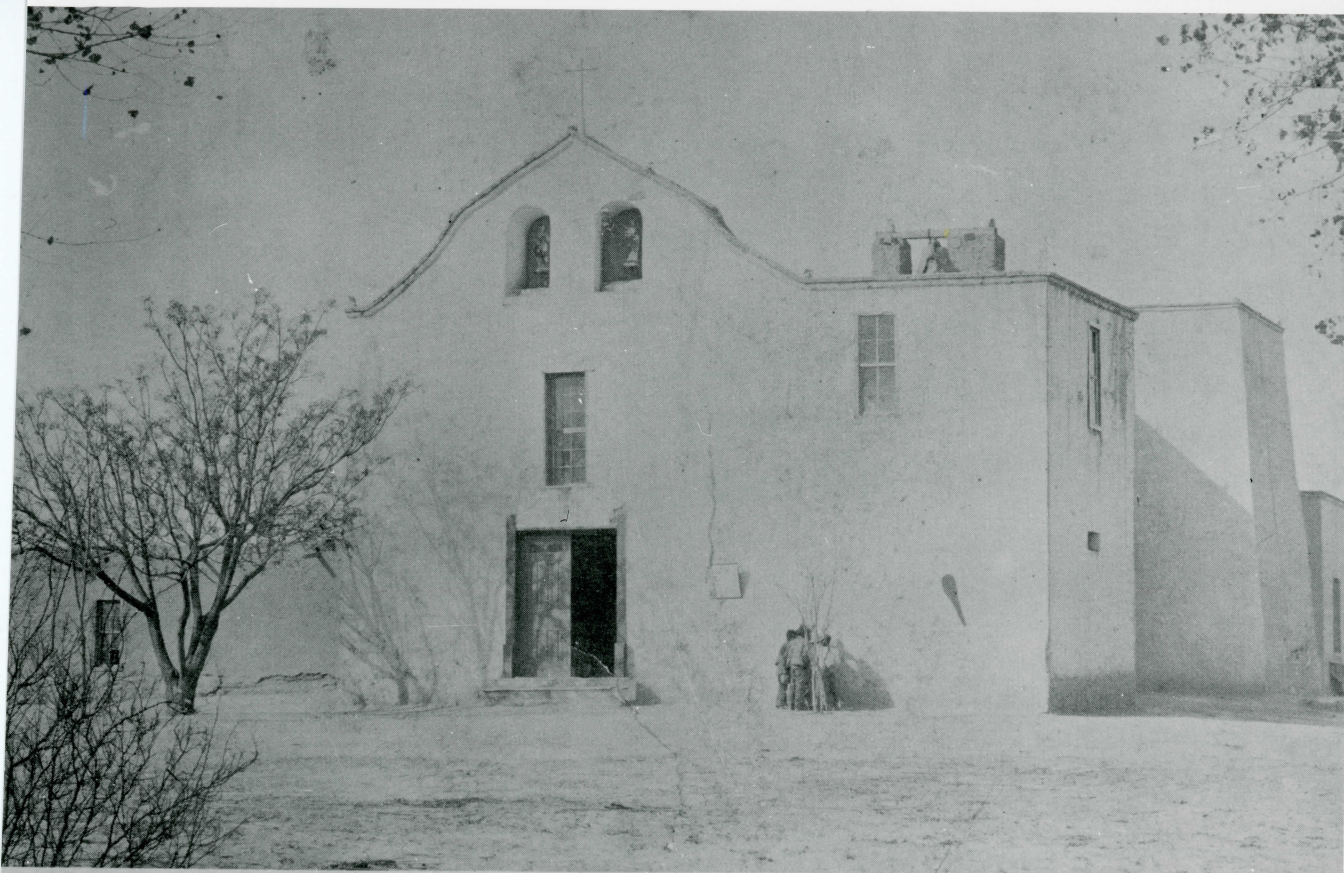
(2.)

YSLETA MISSION ABOUT 1860

About 1860. South

of main facade

Ysleta Mission about 1860. South or main facade.
