United States Department of the Interior
National Park ServiceNational Register of Historic Places
Inventory—Nomination Form

SITE NO. 6

Reeder-Omenson farm

FM 182, ⁹8 miles southwest of Clifton, on FM 182
Bosque County, Texas, on the A.W. Moore
survey

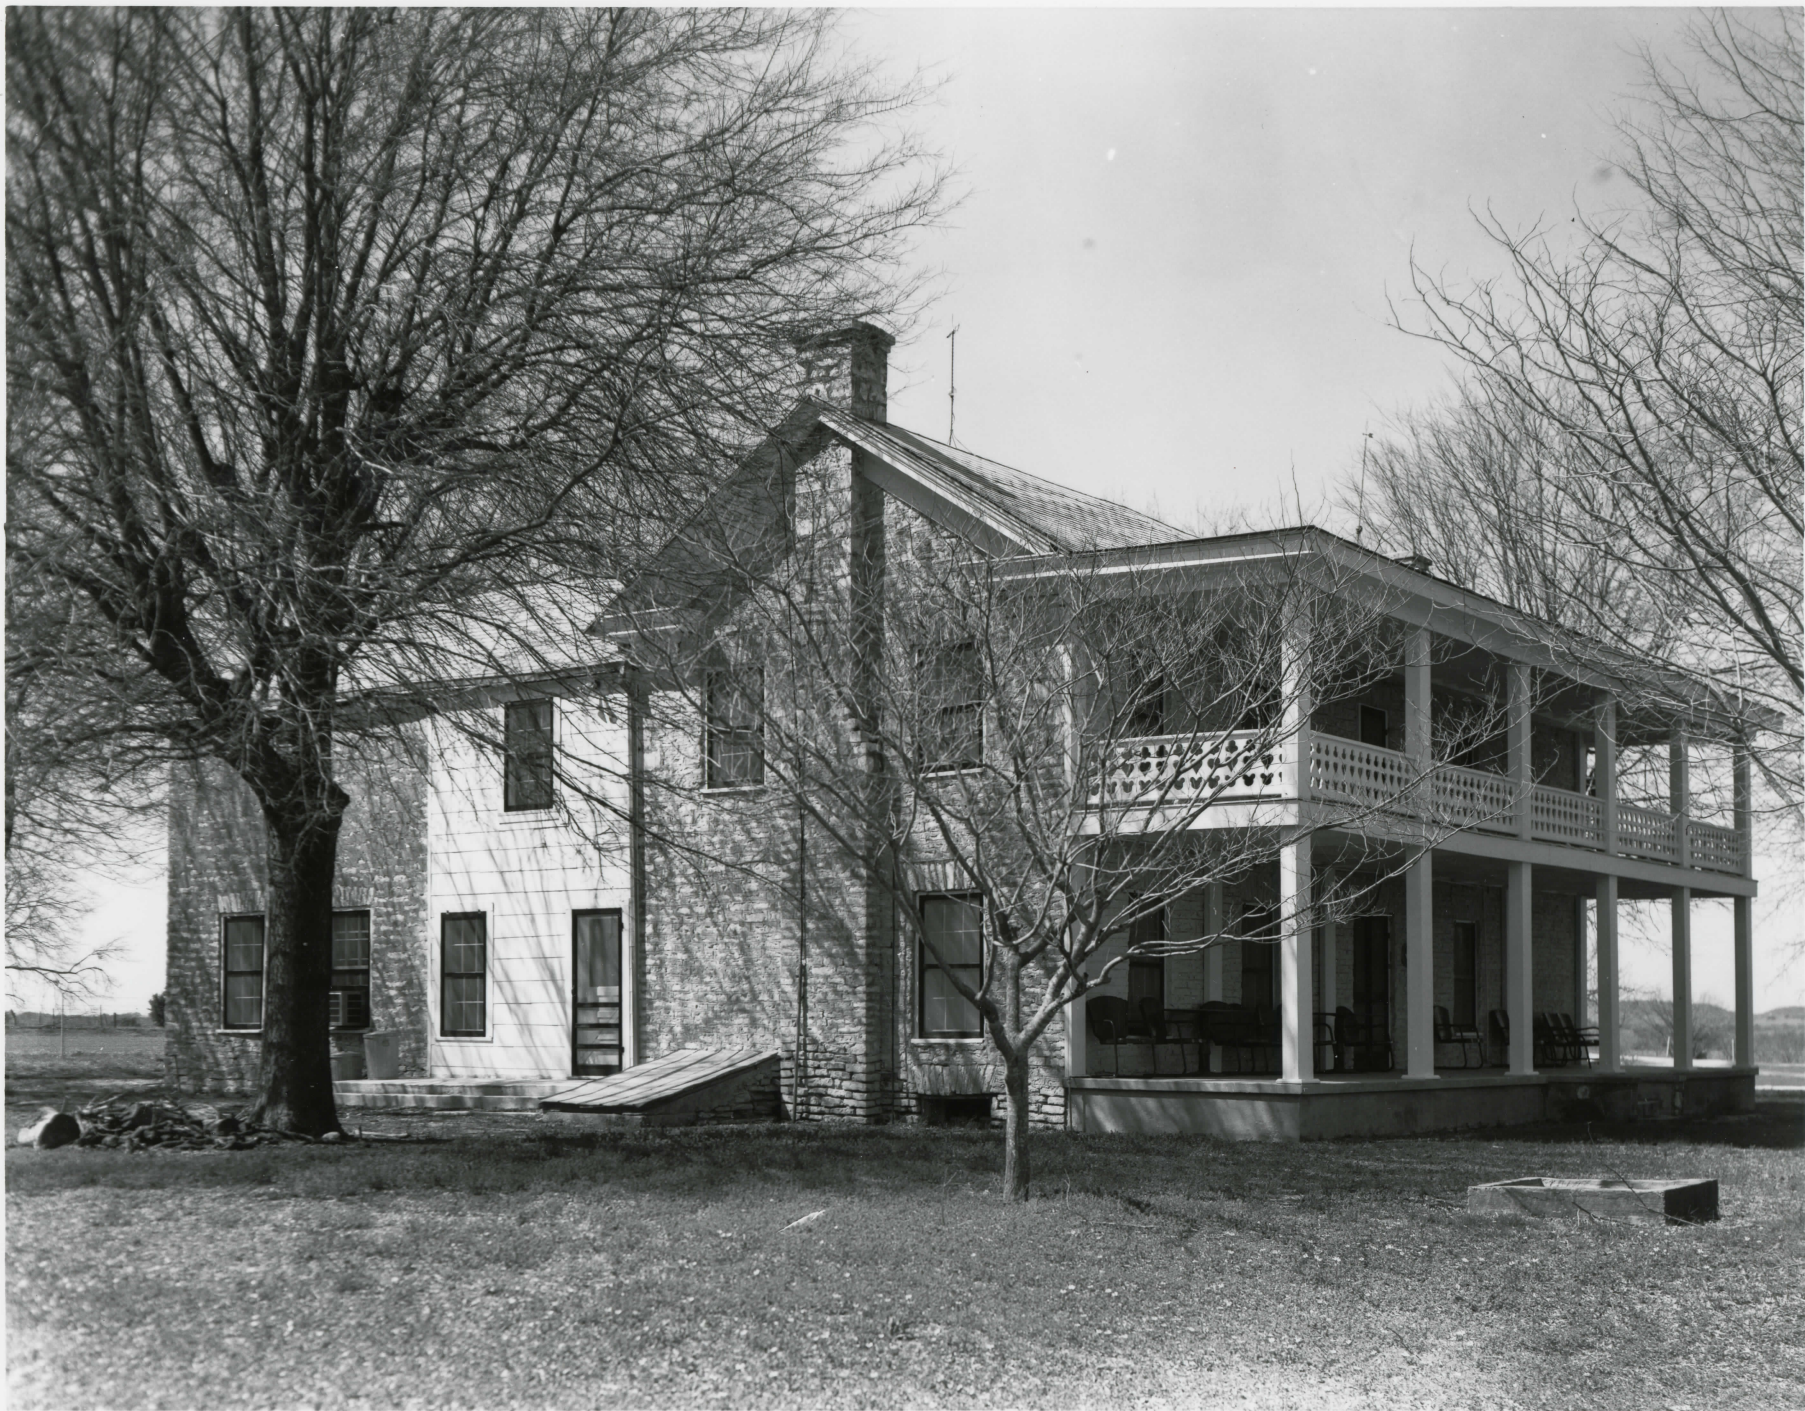
Site No. 6, Reeder-Omenson Farm, FM 182,
8 miles southwest of Clifton, Bosque County,
Texas

Photograph: March 1979, by Daniel Hardy
On file, Texas Historical Commission
View of front facade, looking northwest
Photo 15 of 72

Exhibiting some Greek Revival detailing, such as the returned cornices in its gables, the Reeder-Omenson house is a large, two-story stone residence, which faces northeast on the opposite side of a stream that flows by Norway Mill (no. 5). Despite several alterations, it retains much of its integrity and remains in excellent condition. The original plan of the house was rectangular, although it is now L-shaped because of rear additions. A five-bay, two-tiered attached gallery, with a jig-sawn balustrade, dominates the front facade. According to a nearby resident, this porch was rebuilt

about 1967, but the new concrete floor is the only significant change from its original appearance. The fine gallery balustrade and thin square piers remain the same. Under this porch, the stone wall retains its stucco veneer, which has regularly coursed scoring. Exterior stone chimneys terminate both gable ends, and contribute to the overall symmetry of the composition. Flat arches with stone voussoirs span all of the openings. The only addition to the house occurs on the rear elevation, where a two-story, frame wing was built to join the house to an originally detached, two-story stone kitchen. One of the mill stones from Norway Mill has been planted in the ground just north of the house.
