**NATIONAL REGISTER OF HISTORIC PLACES
INVENTORY -- NOMINATION FORM**

Daniels Farm House

Big Bend National Park

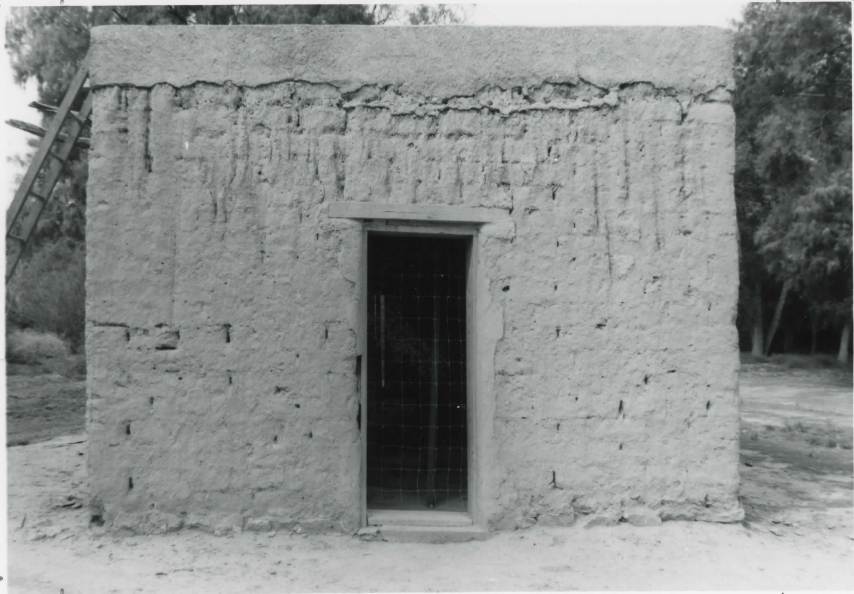
Photo Number 1

East elevation view of doorway (facing west)

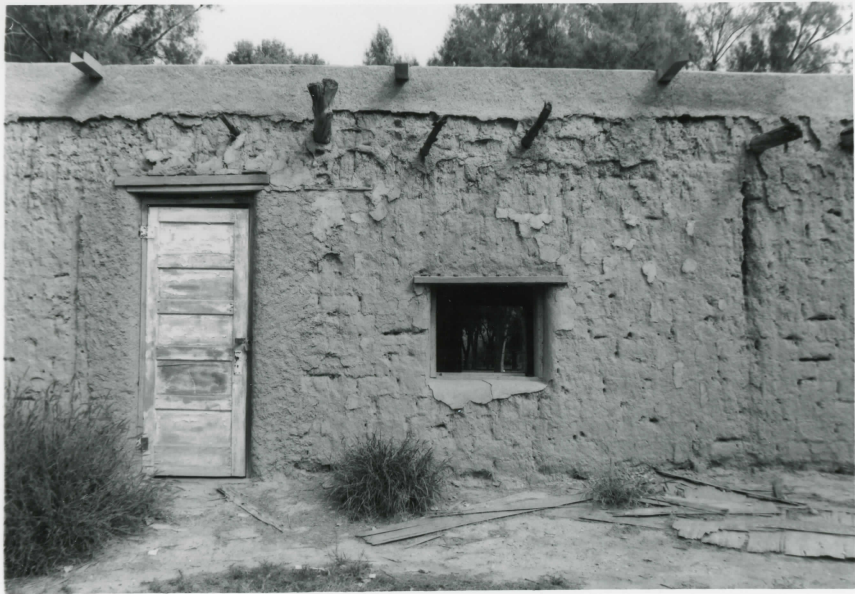
Daniels Farm House
Big Bend National Park, Texas
Tom Vitanza November 1984
NPS/ Southwest Region Office
Santa Fe, New Mexico
View of southern elevation exposed vigas &
caneles. (camera facing north)
Photo Number 2

The construction of the exterior walls is adobe brick, which appears rather rough in texture. The parapet along the south is broken by six existing canales that extend beyond the surface of the wall approximately 24". Vigas, which support the roof, are also visible on this elevation, extending to about 10".

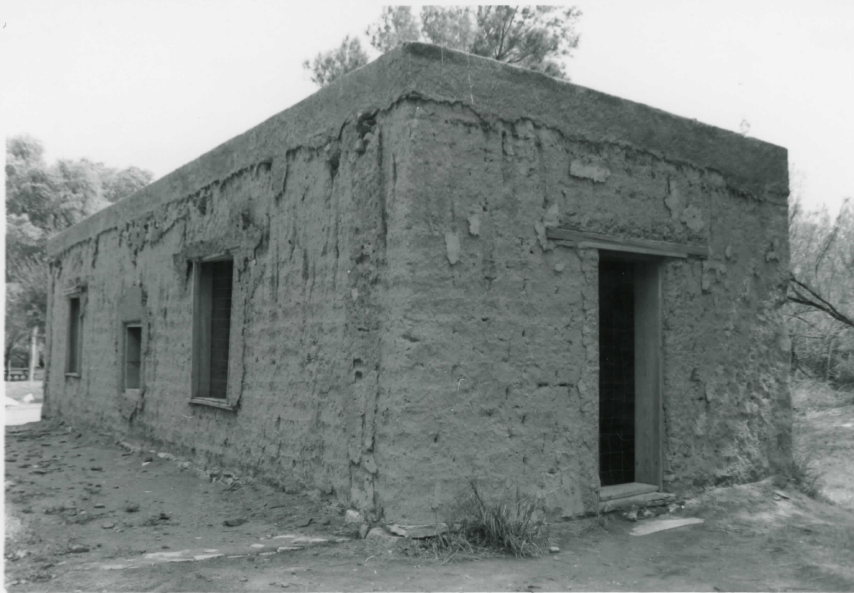
Daniels Farm House
Big Bend National Park, Texas
Tom Vitanza November 1984
NPS/ Southwest Region Office
Santa Fe, New Mexico
View of NW corner showing both north eleva-
tion and west elevation. (facing southeast)
Photo Number 3

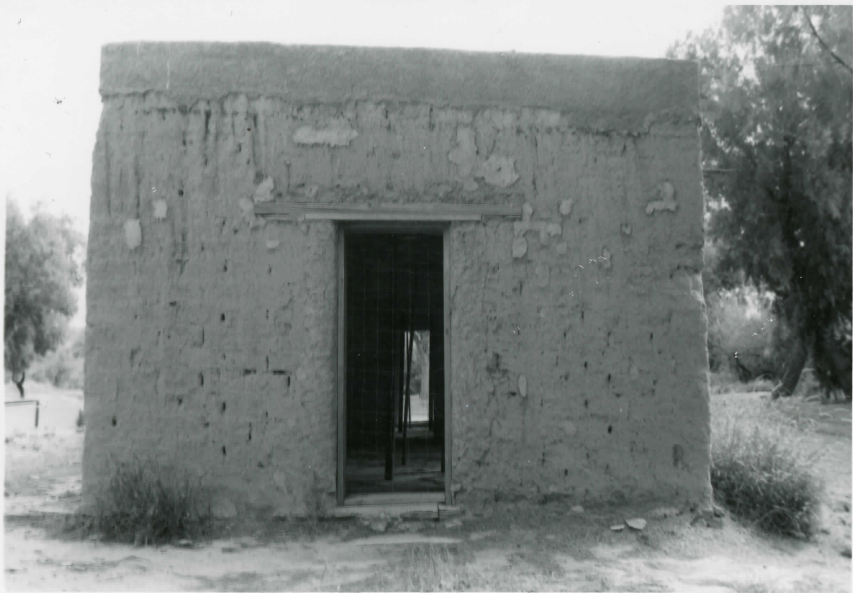
Daniels Farm House
Big Bend National Park, Texas
Tom Vitanza November 1984
NPS/ Southwest Region Office
Santa Fe, New Mexico
View of west elevation showing doorway.
(camera facing east)
Photo Number 4

The adobe walls are built on a stone rubble foundation measuring approximately 18" to 24" wide. The south elevation has two doors, one at each end and a single window located just west of the central interior wall. The north elevation is broken by three window openings, two of which open into the western room. The average size of all windows is 3'-6" X 4'-9". All window frames and door jambs are constructed of rough-cut, dimensional lumber measuring 2" X 12". The lintels extend through the entire thickness of the wall and are exposed on the interior. None of the window sashes remain and only one of four doors is in existence. The latter is constructed of five equally-sized panels of rough-cut dimensional lumber held together by heavier stiles and rail.

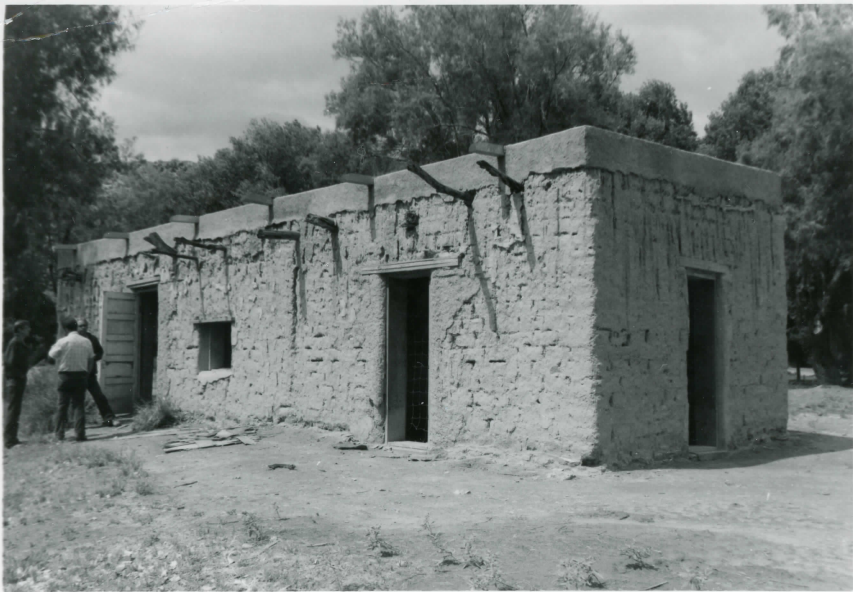
Daniels Farm House
Big Bend National Park, Texas
Tom Vitanza November 1984
NPS/ Southwest Region Office
Santa Fe, New Mexico
View of SE elevation (camera facing NW)
Photo Number 5

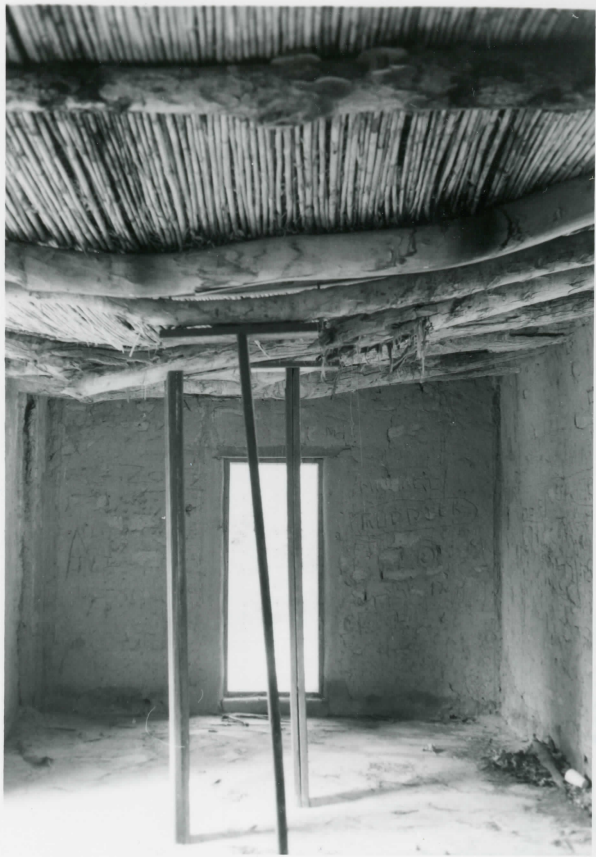
Interior view of cane and viga roof construction. Note deterioration & graffiti (facing east). Photo Number 6

The most striking feature of the interior is the ceiling, which is actually the underside of the roof construction. A series of unevenly spaced aspen vigas, measuring 9-11" in diameter, support the weight of the roof. These supports rest on a dimensional lumber bearing plate that is an integral part of the wall construction. Running perpendicular to the vigas are river cane and reed latillas woven together into a series of mats that give a corrugated look to the ceiling. Above the latillas is a covering of reeds and grass thatching capped with adobe mud. Notably, this roof is also not the original, but also part of the 1972 rehabilitation project. Today, the roof shows signs of serious deterioration. Several of the vigas are fractured and are presently being held by vertical supports. Portions of the latilla ribbing have also deteriorated beyond reuse.
