National Register of Historic Places
Registration Form

historic name Texas Technological College Dairy Barn

Texas Tech Dairy Barn
Lubbock, Lubbock County, Texas

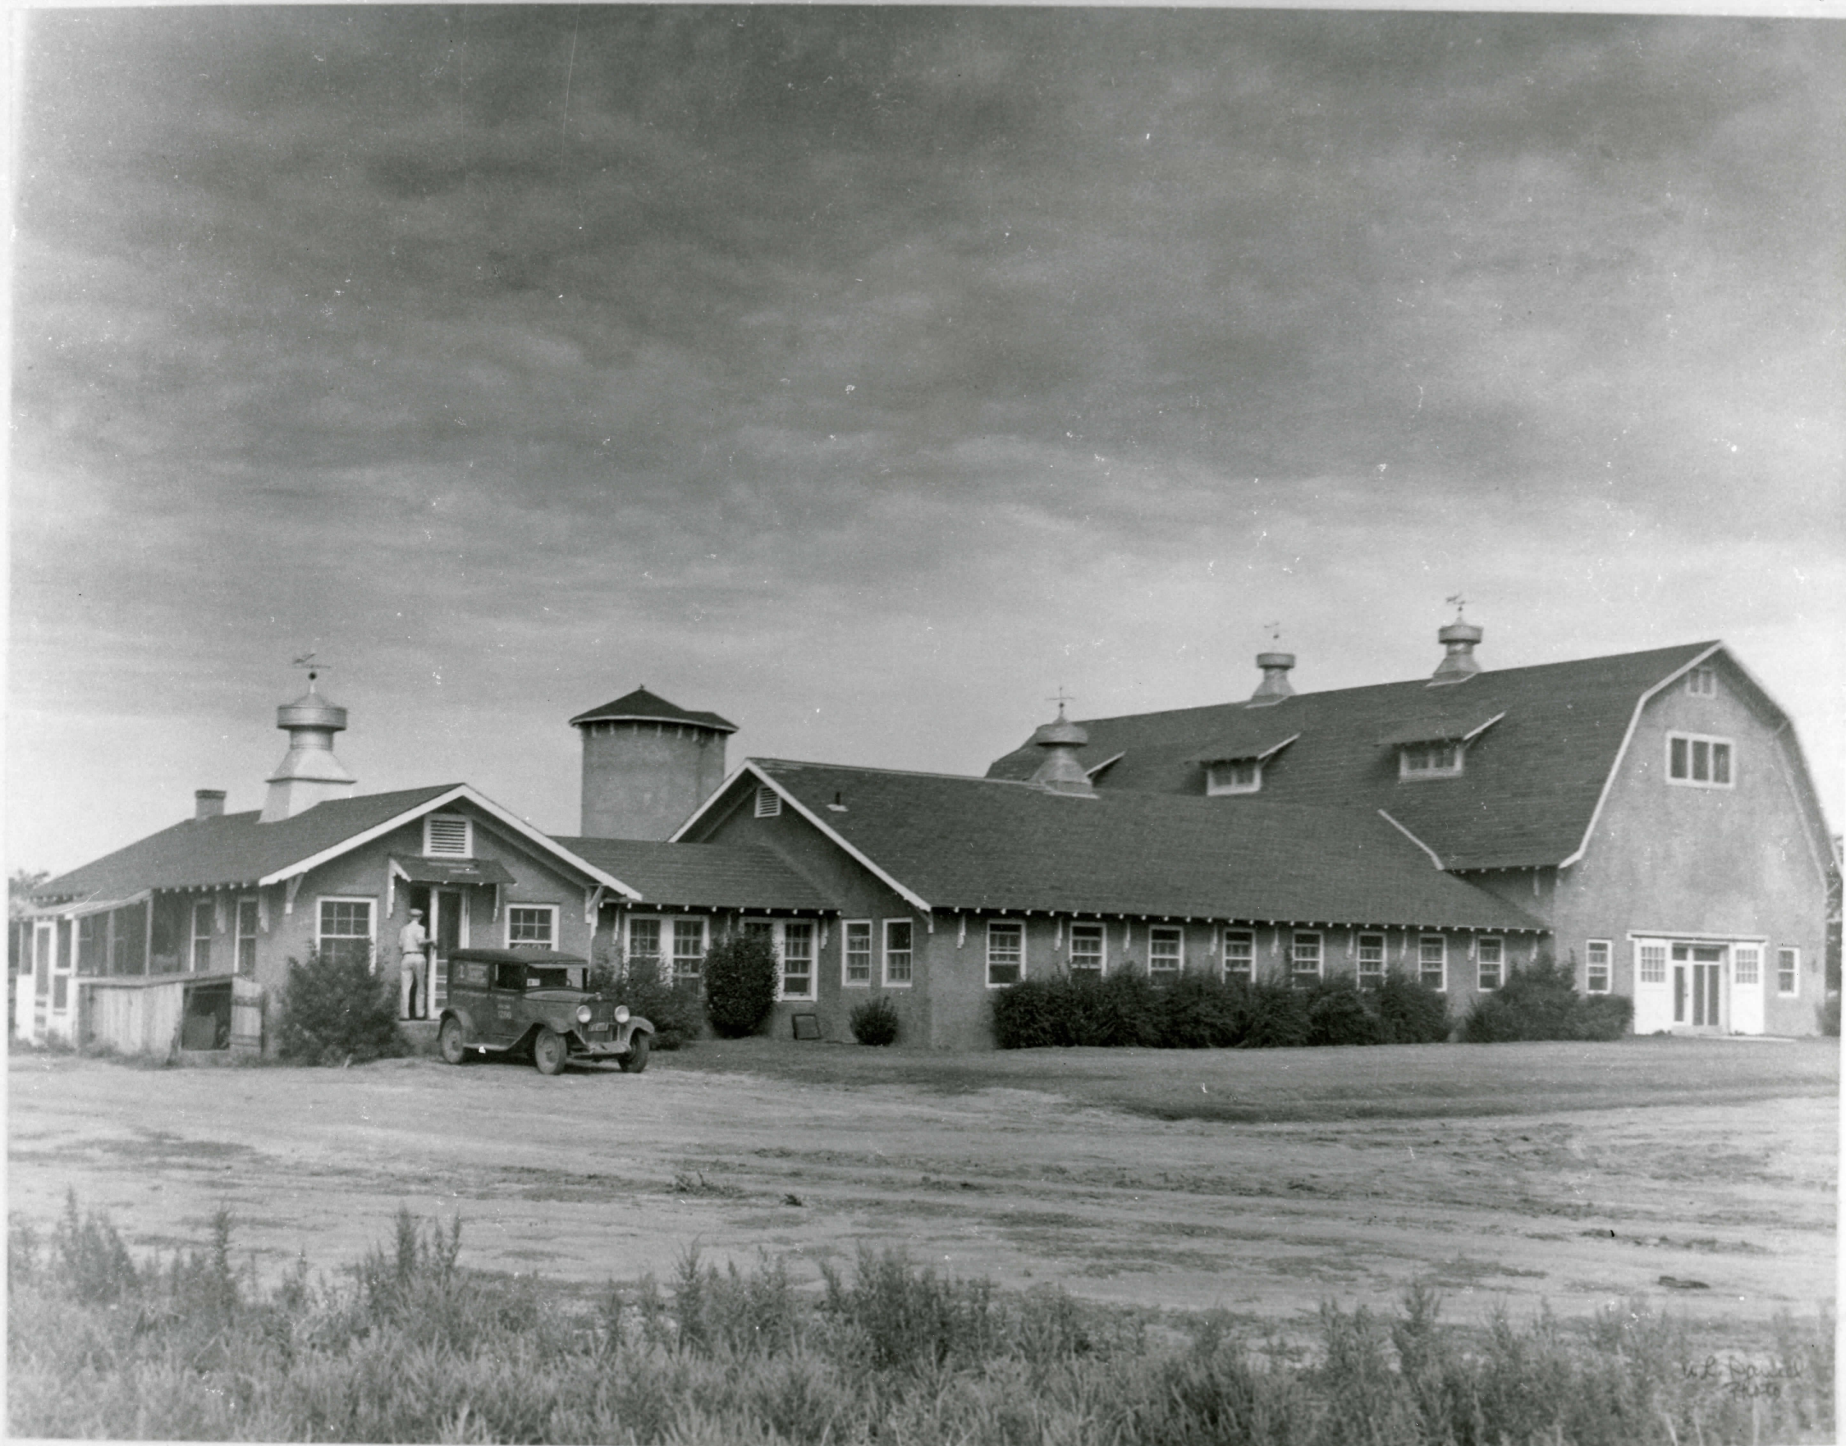
PHOTOGRAPH 1 of 6

Texas Technological College Dairy Barn
Texas Tech University
Lubbock, Lubbock County, Texas
Photographer unknown
circa 1930
Negative on file with the Southwest Collection, Texas Tech University
Southeast oblique, camera facing northwest
Photograph 1 of 6

The north-south axis of the barn's overall L plan originally ambled along three 1-story wings with gabled roofs (Photo 1). At the south end of the stem was a 16'x 36' "milk house" wing with an east-west ridgeline. A "sun room" extended immediately north under a north-south ridgeline, connecting milking operations with a 1-story barn area under a larger gabled roof, running into the east-west gambrel roof of the 36'x130' 2-story north wing of the L. The 14' diameter by 40' high silo was placed about 75' west of the 2-story wing. Fenced areas south and west of the barn, with elm and other trees planted along some fencelines, were directly associated with the complex (photo 2).

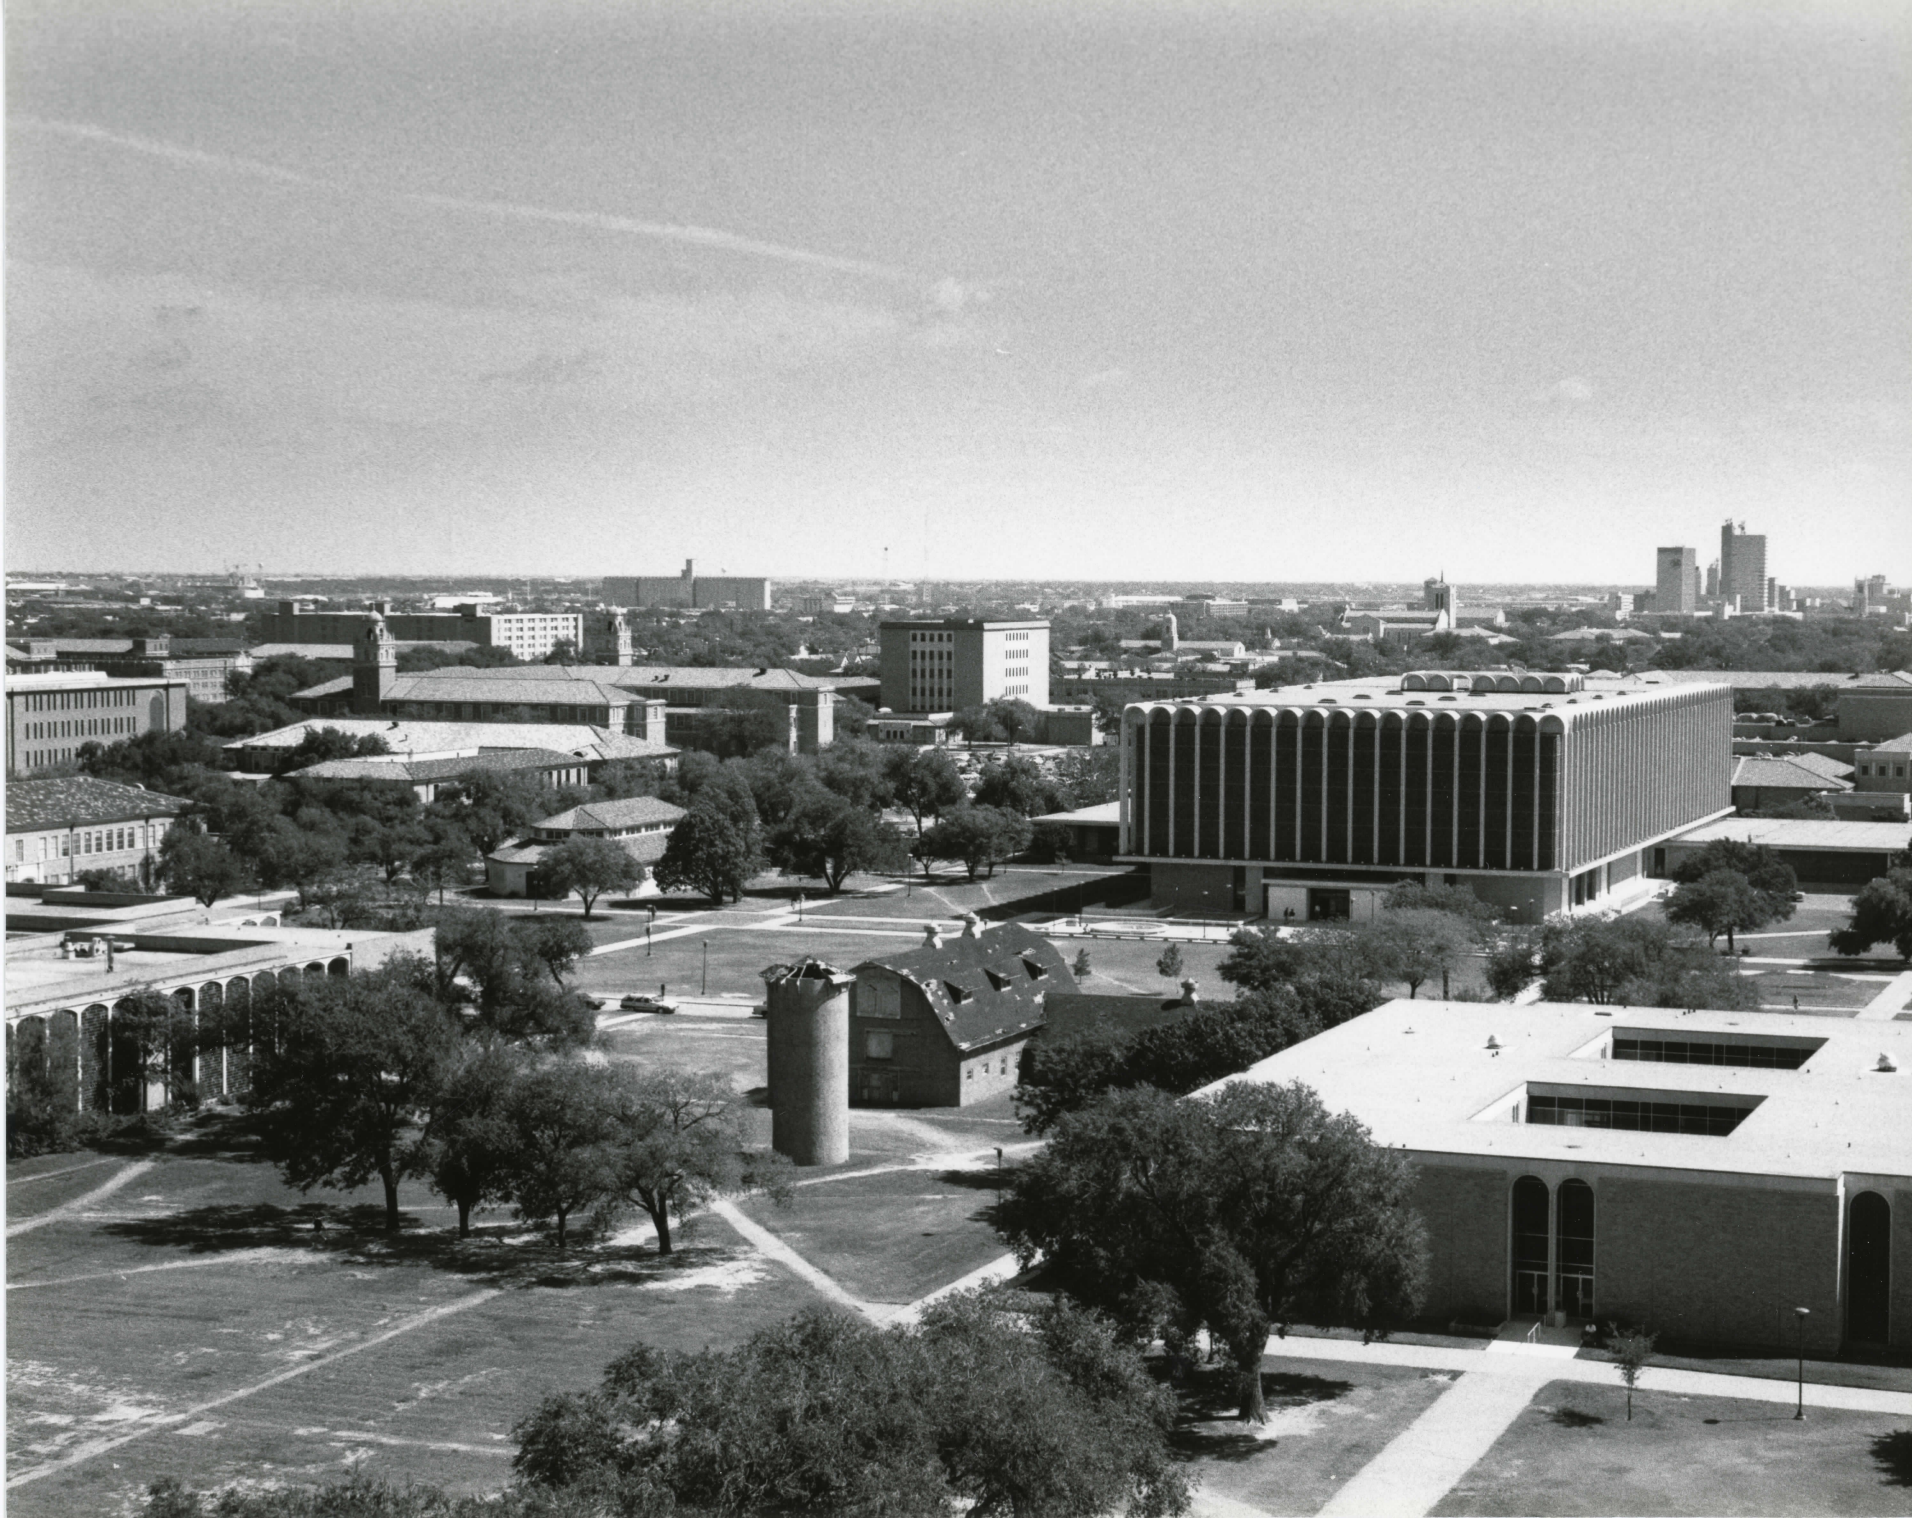
PHOTOGRAPH 2 of 6

Texas Technological College Dairy Barn
Texas Tech University
Lubbock, Lubbock County, Texas
Photographed by Southwest Collection staff
1991
Negative on file with the Southwest Collection, Texas Tech University
Campus and city context (from Architecture Building), camera facing E-NE
Photograph 2 of 6

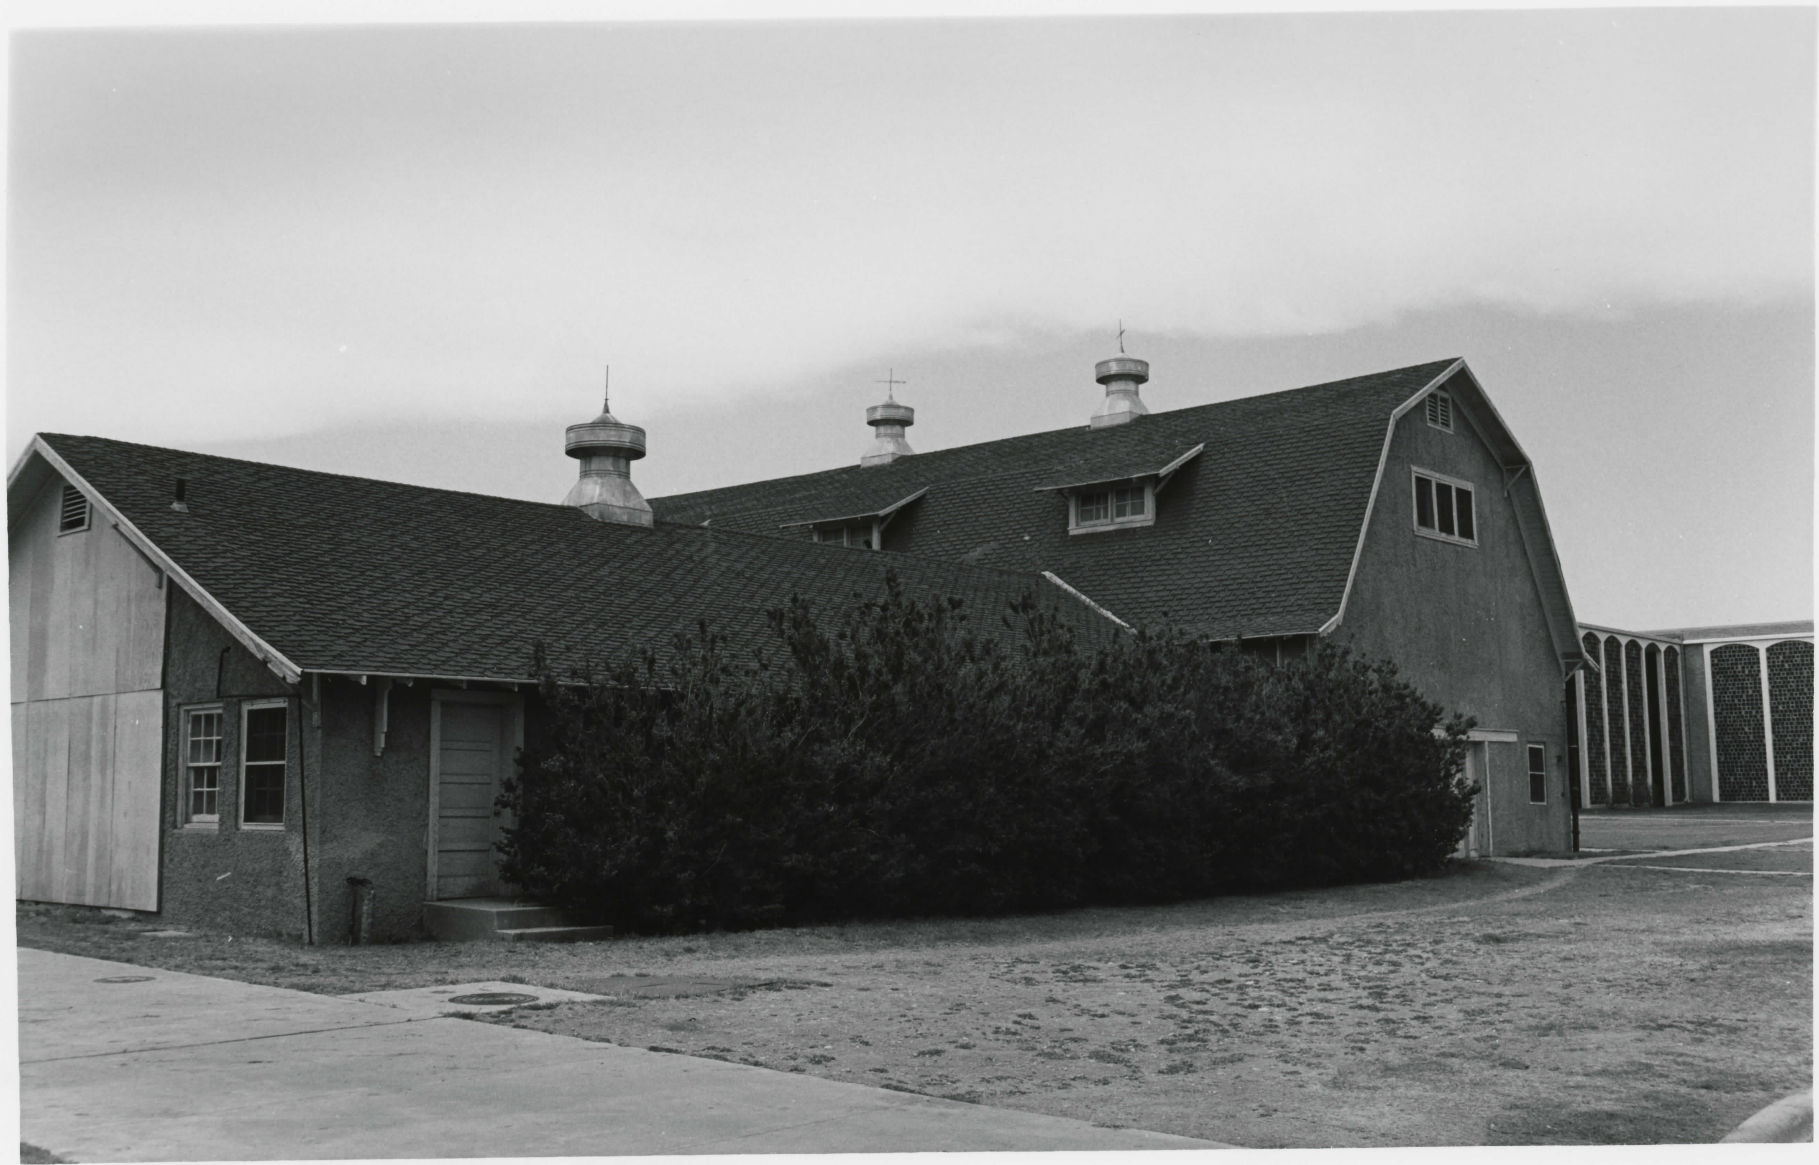
PHOTOGRAPH 3 of 6

Texas Technological College Dairy Barn
Texas Tech University
Lubbock, Lubbock County, Texas
Photographed by Southwest Collection staff
1990
Negative on file with the Southwest Collection, Texas Tech University
Southeast oblique, camera facing northwest
Photograph 3 of 6

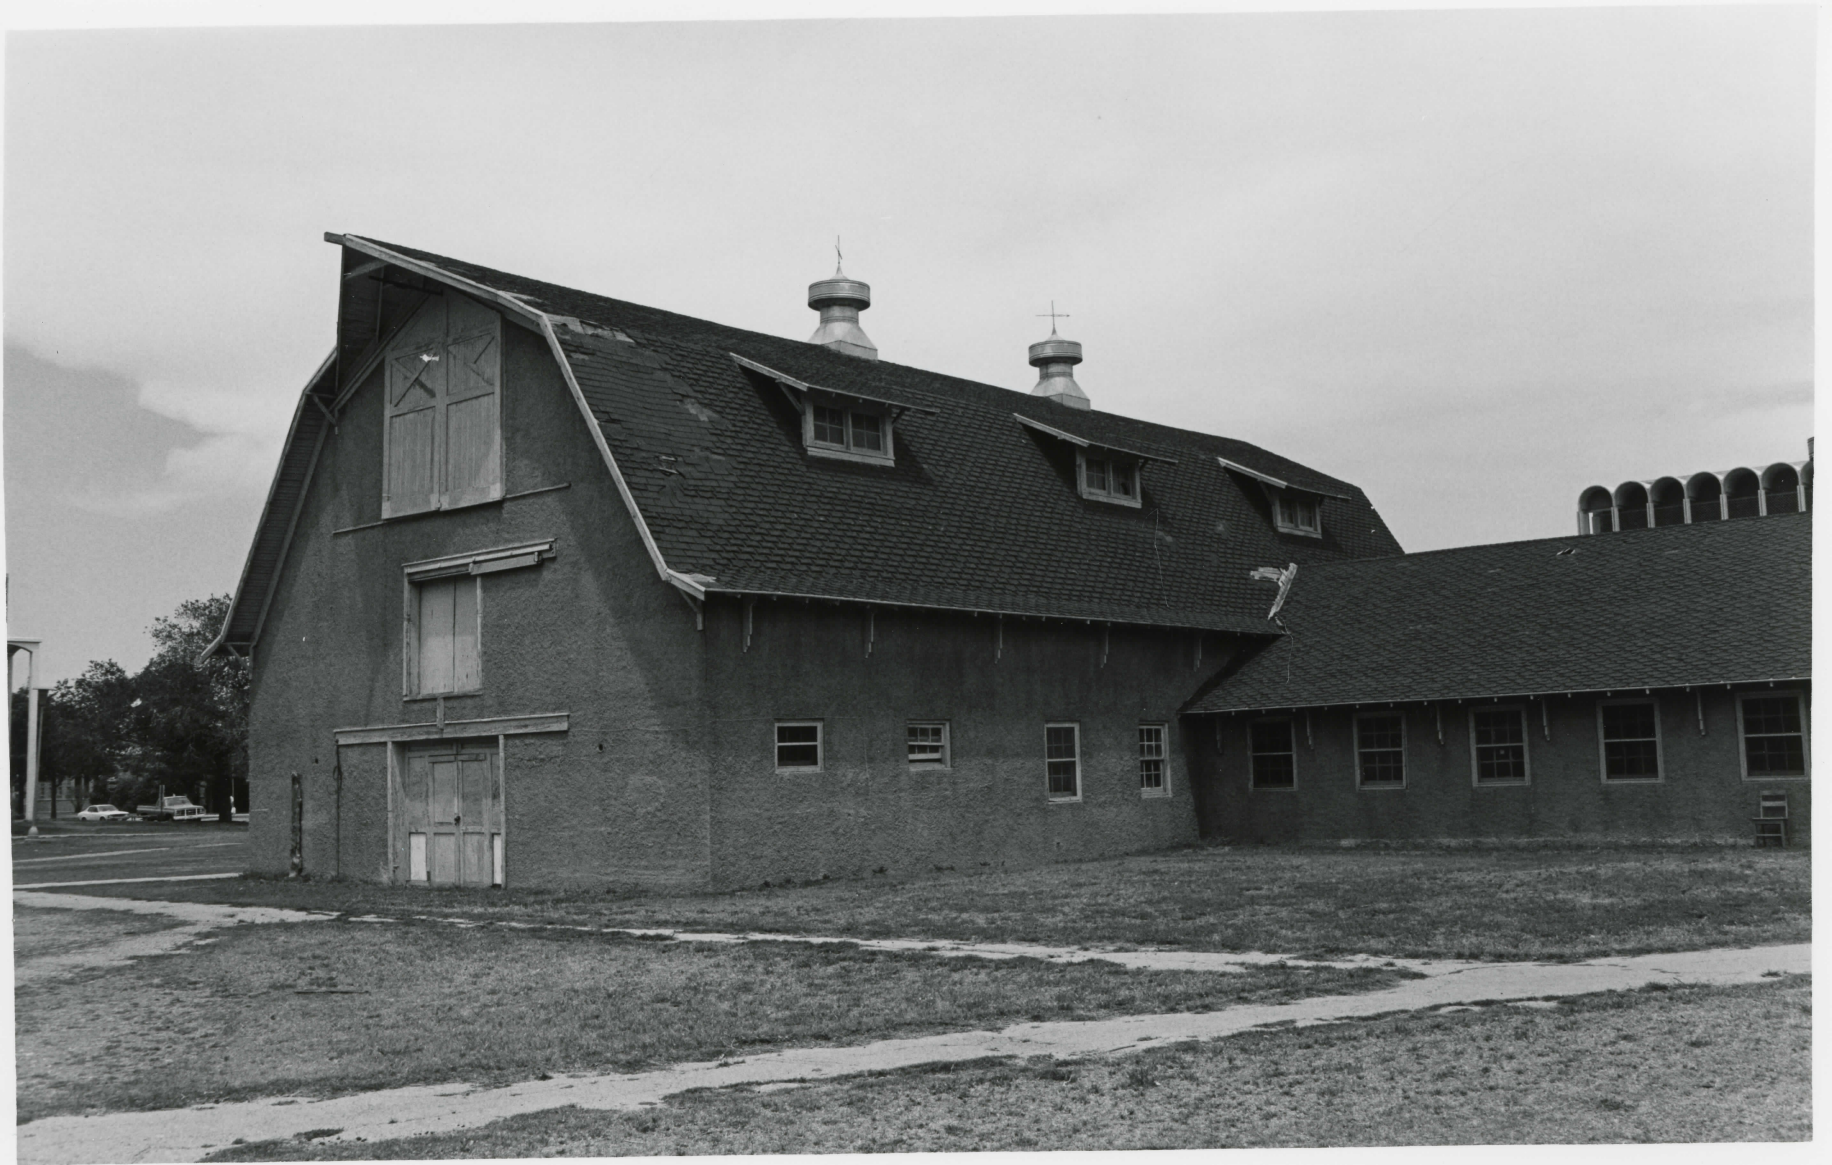
PHOTOGRAPH 4 of 6

Texas Technological College Dairy Barn
Texas Tech University
Lubbock, Lubbock County, Texas
Photographed by Southwest Collection staff
1990
Negative on file with the Southwest Collection, Texas Tech University
Southwest oblique, camera facing northeast
Photograph 4 of 6

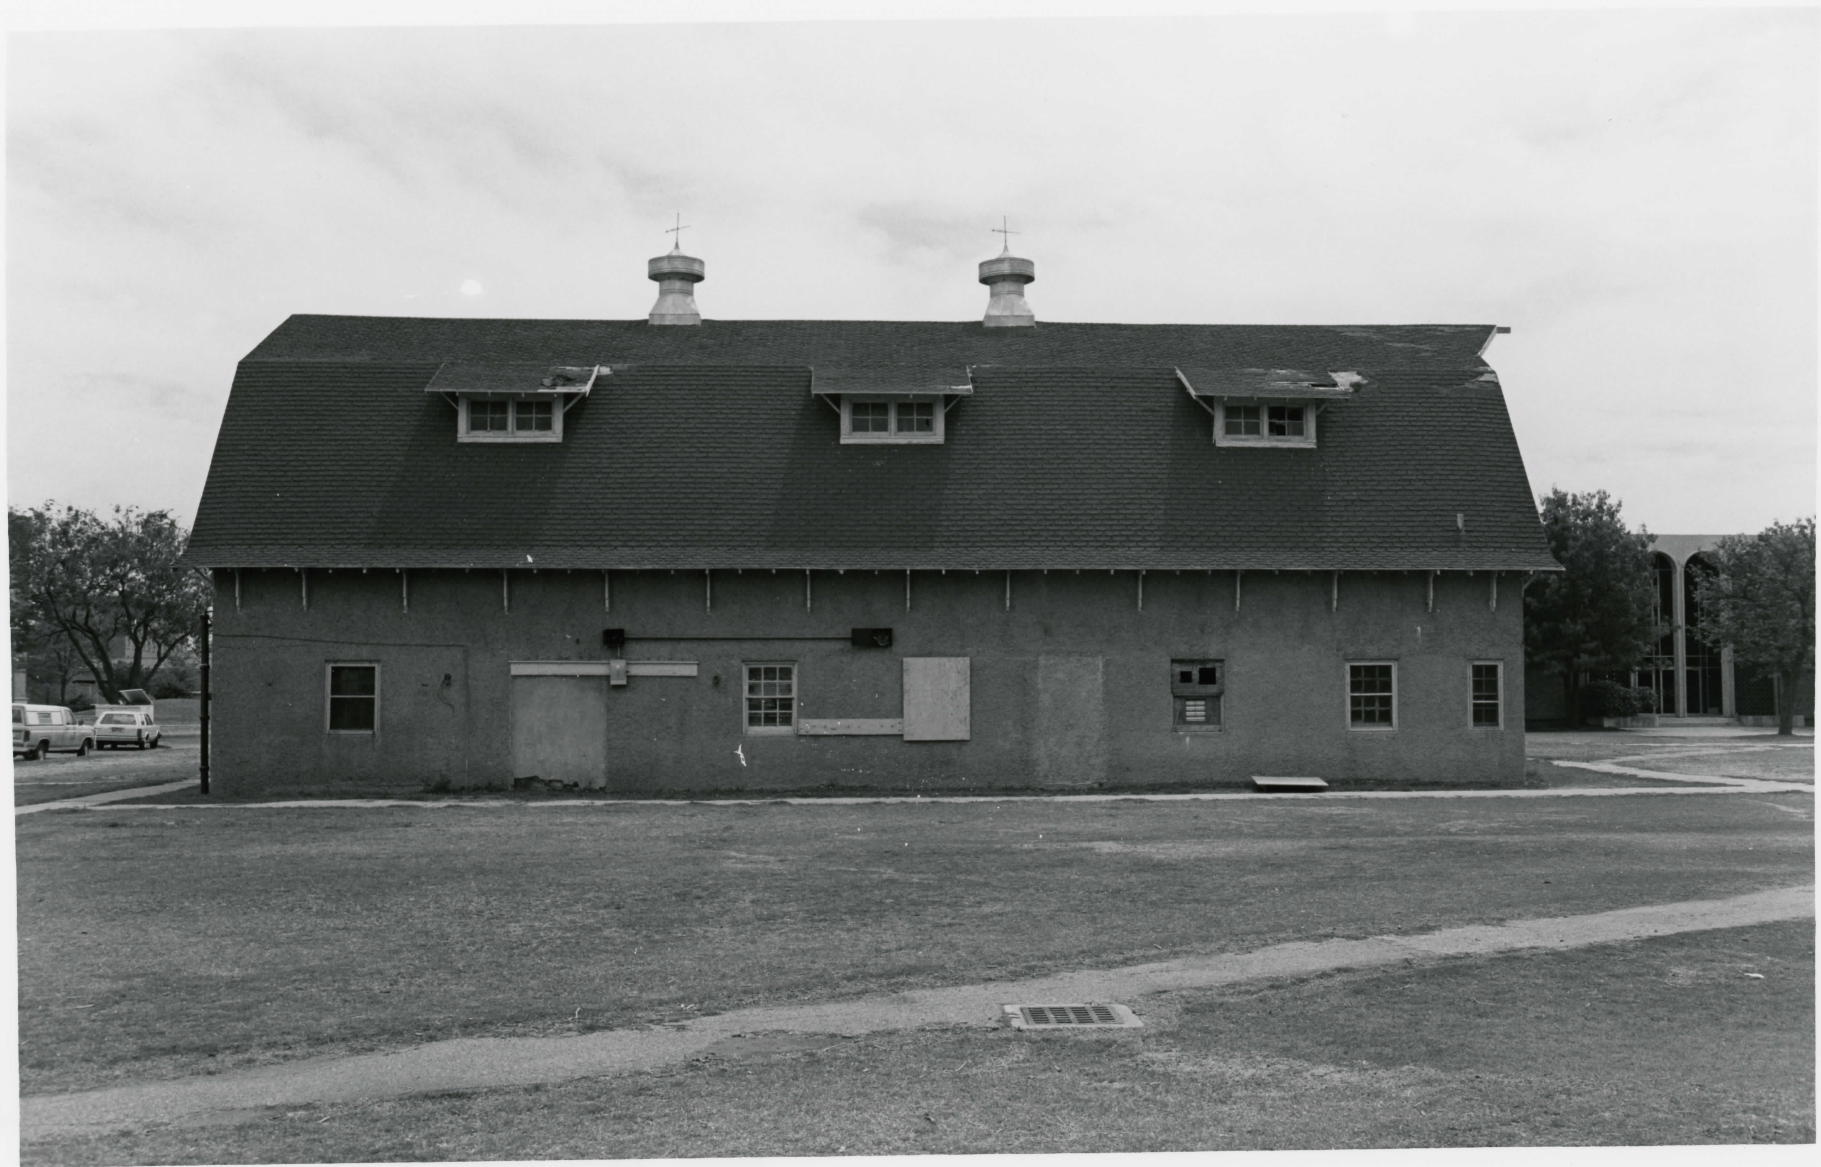
PHOTOGRAPH 5 of 6

Texas Technological College Dairy Barn
Texas Tech University
Lubbock, Lubbock County, Texas
Photographed by Southwest Collection staff
1990
Negative on file with the Southwest Collection, Texas Tech University
North elevation, camera facing south
Photograph 5 of 6

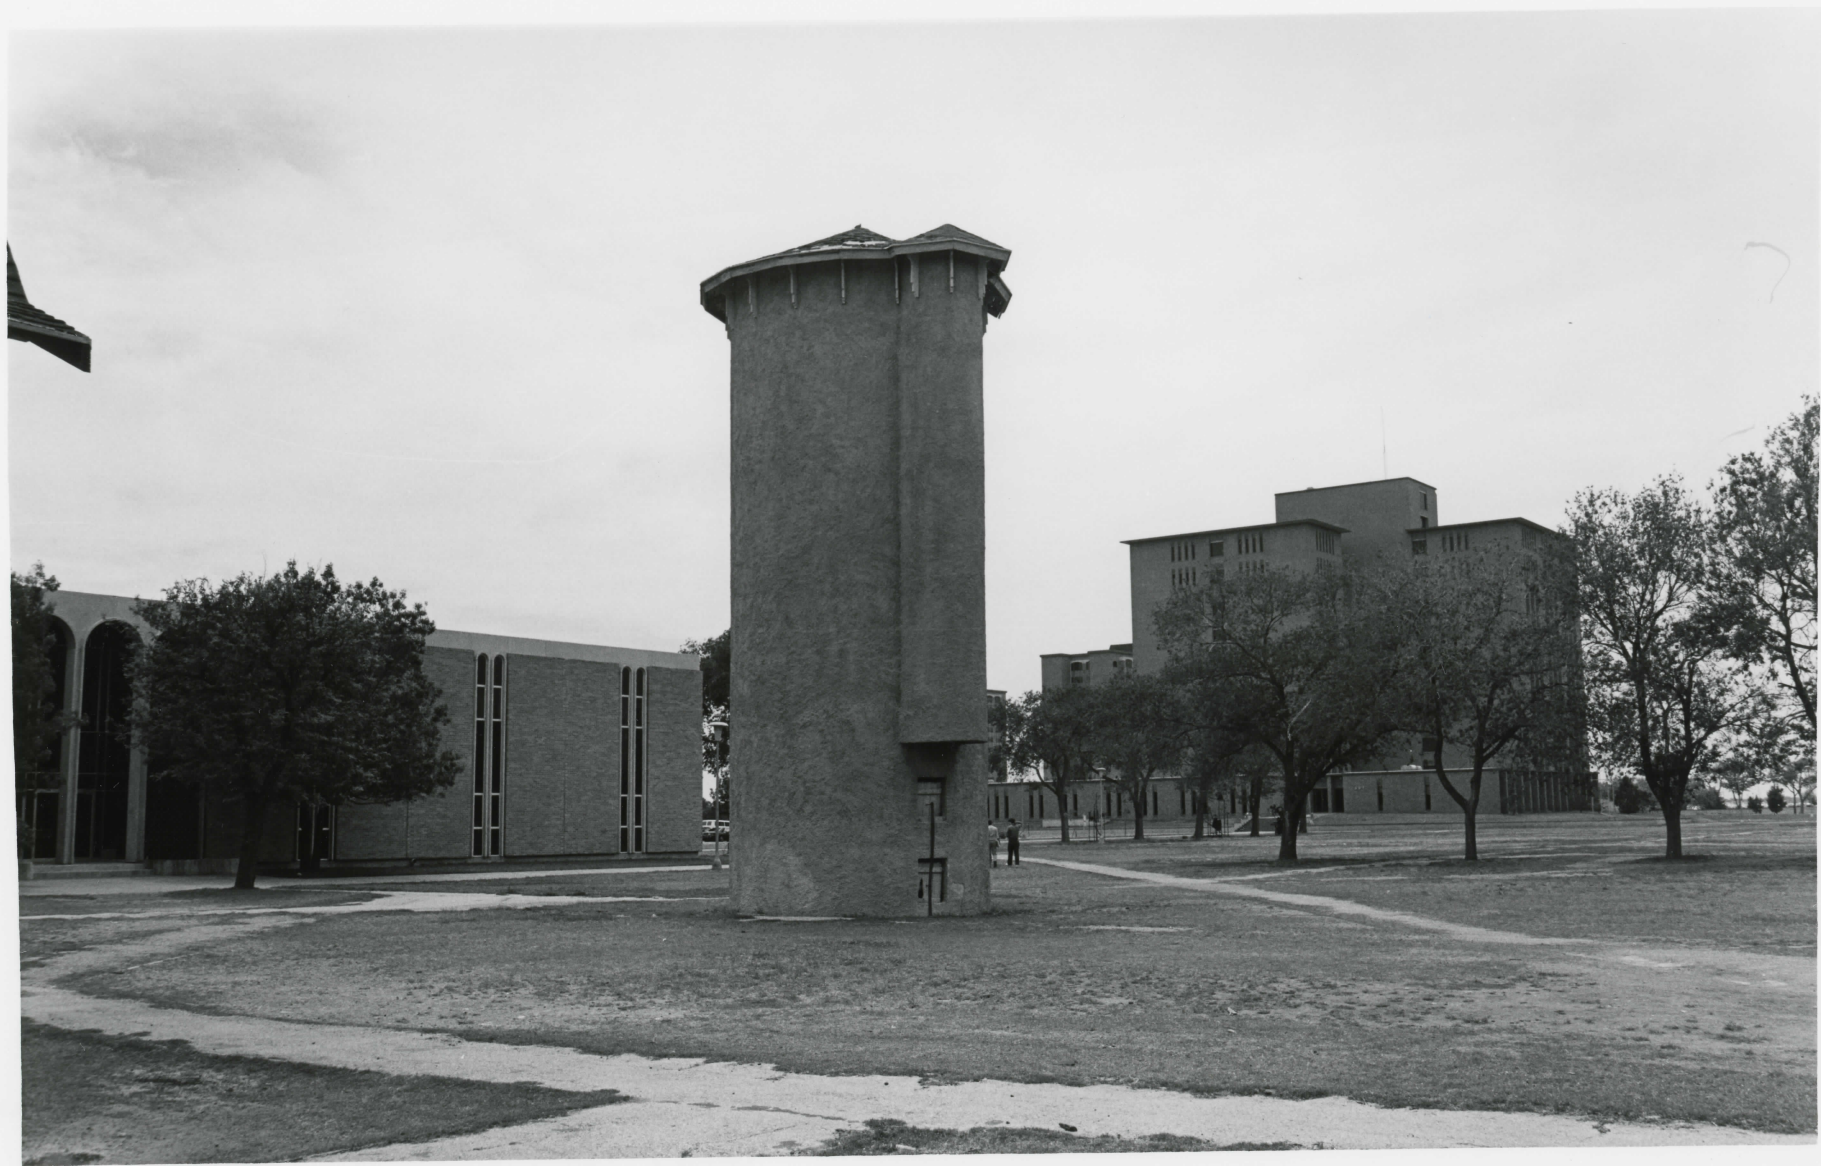
PHOTOGRAPH 6 of 6

Texas Technological College Dairy Barn
Texas Tech University
Lubbock, Lubbock County, Texas
Photographed by Southwest Collection staff
1990
Negative on file with the Southwest Collection, Texas Tech University
Silo northeast, camera facing southwest
Photograph 6 of 6
