NATIONAL REGISTER OF HISTORIC PLACES  
REGISTRATION FORM

HISTORIC NAME: US 190 Bridge at the Colorado River  
OTHER NAMES/SITE NUMBER: LM0272-05-023

Historic Bridges of Texas  
US 190 Bridge at the Colorado River  
Lampasas and San Saba counties, Texas

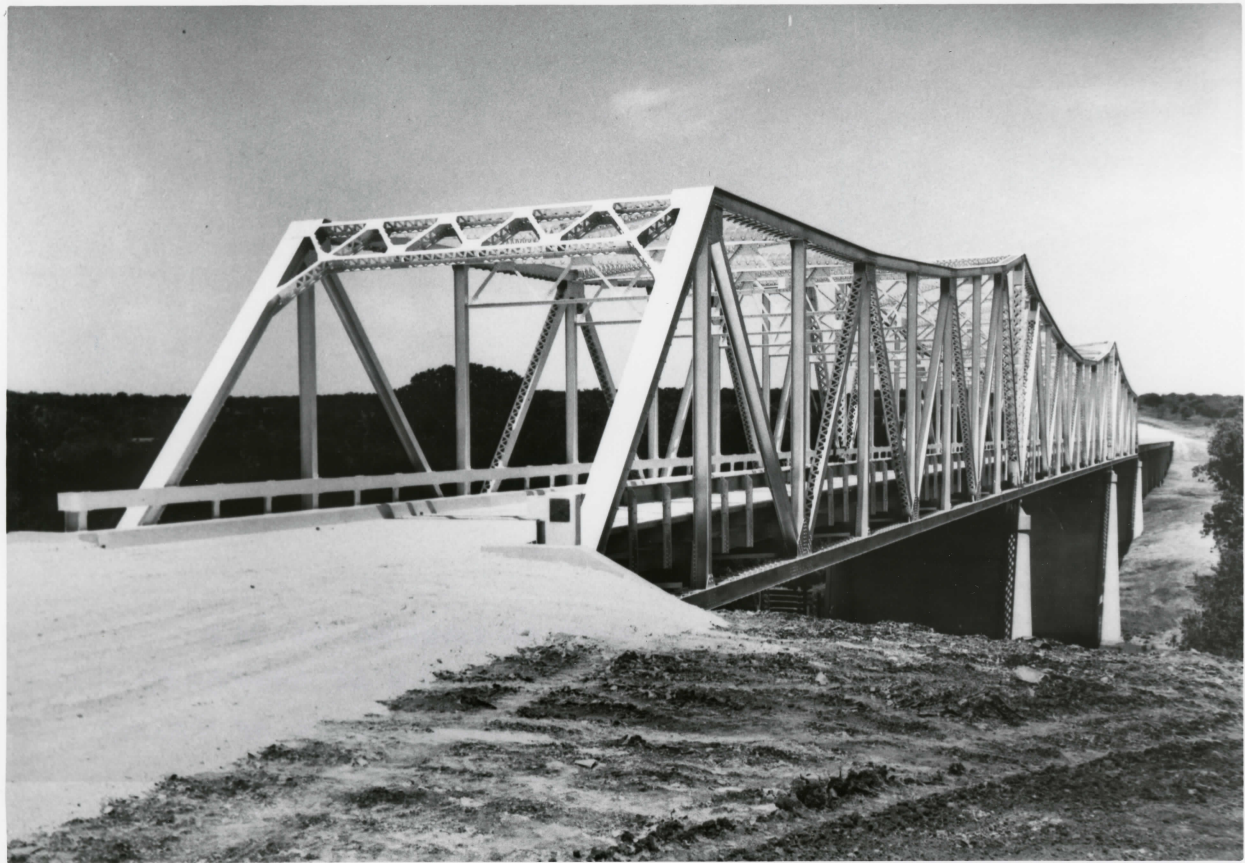
SITE NO. LM0272-05-023  
US 190 BRIDGE AT COLORADO RIVER  
HISTORIC BRIDGES OF TEXAS  
LAMPASAS CO., TEXAS  
PHOTOGRAPH 3 OF 3 (HISTORIC)

Texas Highway Department (THD) engineers custom-designed the bridge's truss spans. These spans form a continuous Warren truss with top chords resembling the curve seen in suspension bridges (see Photograph 3). Both the truss spans and the concrete approach spans rest on reinforced concrete dumbbell piers, some with square battered columns and others with cylindrical battered columns (see Photograph 2). Both spread footing and precast concrete pile foundations are employed. The bridge provides a 24-foot roadway with 1½-foot curbs serving as refuge walks for stranded pedestrians. THD Type P approach railing consists of steel channel rails and reinforced concrete posts. Truss railing employs 12-inch deep steel channels (see Photograph 1). At each end of the bridge, a bronze plaque affixed to a concrete monument identifies the bridge contractor, as well as the governmental agencies responsible for the project. The plaque reads:

THD engineers prepared the plans for the new bridge and BPR engineers reviewed and approved them. Rather than use a standard design, THD bridge engineers developed a special design for the bridge, employing a continuous truss span for improved economy and appearance. The bridge's top chord curves between two high points, similar to the cable configuration used on suspension bridges. The truss' high points lie over the piers, reflecting the need to resist larger stresses at these locations.
